Research Article

Effect of Web Openings on Flexural Behaviour of Underground Metro Station RC Beams under Static and Cyclic Loading

This paper investigates the influence of multiple transverse web openings on the flexural behaviour of underground metro station reinforced concrete (RC) beams. This problem is outlined with an actual underground engineering project, in which the web opening used in the RC beams violates the current specifications. A total of five beams with different numbers of web openings are fabricated and tested under static and cyclic loading conditions, thereby simulating actual operations in unfavourable conditions. The results suggest that the existence of the openings decreases the loadbearing capacity, ductility, stiffness, and energy dissipation ability of the RC beams. Moreover, the results show that the corners of the openings are the weakest parts of the beams. However, additional reinforcements around the openings can partially mitigate the impact of the openings on the loadbearing and seismic performance of the RC beams. The laboratory experiments presented herein not only provide guidelines for the use of RC beams with web openings in actual enginee

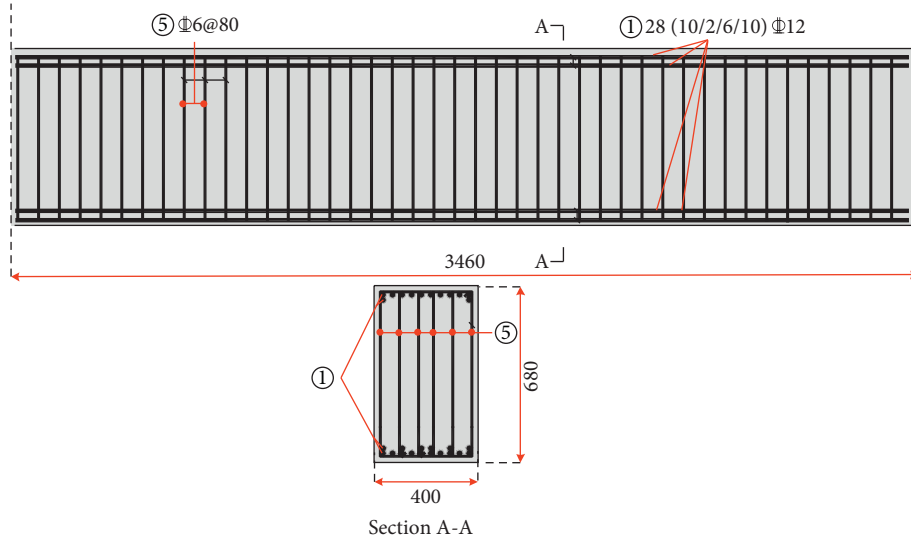
FIGURE 1: Beam R: reinforcement arrangement (mm).

As shown in Table 2 and Figures 1–3, a total of five RC beams with a span length of 3,460 mm were fabricated and tested. The specimen with a 400 mm \times 680 mm rectangular section without openings was denoted with the capital letter “R” (i.e., the reference beam). Two specimens with 400 mm \times 680 mm rectangular sections were denoted with the capital letter “O,” in which each has one 840 mm \times 220 mm rectangular opening. Two specimens with 400 mm \times 760 mm rectangular sections were denoted with the capital letter “T,” in which each has two 760 mm \times 380 mm rectangular openings and one 580 mm \times 380 mm rectangular opening. Both the locations and the sizes of the web openings were designed to meet the needs in engineering practice. The reinforcements used in the specimens can be divided into 4 different groups: side reinforcements, chord reinforcements, diagonal reinforcements, and stirrup reinforcements, as detailed in Table 2 and Figures 1–3.

3.1. Reinforcement Arrangement. As illustrated in Figures 2–3, the diagonal reinforcements were used to control the crack widths. Moreover, the upper and lower chord reinforcements were adopted in the beams with

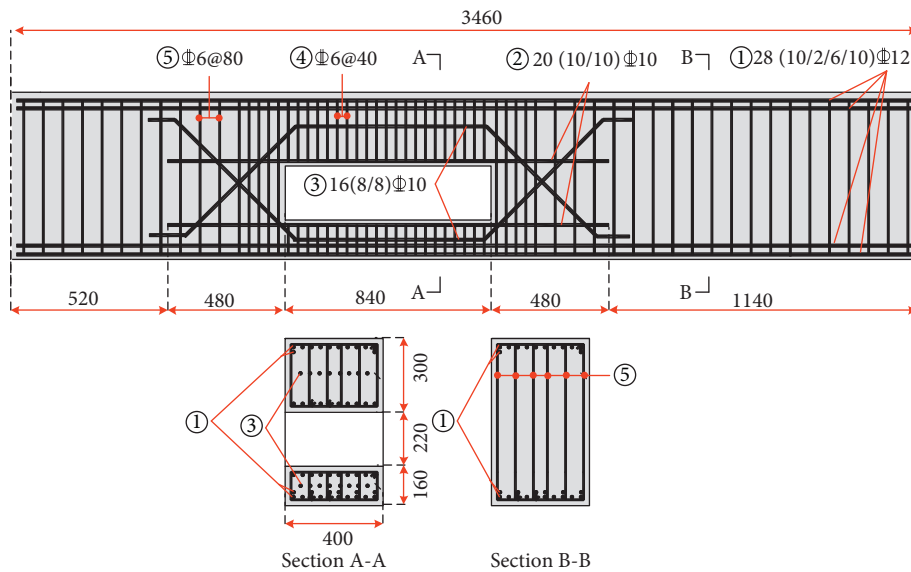
FIGURE 2: Beam O: reinforcement arrangement (mm).

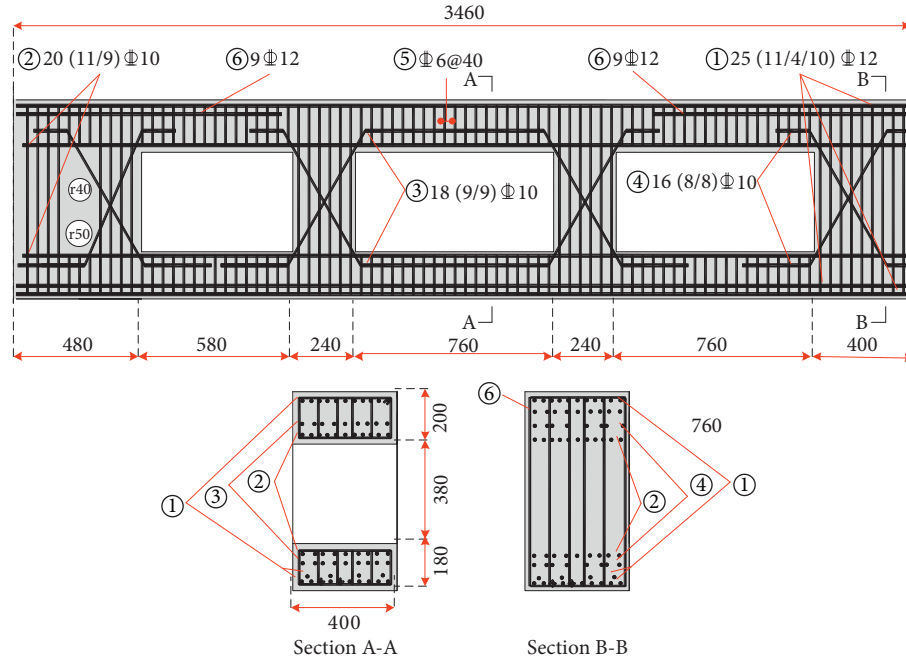
FIGURE 3: Beam T: reinforcement arrangement (mm).

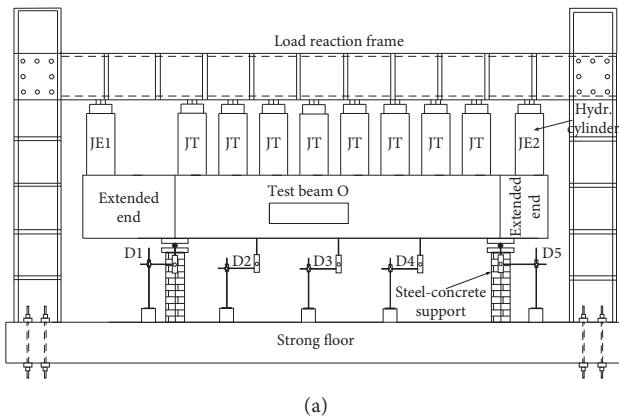
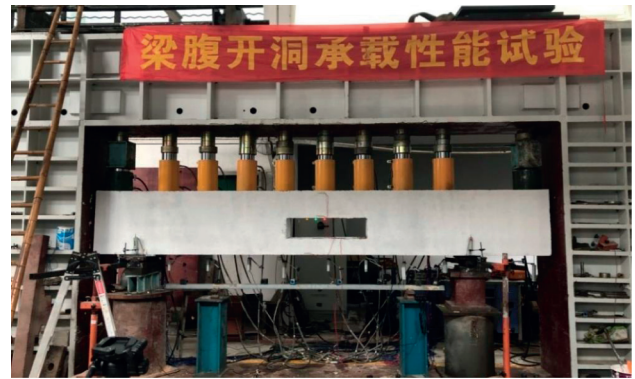
FIGURE 4: Static test setup. (a) Setup schematic. (b) Setup photograph.

A schematic of the testing setup is provided in Figure 4, which shows that the specimens were simply supported on two steel-concrete supports and loaded in a steel frame with a loading capacity of 4000 kN. For the static loading tests, the beams were cast with 400 mm-long extended ends and contained both side reinforcements and stirrup reinforcements. The extended ends on both sides were used to simulate the reverse bending moment on continuous beams. The loads from eight JT hydraulic cylinders were equally distributed on the test beams. Two JE hydraulic cylinders were positioned on both extended ends to exert negative moments on the test beams. The settlement of the two supports and the vertical deflections at the midspan were collected through five linear variable differential transformers (LVDTs).

Special attention was paid to achieving equal and concentric loading on the test beams with the JT hydraulic cylinders. The deviations from this uniform loading due to the excessive asymmetrical deformations in the plastic phases of the tests were ignorable. The beams were loaded up to designed levels to simulate the conditions in actual engineering projects. For static loading, the loads from hydraulic cylinders JE1 and JE2 were 3.3 times and 2 times larger than that from the JT hydraulic cylinders, respectively. The locations and widths of the cracks generated at different load levels were marked and measured, respectively. Each specimen was instrumented with an extensive set of internal sensors. A large number of conventional strain gauges (SGs) were placed along the longitudinal rebars to measure the internal strain changes due to the applied loading and to identify local yielding and rebar extension. According to internal force analyses, for beams O (O1 & O2) with one opening and beams T (T1 & T2) with three openings, all the openings were located in both shear and flexure zones.

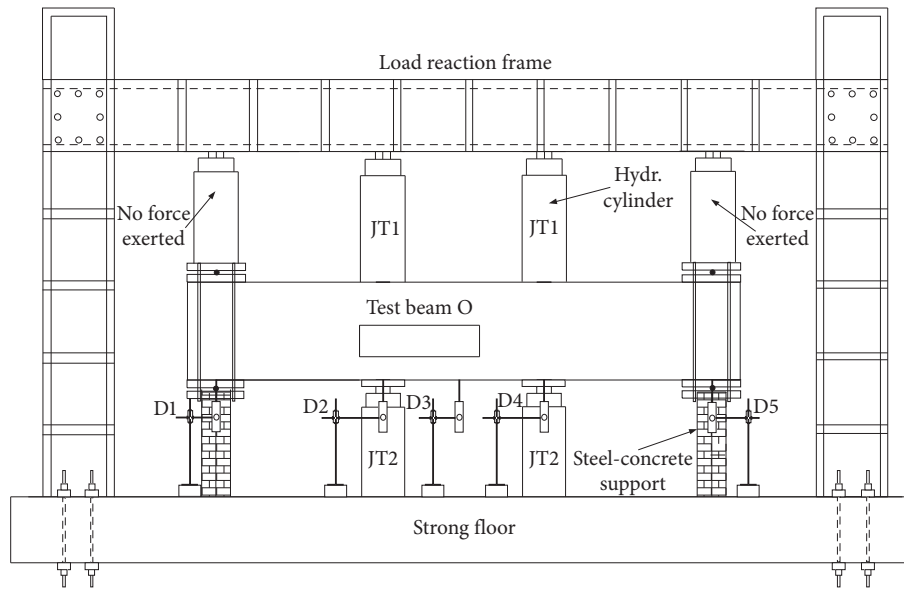
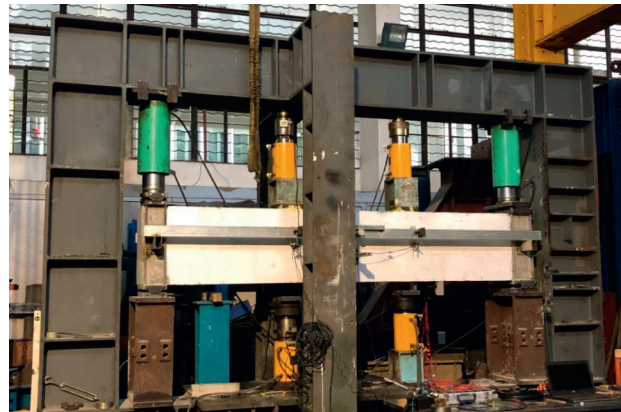
FIGURE 5: Cyclic test setup. (a) Setup schematic. (b) Setup photograph.

For the cyclic loading test shown in Figure 5, the beams were simply positioned on the supports. Moreover, two

hydraulic cylinders exerting no force were fixed on the ends of the beam to restrict its entire vertical movement during the loading process. The loads from four JT hydraulic cylinders were concentrated on tripartite points to simulate repeated earthquake loads. The settlement of the two supports, the displacements at the tripartite points, and the deflections of the midspan were collected with five LVDTs.

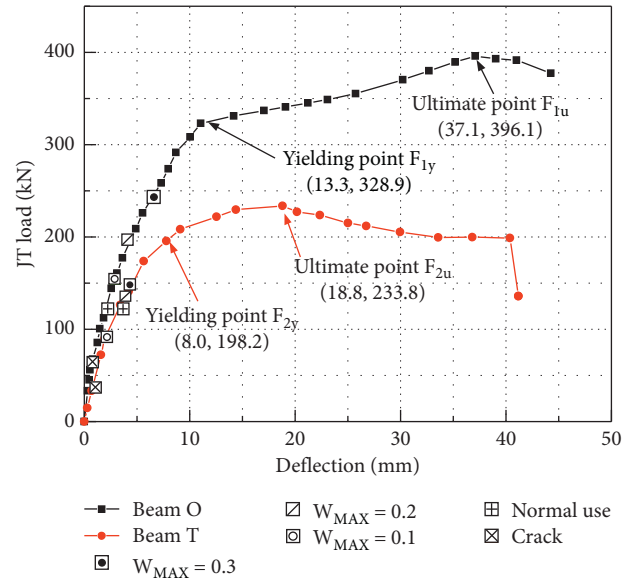
FIGURE 7: Load-deflection curves of the specimens.

4.2. Ductility and Rigidity. The load-deflection curves of the specimens are illustrated in Figure 7. Table 3 tabulates the deformation ductility indices (u) and the stiffness of the specimens. The indices (u) are the ratio of the midspan deflection at the ultimate load to that at the yielding of the tensile reinforcement, which represents the deformation capacity of the beam. The equivalent yield points in both curves were determined using the Park method with a load factor of 0.75 [23]. The initial secant stiffness represents the initial value at the very beginning of the test, whereas the average stiffness corresponds to the average value in the linear stage up to yielding. Since it is cumbersome to determine the specific value of the moment-curvature curve in the test beams, the slope of the load-deflection curves was used for the stiffness calculation. Five marks were positioned on both curves, representing five different loading states: crack (first crack observed), normal use (engineering design load), $W_{\max} = 0.1$ (maximum crack width reaching 0.1 mm), $W_{\max} = 0.2$, and $W_{\max} = 0.3$. The failure state was defined when a sudden offload was detected on the hydraulic cylinders.

For the test of beam O, the obtained yield load was 328.9 kN, which was 65.9% larger than the yield load of beam T (198.2 kN). The ultimate load for beam O was 396.1 kN,

which was 20.4% larger than its yield load. The results clearly suggest that increasing the number of openings significantly decreased the loadbearing capacity of a beam. As illustrated in Figure 7, cracks initiated before the sustained load reached the engineering design load, which is indicative that even under design loads, cracks propagated in beams with openings.

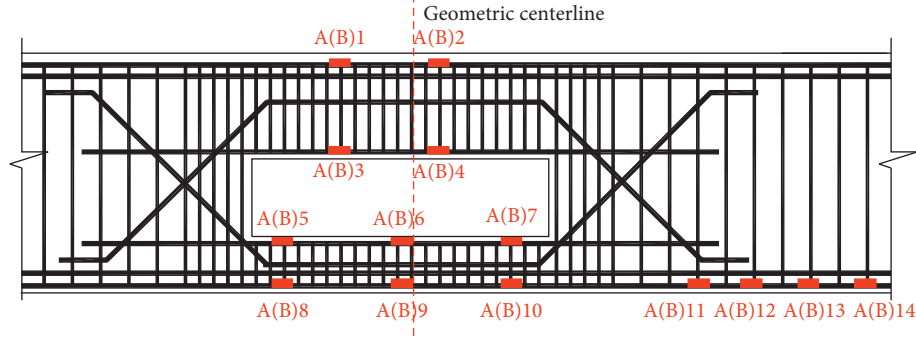
FIGURE 8: Beam O: strain gauge measurement schematic diagram.

4.3. Steel Reinforcement Strain Analysis. The strains in beam O were collected along the steel reinforcements according to the schematic diagram in Figure 8. The strain gauges were adhered to two side faces of the steel cage of the reinforcements, which are labelled “A” and “B”. The average value $G(n)$ was taken from the two strains monitored at the same positions of the two side faces. The loads applied by the JT hydraulic cylinders and the corresponding maximum crack width measured in the beam are listed in Table 4. To better understand the reinforcement stress status, the measured strains were then converted into stresses for analysis.

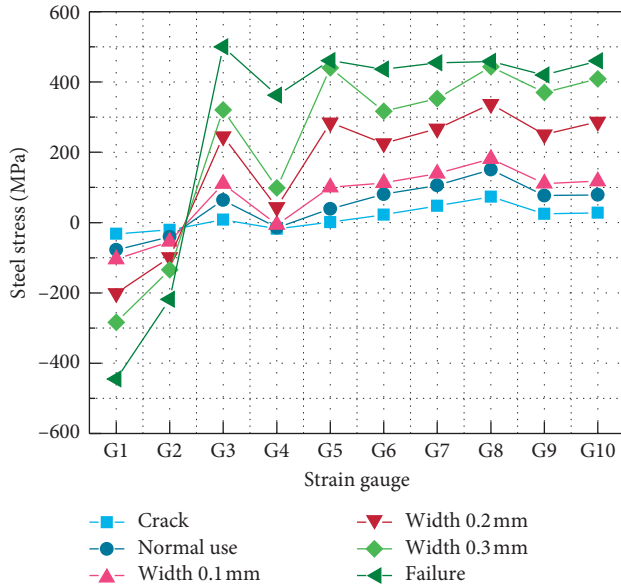
FIGURE 9: Beam O: steel stress evolution near the web opening.

To directly illustrate the stress evolution chronologically, the measured stress values were arranged according to different loading stages in Figure 9. The stress values measured with gauge 1 and gauge 2 show that the longitudinal rebars in the upper chord were compressed at the top, whereas tensile stresses were also detected in the bottom, exhibiting the features of the so-called “trabecular beam.” Like ordinary structural beams, the longitudinal

rebars in the lower chord were tensioned. Therefore, both typical beam-type loading and trabecular beam loading patterns were observed during the testing of this specimen. Moreover, an interesting trend was also observed in the stress variation curves monitored at different gauges. As shown in Figure 9, for the area surrounding the web opening, smaller tensile or compressive stresses were detected in the gauges (G6 and G9) closer to the geometric centreline compared to those (G5, G7 and G8, G10) away from the centreline in the same row. During the entire loading process, all the stresses, compressive or tensile, increased as the exerted force increased until specimen failure. Upon reaching the failure state, nearly all the steel reinforcements yielded, showing an effective utilization of the steel strength.

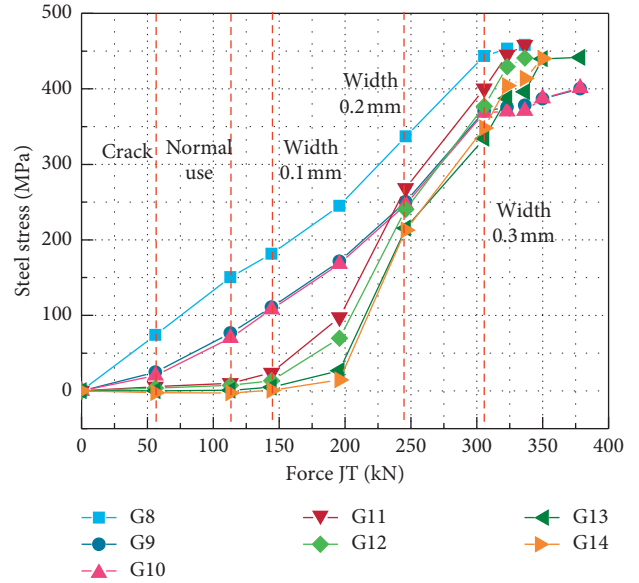
FIGURE 10: Beam O: steel stress evolution in the lower chord.

Figure 10 illustrates the evolution of the stresses in the longitudinal rebars in the bottom of the beam during the loading process. Since the longitudinal rebars under the web openings were basically located in the middle of the beam, their stresses increased evenly with the exerted force. Moreover, for the strain gauges near this area, few strain increments were observed. When the load from the JT hydraulic cylinder reached approximately 200 kN, the longitudinal stress in the rebar near this area started to increase sharply. Finally, the longitudinal reinforcements in the lower chord yielded entirely.

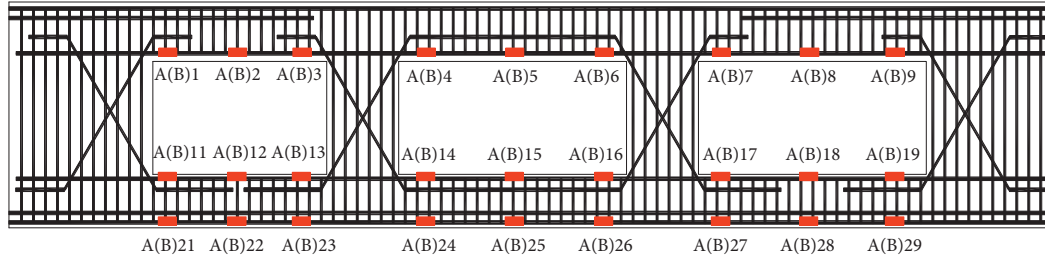
FIGURE 11: Beam T: strain gauge measurement schematic diagram.

The distributions of the strain gauges in beam T are shown in Figure 11. Similar to those in beam O, both side faces (A and B) of the steel cages in beam T are monitored to collect steel strain at a specified position. The relationship between the loads applied by the JT hydraulic cylinders and the maximum crack width measured in the beams is presented in Table 5.

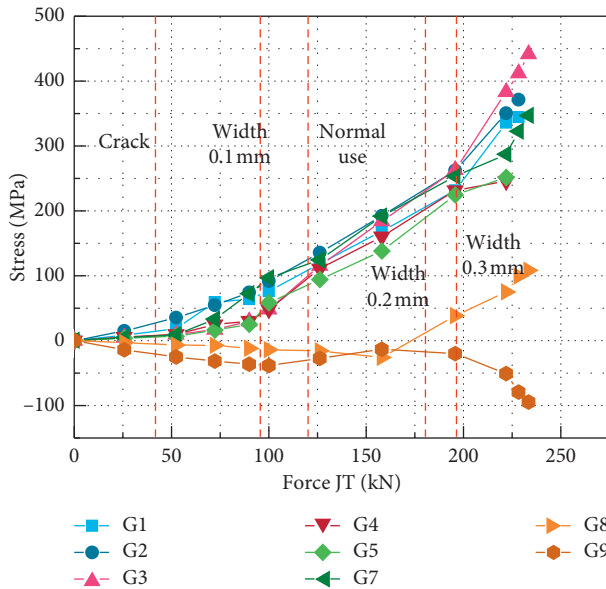
FIGURE 12: Beam T: steel stress evolution in the upper chord.

The load on the upper chord was similar to that of the abovementioned “trabecular beam,” and the longitudinal rebars at the bottom of the chord were mainly subjected to a tensile load. Under the same load, the stress in the longitudinal rebars of the upper chord in the right opening was generally smaller than that in the left opening, as shown in Figure 12. This phenomenon can be primarily attributed to the larger area of the right opening, and the stiffness of the right-side section was weakened to a greater extent. The reinforcements in the corner of the right opening sustained compressive stresses, as indicated by gauge 9; crushed concrete was observed in this location, as shown in Figure 6. A dislocation around the crushed concrete was also identified. The different stress evolution trends shown by gauge 9, the corner concrete crushing, and the corner dislocation may all result from the stress concentrations induced by sharp corners and the weakened stiffness in the right-side section.

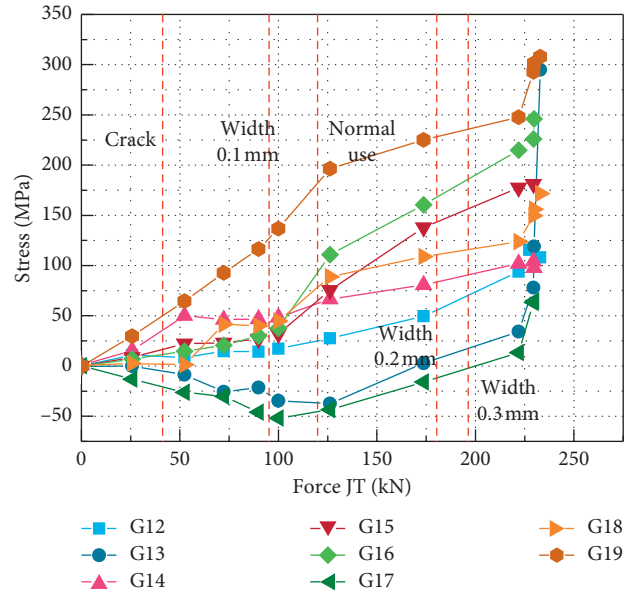
FIGURE 13: Beam T: steel stress evolution in the upper row of the lower chord.

The longitudinal rebars in the upper row of the lower chord were mainly subjected to tensile stresses, and a small number of strain gauges (G13 and G17) also initially detected compressive stresses, as shown in Figure 13. Considering the positions of gauges 13 and 17, the torsional deformation of the openings was believed to lead to the presence of corner compression. As beam T progressed towards the failure state, the final sharp growth in reinforcement stress could be explained by the dense concrete cracking. The stresses measured with gauge 19 were generally greater than those of other gauges but still smaller than

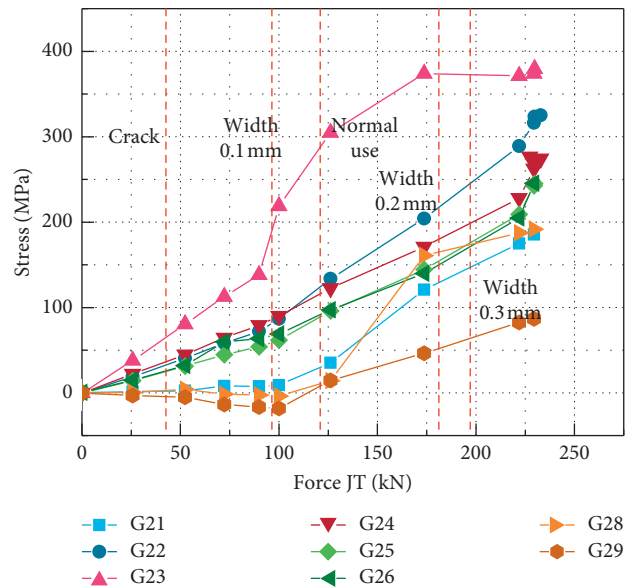
FIGURE 14: Beam T: steel stress evolution in the lower row of the lower chord.

the reinforcement yield strength. For the steel stress evolution in the lower row of the lower chord, the overall growth of the longitudinal steel bars was relatively uniform, as shown in Figure 14. Similarly, under the same load, the stress values besides the right opening were generally smaller due to the weakened stiffness of the right side of the test beam. The tensile stresses measured with gauge 23 were larger than those of the other gauges from the beginning to the end. In both beam tests, the “trabecular beam” behaviour was detected. The upper chord longitudinal reinforcements can also be subjected to tension. According to the steel stress analysis above, the reinforcement stresses in beam T were basically smaller than those in beam O, which could be attributed to the smaller loadbearing capacity of beam T.

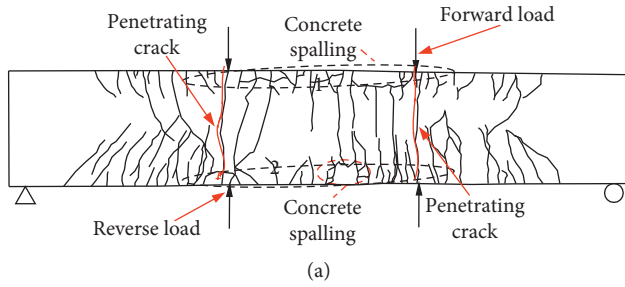
FIGURE 15: Beam R: (a) crack schematic and (b) crack photograph.

5.1. Loading Process. The cyclic tests were conducted in accordance with the procedure described in Section 3.2, and Figure 15 shows the fracture pattern of the reference beam R.

When the reverse load applied from the bottom first reached 200 kN, cracks initiated on the top of beam R; these cracks are labelled “No. 1” in Figure 15(a). The maximum measured crack width was 0.10 mm, and the measured midspan displacement was 1.76 mm. Then, a forward load of 200 kN was applied from the top, and cracks initiated between the bottom loading points; these cracks are labelled “No. 2” in Figure 15(a). The induced maximum crack width was measured as 0.10 mm, and the corresponding midspan displacement was 1.78 mm. Due to the reciprocating cycle, the cracks generated on the top of the beam by the reverse loading were closed due to the compression induced by forward loading. When the reverse load increased to 375 kN, the measured strain indicated that the top steel reinforcements started to yield. The reverse yield displacement u_y was

5.10 mm, and the maximum crack width within region No. 1 was measured as 0.22 mm. When the forward load increased to 435 kN, the reinforcements in the bottom yielded, and the cracks developed further. The forward yield displacement u'_y was 6.00 mm. The reason why the forward yield displacement was larger than that induced by the reverse loading can be attributed to the additional reinforcements in the bottom of the beam.

Afterwards, each step was implemented by an increment in the reverse yield displacement u_y and the forward yield displacement u'_y . After the reverse displacement reached $-2u_y$ (“-” indicates reverse loading, whereas “+” indicates forward loading), the maximum crack width was measured to be 1.04 mm. As the forward displacement increased to $+2u'_y$, the maximum crack width reached 1.24 mm. When the cycling loading was applied, the beam was densely cracked. After the displacements exceeded $-4u_y$ and $+4u'_y$, concrete spalling was observed on the top and bottom of the test beam, and the crack width measurements were stopped. As the displacements increased to $-5u_y$ and $+5u'_y$, the cracks penetrated along the beam height, as illustrated in Figure 15(a). Finally, when a reverse displacement of $-8u_y$

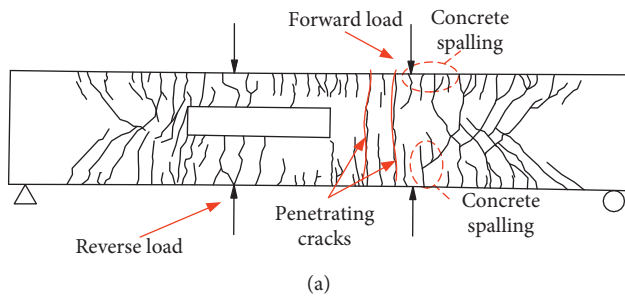
FIGURE 16: Beam O: (a) crack schematic and (b) crack photograph.

As shown in Figure 16, under reverse loading, cracks initiated between the top loading point with a maximum crack width of 0.02 mm and a midspan displacement of 0.85 mm. When the reverse load increased to 530 kN, the strain gauge measurements indicated that the top reinforcements began to yield. At this time, the corresponding reverse yield displacement was 7.00 mm, and the maximum crack width was 0.20 mm. After the forward load reached 620 kN, the strain gauge measurements indicated that the steel rebar yielded, and the forward yield displacement was 8.00 mm.

As the loaded reverse displacement increased to $-2u_{2y}$, the maximum crack width at the loading point developed rapidly, reaching 1.80 mm. When the loaded displacement further increased to $-3u_y$ and $+3u_y$, concrete spalling was

observed near the right loading points at the top and the bottom. The cracks penetrated along the beam height, as illustrated in Figure 16(a). Finally, when the loaded displacement reached $-4u_y$ and $+4u_y$, the reinforcements audibly failed, after which the test was ended.

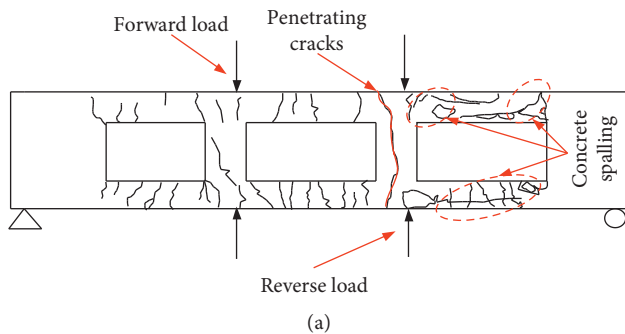
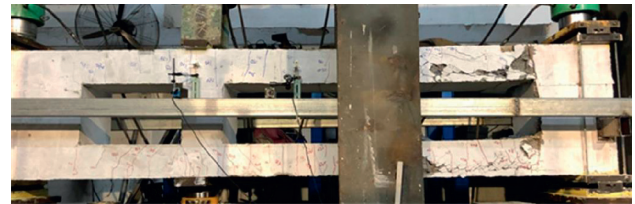
FIGURE 17: Beam T: (a) crack schematic and (b) crack photograph.

As shown in Figure 17, the initial cracks began to form when the reverse load reached 120 kN. The measured maximum crack width was 0.04 mm, and the midspan displacement was 1.36 mm. When the reverse load reached 400 kN, the measured strain indicated that the reinforcements at the top yielded, and the corresponding reverse yield displacement u_{3y} was measured as 10.29 mm. After the forward load reached 400 kN, the measured forward yield displacement u_{3y}' was 11.18 mm.

As the loaded displacement increased to $-2u_{3y}$, the largest crack in the beam top propagated rapidly, reaching 1.80 mm. When the test specimen was loaded to $+2u_{3y}$, concrete spalling was observed around the right-side opening, as illustrated in Figure 17(a). After the loaded displacement reached $-3u_{3y}$ and $+3u_{3y}$, the cracks penetrated along the beam height. Finally, at $4u_{3y}$, a large area of concrete spalling was observed, after which the test was ended.

Compared to the reference beam and the beam with only one opening, fewer cracks were identified in the cycling test of the beam with three openings. However, the concrete spalling was more severe in the beam with three openings. A large area of concrete spalling around the right-side web opening suggested a much more weakened stiffness on the right section of the test beam. Table 6 summarizes the key characteristics of the load-deflection responses of the underground metro station RC beams with various openings under static and cyclic loading conditions.

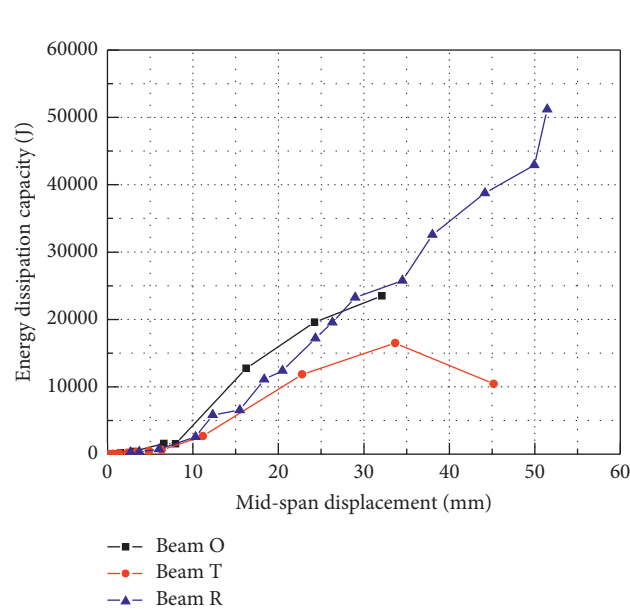
FIGURE 19: Energy dissipation capacity.

Figure 19 shows the energy dissipation capacities of the three beams obtained from the cyclic tests. These results show that the energy dissipation capacity of beam T was the weakest. Under the same midspan displacement, the energy consumption of beam O was close to or better than that of beam R. This phenomenon can be primarily attributed to the reinforcements around the opening effectively suppressing the generation and development of cracks. Later, after reaching the peak load, the energy dissipation capacity of beam T degraded.

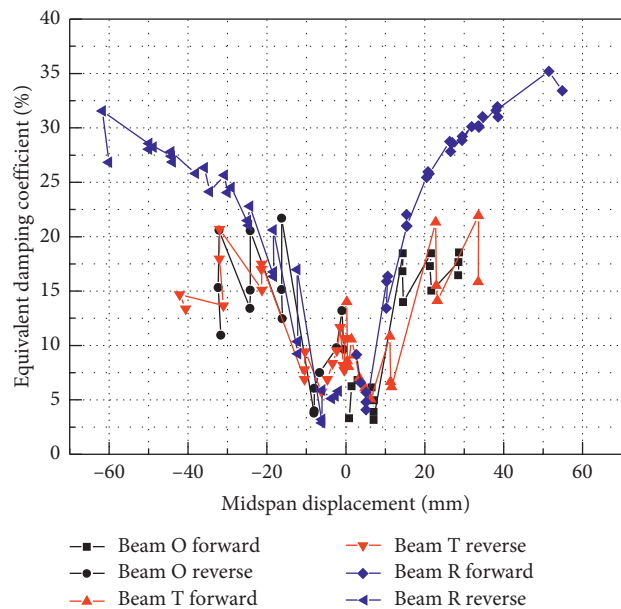
FIGURE 20: Equivalent damping coefficients.

Figure 20 shows the comparison of the equivalent damping coefficients of the three specimens. Under the same midspan displacement, the equivalent damping coefficient curves of beam O and beam R were basically consistent in the early stages. As loading increased, the equivalent damping coefficient evolution curve of beam O separated from that of beam R, indicating that strengthening from the reinforcements around the opening cannot completely compensate for the impact on energy dissipation. Moreover, the forward and reversed equivalent damping coefficients of beam T were relatively small during the whole loading process, showing a weaker energy dissipation capacity.

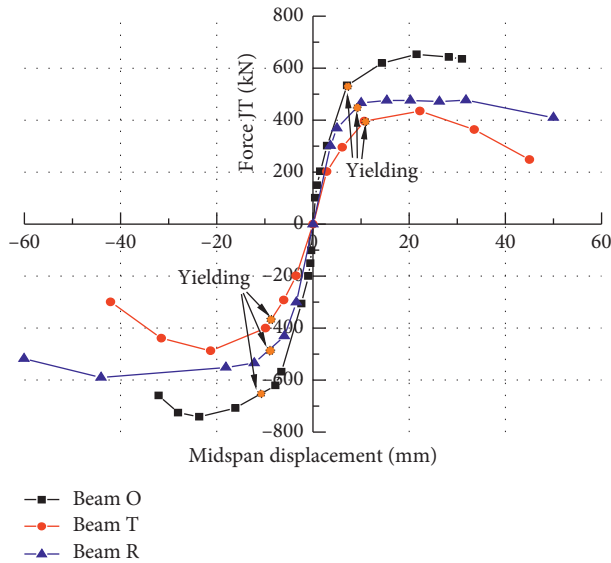
FIGURE 21: Skeleton curves of the three specimens.

5.2.2. Ductility Performance Analysis. Figure 21 compares the skeleton curves of the three specimens in the cyclic tests. The forward and reverse yield loads of beam O were larger than those of the other two beams, which is consistent with the results provided above. For beam T, yielding occurs earlier due to the weakening of the beam section by the multiple openings. Moreover, under the same load, beam T exhibited the largest displacement. After yielding, beam R continued to sustain multiple yield displacements with a mild curve segment, showing promising ductility.

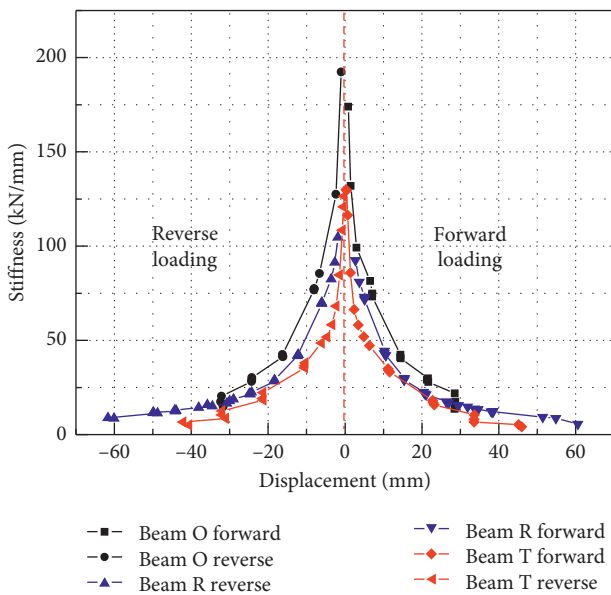
FIGURE 22: Stiffness degradation curves.

5.2.3. Stiffness Degradation Performance. Figure 22 compares the stiffness degradation curves of the three specimens

in the cyclic tests. The forward and reverse initial stiffnesses of beam O were larger than those of the other two beams. The stiffness of beam T was the smallest. As the loaded displacements increased, all the stiffnesses gradually degraded and approached each other. The stiffness of beam O decreased faster than the other two beams; the main reason for this phenomenon was that more concrete cracks initiated in the early stage.
