OLD TIP SITES IN HOBART: BENEFITS AND IMPACTS

A Thesis submitted in partial fulfilment of the
requirements of the degree of Master of
Environmental Studies (by Coursework).

Centre for Environmental Studies
University of Tasmania

Hobart
1994

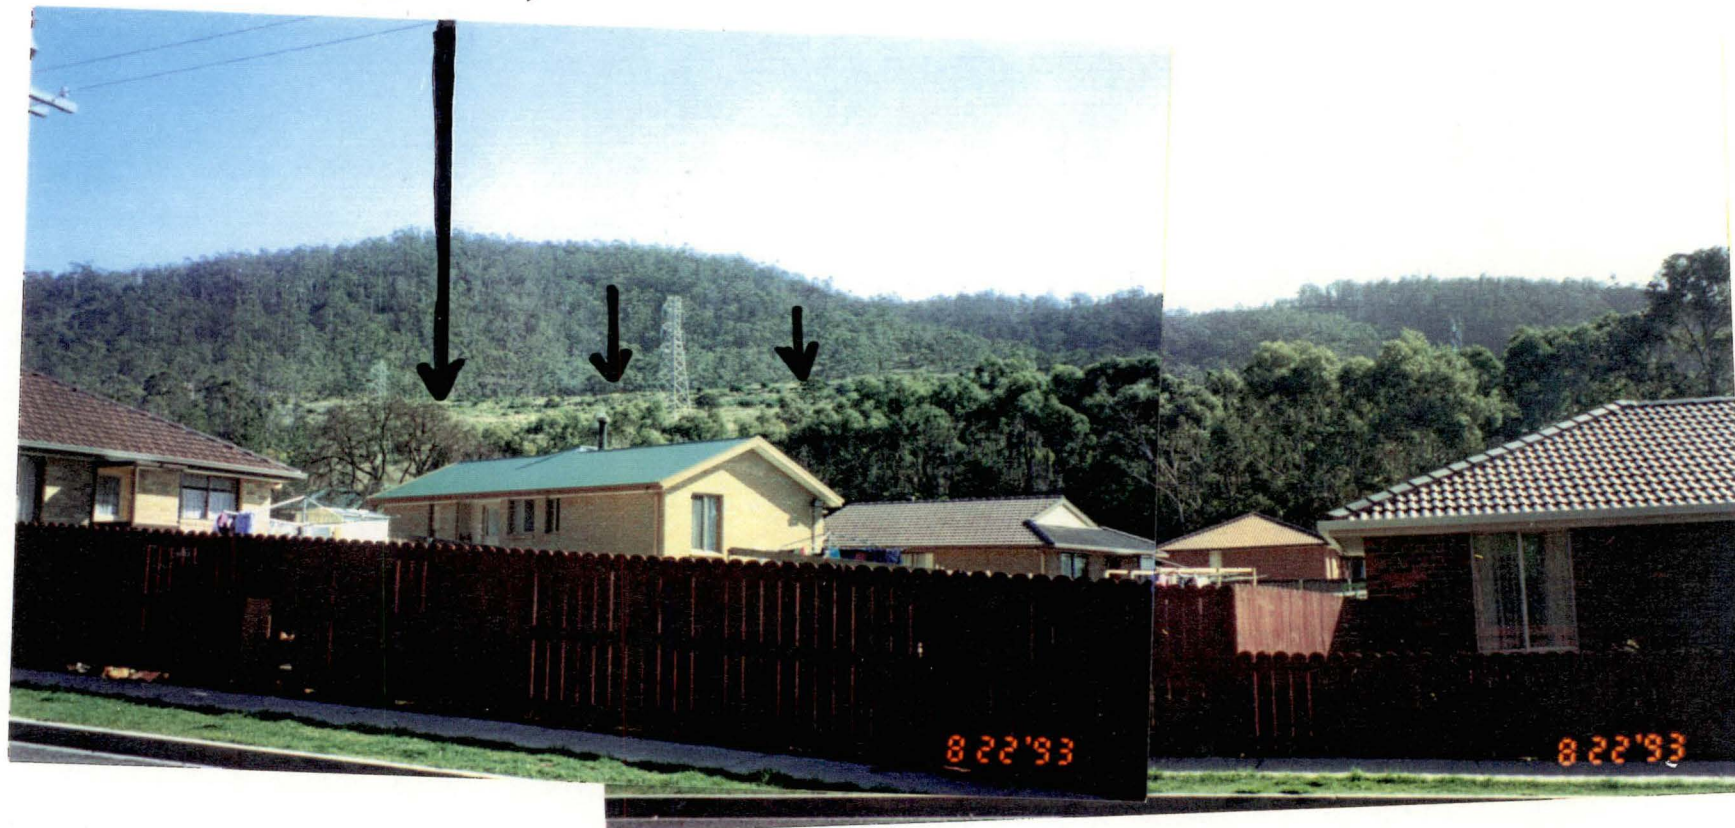
Figure 3.31 - Photo of Chapel Street Tip Site

(arrows indicate location of fill)

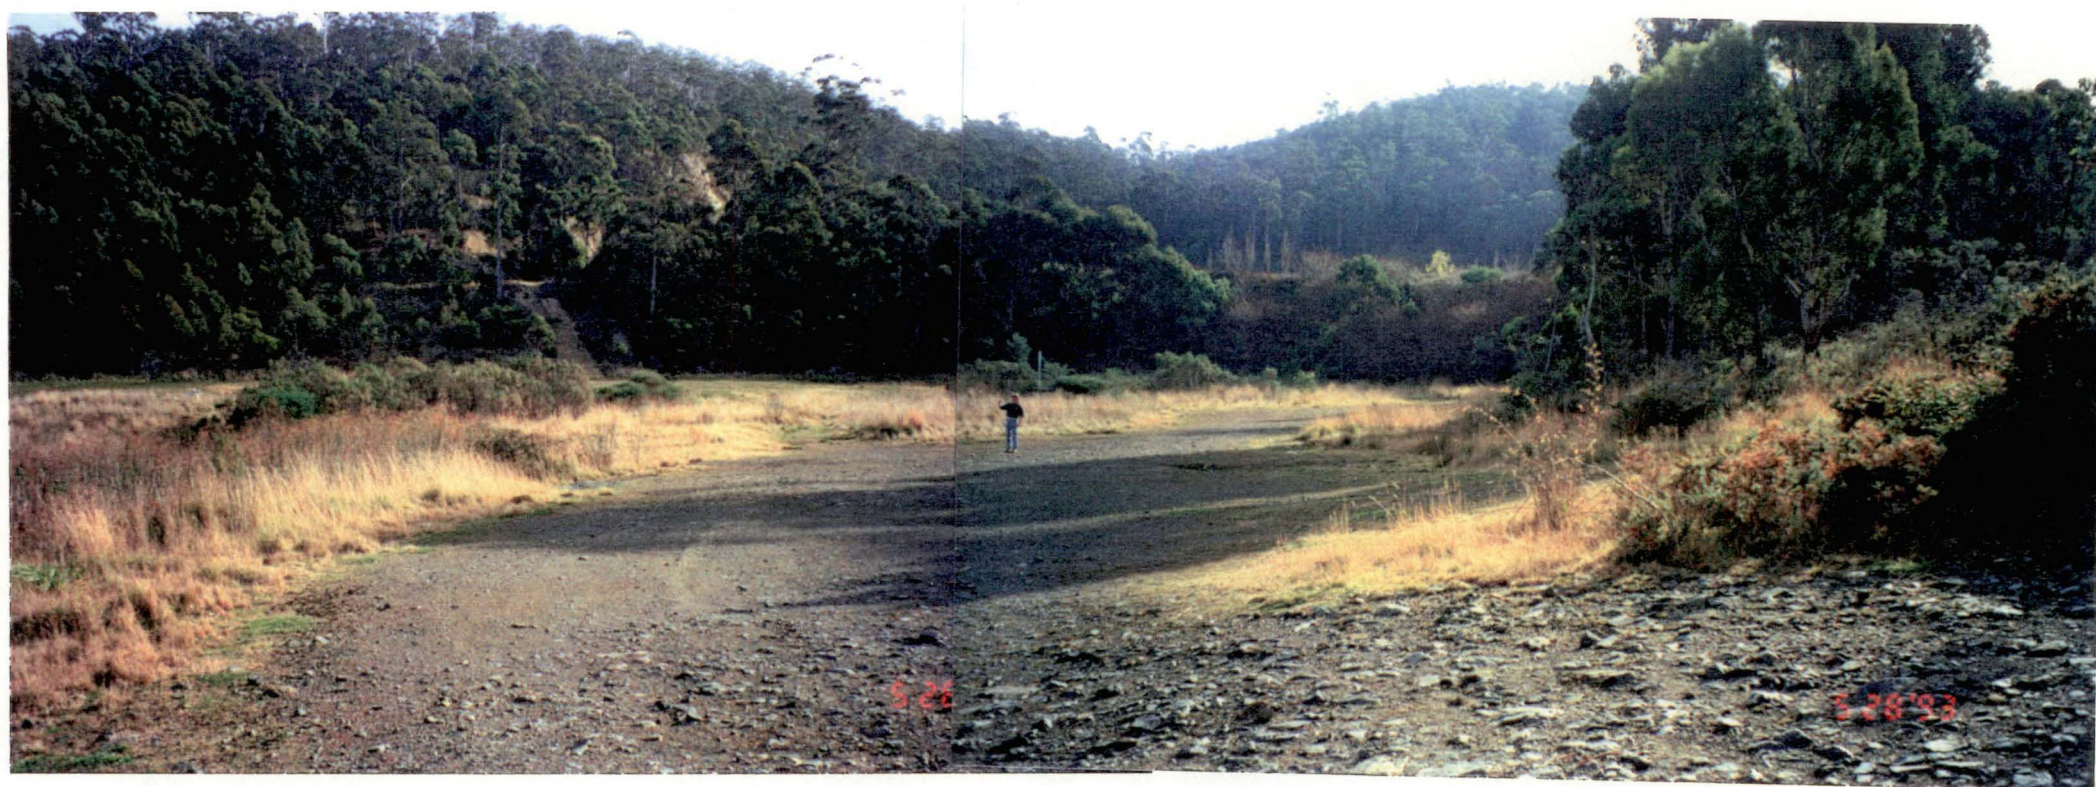
Figure 5.7 - Vegetation on Old Proctor's Road Tip Site

decomposing wastes beneath. This is an expensive activity, which explains why the redevelopment of old tip sites is mainly restricted to recreational use and open space.
