# TECHNICAL REPORT

## Ice Bulletins for the Antarctic Shipping Season 2019 – 2020

Prepared by Dr Jan L Lieser

Antarctic Meteorology Section — Bureau of Meteorology

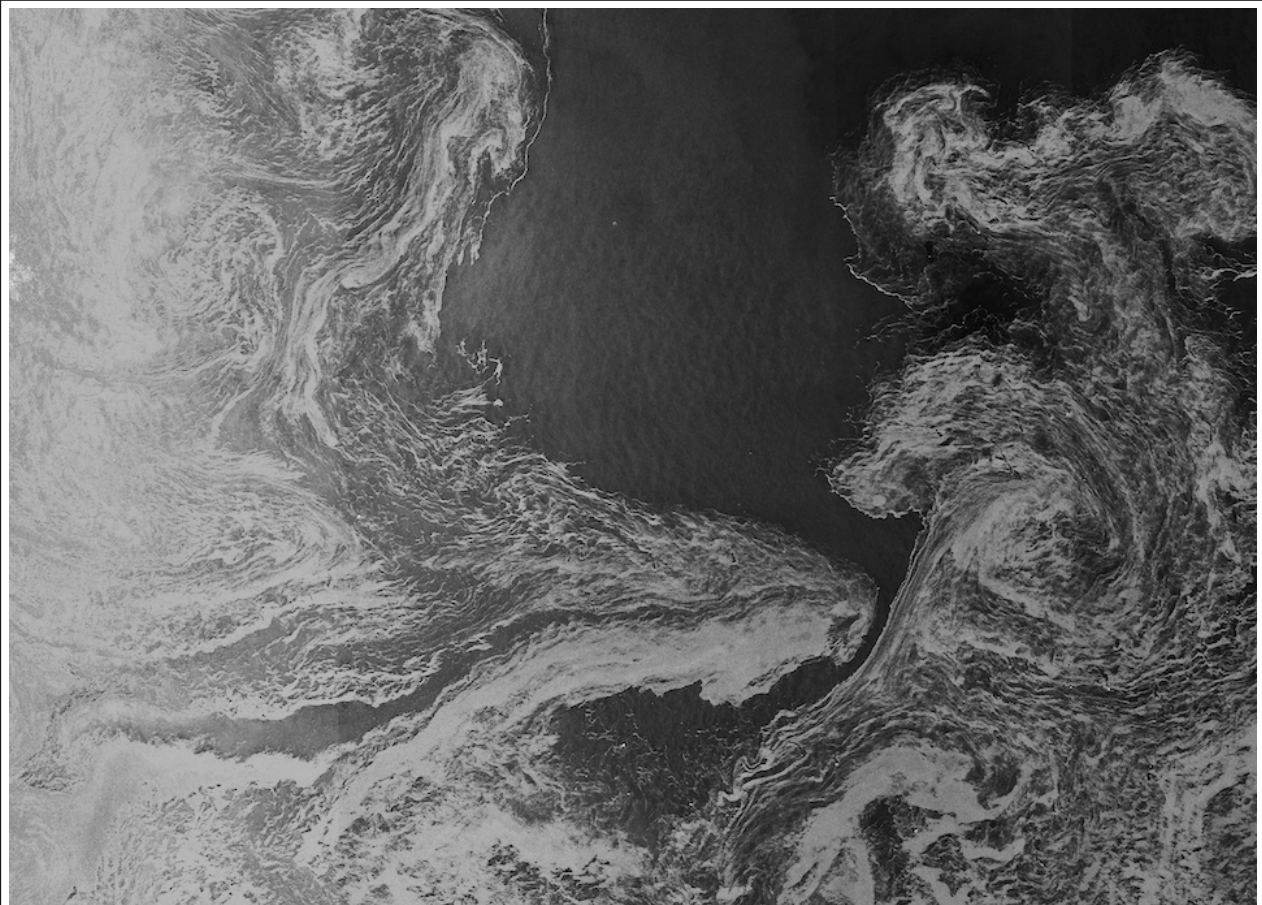
*The sea-ice edge off Knox Coast (centre roughly at 104° E and 61° S).*

*Sentinel-1b SAR EW scene acquired 28/10/2019 at 12:37 UT and provided by PolarView.*
