Ice Bulletins for the Antarctic Shipping Season 2022 – 2023

Prepared by Dr Jan L Lieser

Antarctic Meteorology Section — Bureau of Meteorology

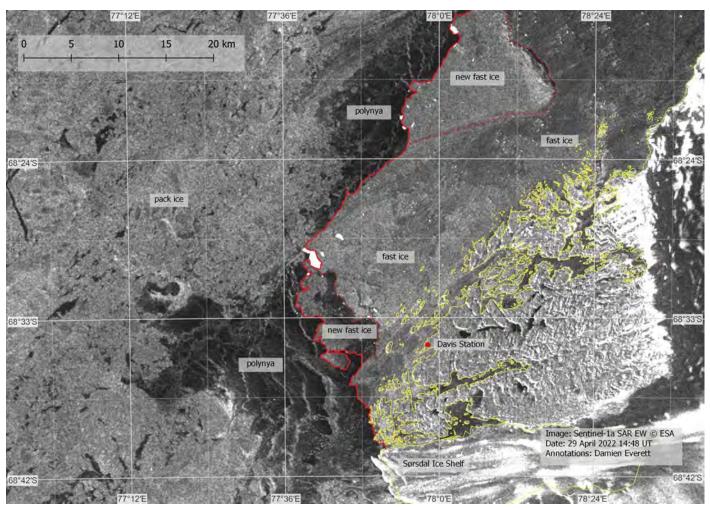
Figure 1 shows SAR data of Davis Station and surrounds. Fast-ice areas are outlined by red lines.

Figure 1: Sentinel-1a SAR EW data acquired 29 April 2022 at 14:48 UT and provided by Polar View.

Off Davis Station, the fast-ice edge has recently been dynamic, forming and shifting back and forth (depicted by the dashed red lines) at the mercy of wind and current.

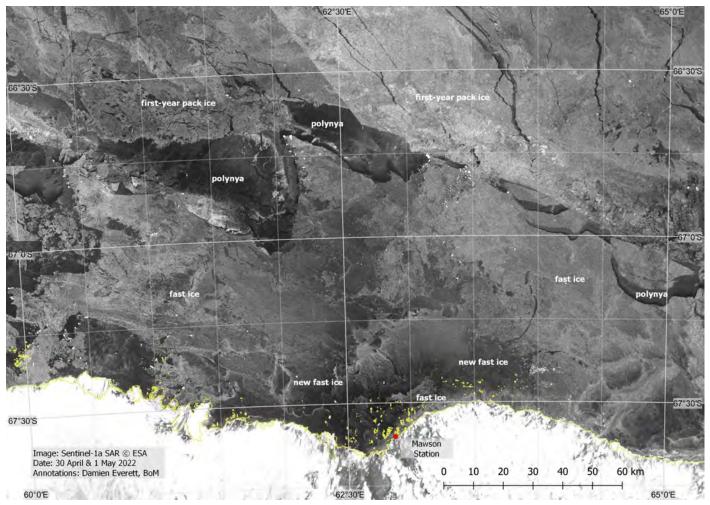
Figure 1 shows SAR data off the Mawson coast and well offshore.

Figure 1: Sentinel-1a SAR EW/IW data composite acquired 30 April 2022 at 15:28 UT and 1 May 2022 at 16:10 UT, both provided by Polar View.

After the complete breakout of ice north of Mawson Station last summer, new sea-ice growth and development in the region has been slow and extremely dynamic. Katabatic winds have forced new coastal sea ice offshore during April where the leading edge has merged with first-year pack ice, with several former polynyas evident along this interface.

Off Mawson Station, fast ice has started to thicken between the coast and islands, but further afield new fast ice remains thinner as it replaces the more mature fast ice that has been blown further offshore.

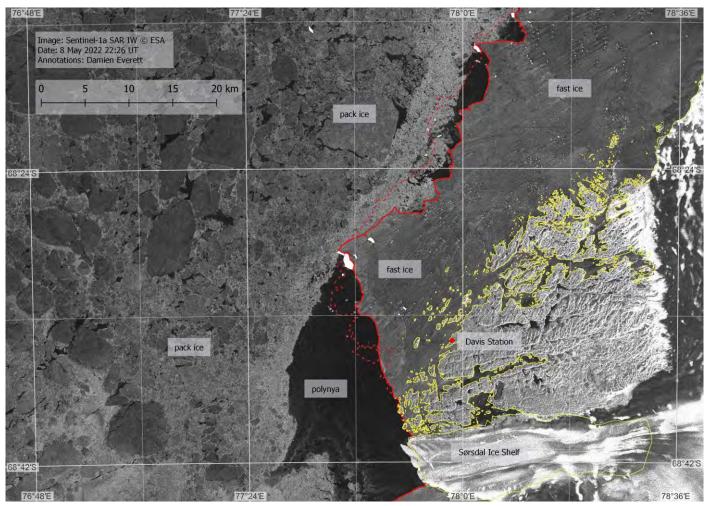
Figure 1 shows SAR data of Davis Station and surrounds. Current fast-ice areas are outlined by the solid red line while the fast-ice edge from the 29th April 2022 is outlined by the dotted red line.

Figure 1: Sentinel-1a SAR IW data acquired 8 May 2022 at 22:26 UT and provided by Polar View.

Off Davis Station, the fast-ice edge remains dynamic (illustrated by the solid and dotted red lines) due to wind and current. Broken fragments of last week's fast-ice edge are floating near the current fast-ice edge in the north.

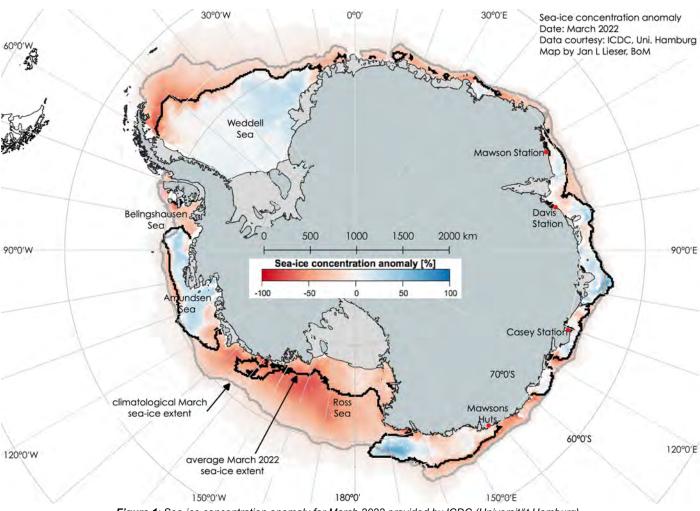
Figure 1 shows the pan-Antarctic sea-ice concentration anomaly based on passive microwave remote sensing data.

Figure 1: Sea-ice concentration anomaly for March 2022 provided by ICDC (Universität Hamburg).

In March 2022, pan-Antarctic sea-ice conditions remained at near record low conditions. Regionally, sea-ice extent and associated concentration anomalies varied however, only between 80°0'E and 100°0'E in East Antarctica and in parts of the Amundsen Sea and western Bellingshausen Sea near average conditions prevailed through summer. In the Ross Sea, a small positive anomaly patch persisted around 170°0'E north of Cape Adare.

Otherwise, persistent negative anomalies were widespread around the continent including coast exposed to the sea off Dronning Maud Land (10°0'E to 30°0'E) and parts of East Antarctica, including off Enderby Land (west of Mawson Station), and parts of the coast between Casey Station and Dumont D'Urville Station. The entire Ross Sea shows a large negative sea-ice concentration anomaly. West of the Antarctic Peninsula (Bellingshausen Sea) and almost the entire western Weddell Sea (between 60°0'W and 10°0'W) are also below average conditions.

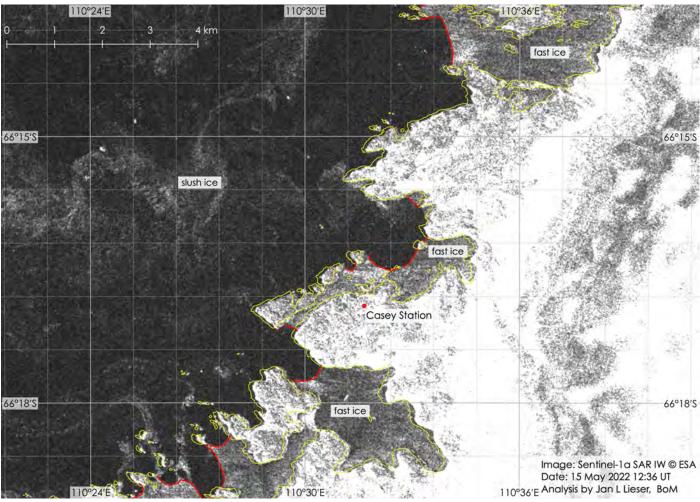
Figure 1 shows high-resolution SAR data off Casey Station. Fast-ice areas are marked with a red line.

Figure 1: Sentinel-1a SAR IW data acquired 15 May 2022 at 12:36 UT and provided by ESA.

Off Casey Station, seasonal fast ice has formed nearshore and between the offshore islands. Off the fast-ice edge, new sea ice and slush ice is forming and transported by wind and ocean surface currents.

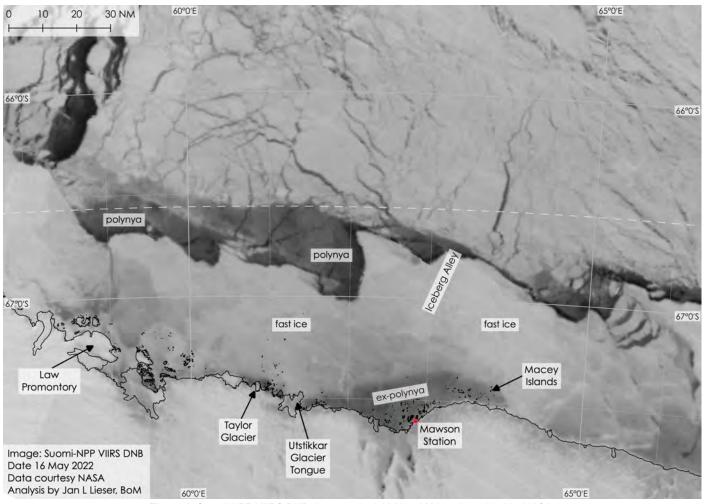
Figures of this bulletin show almost entirely cloud-free panchromatic Day-Night-Band data off Mawson Station.

The Visible Infrared Imaging Radiometer Suite (VIIRS) Night-time Imagery (Day/Night Band or Enhanced Near Constant Contrast) is mainly a qualitative product and should be strictly used for image display purposes only. It shows the Earth's surface and atmosphere using a sensor designed to capture low-light emission sources, under varying illumination conditions. It is displayed as a grayscale image.

Figure 1: Suomi-NPP VIIRS DNB data acquired 16 May 2022 and provided by NASA.

The scene presented in the figures of this bulletin is illuminated by the near-full moon under cloud-free conditions. While ice and snow-covered surfaces appear in lighter grey, open ocean and polynya areas appear darker.

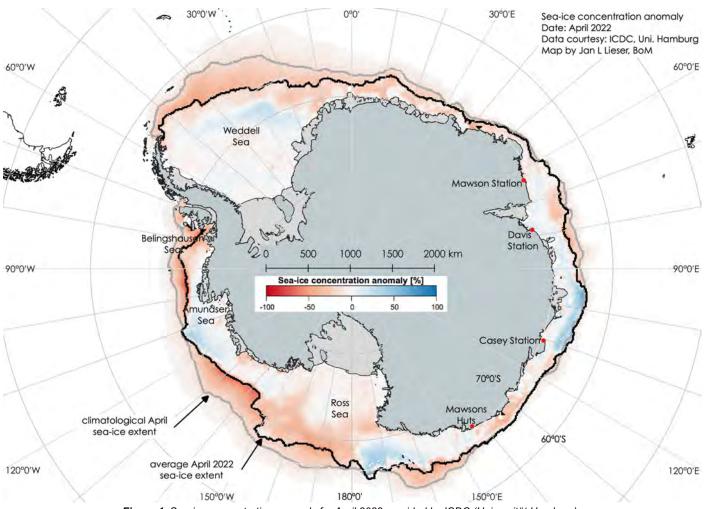
Figure 1 shows the pan-Antarctic sea-ice concentration anomaly based on passive microwave remote sensing data.

Figure 1: Sea-ice concentration anomaly for April 2022 provided by ICDC (Universität Hamburg).

While February and March 2022 saw the Antarctic sea-ice extent at respective second-lowest levels, sea-ice growth has picked up slightly in April 2022 but pan-Antarctic sea-ice conditions remained at low conditions (ranking sixth since records began).

Regionally, sea-ice extent and associated concentration anomalies varied with large parts of East Antarctica at near-climatological sea-ice extent but below average concentration except for the region between 95°0'E and 110°0'E. Also, in very small regions of the Amundsen Sea (around 110°0'W) and western Ross Sea (near 175°0'E) close to average conditions are seen.

Otherwise, persistent negative anomalies were widespread around the continent including the Weddell Sea, almost the entire Ross Sea and west of the Antarctic Peninsula (Bellingshausen Sea) exhibiting below average conditions.

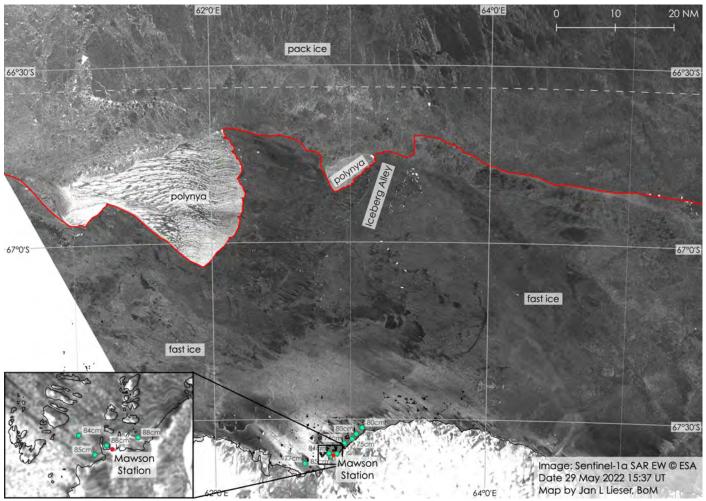
Figure 1 shows SAR data of Mawson Station and surrounds. Fast-ice areas are outlined by the solid red line. Recent fast-ice drilling sites are marked by green dots and their respective thickness annotated.

Figure 1: Sentinel-1a SAR EW data acquired 29 May 2022 at 15:37 UT and provided by Polar View.

North of Mawson Station, the fast-ice edge has assumed roughly its typical shape for the season. The large polynya in the northwest acts as an 'ice factory' with new sea ice forming that is then exported west- and northwards by the wind to merge with the pack ice.

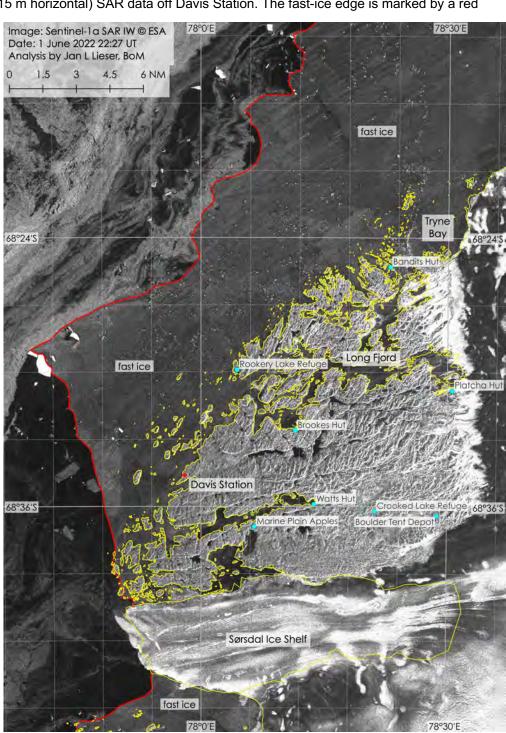
Figure 1: Sentinel-1a SAR IW data acquired 1 June 2022 at 22:27 UT and provided by PolarView.

Off the fast-ice edge, pack ice and some icebergs are drifting generally south-westward.

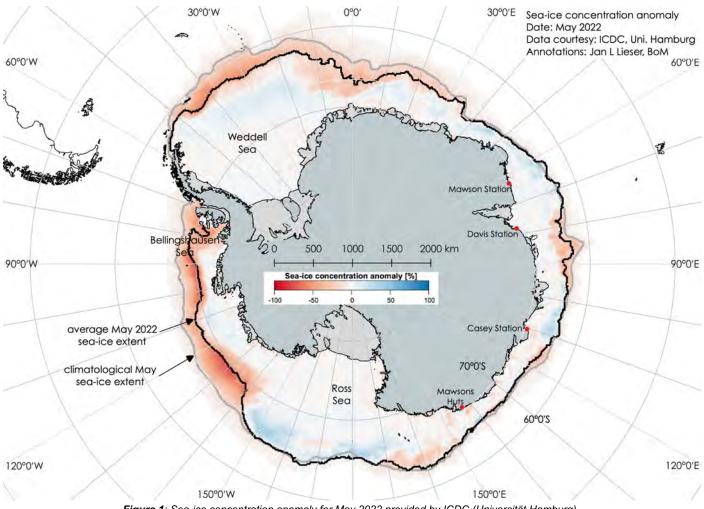
Figure 1 shows the pan-Antarctic sea-ice concentration anomaly based on passive microwave remote sensing data.

Figure 1: Sea-ice concentration anomaly for May 2022 provided by ICDC (Universität Hamburg).

In May 2022, pan-Antarctic sea-ice conditions remained at low conditions continuing to rank sixth since records began.

Regionally, sea-ice extent and associated concentration anomalies varied with large parts of East Antarctica at nearclimatological sea-ice extent but below average extent in the region between 85°0'E and 100°0'E as well as 110°0'E and 120°0'E. Also, the central Ross Sea (between 175°0'E and 145°0'W) experienced close to average conditions.

Otherwise, persistent negative anomalies were widespread around the continent including the Weddell Sea, the western Ross Sea and further west from there towards the Antarctic Peninsula (Amundsen Sea and Bellingshausen Sea) exhibiting below average conditions.

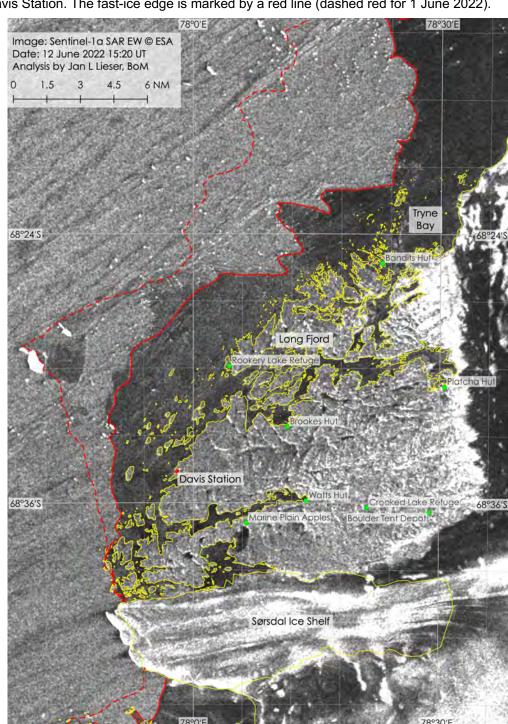
The fast ice has lost a large part offshore (more than 300 km²) and the fast-ice edge retreated towards the coast compared to early June.

Off the fast-ice edge, a polynya is present with pack ice and some icebergs are drifting generally southwestward.

Figure 1: Sentinel-1a SAR EW data acquired 12 June 2022 at 15:20 UT and provided by PolarView.

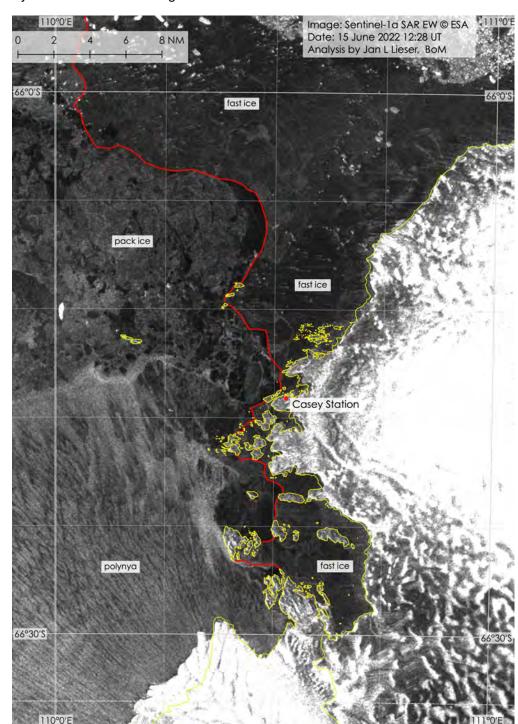
Figure 1: Sentinel-1a SAR EW data acquired 15 June 2022 at 12:28 UT and provided by ESA.

South of the station, a large polynya is currently maintained by strong offshore winds.

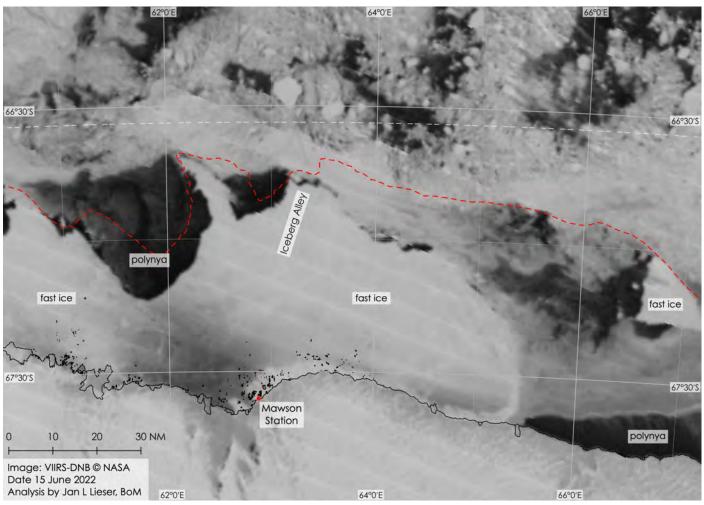
Figure 1 shows Day-Night-Band data of Mawson Station and surrounds. The scene is illuminated by the early stages of the waning full moon. The fast-ice edge on 29 May 2022 is included as a dashed red line.

Figure 1: VIIRS DNB data acquired 15 June 2022 and provided by NASA.

Northwest of Mawson Station, the polynya is significantly larger than at the beginning of the month. Also west of Iceberg Alley, the open water is clearly larger than before. East of the station, fast ice that was temporarily locked between the large sheet off station and a smaller patch locked in by grounded icebergs (roughly at 65°30'E) has been moved northwards and away from the region.

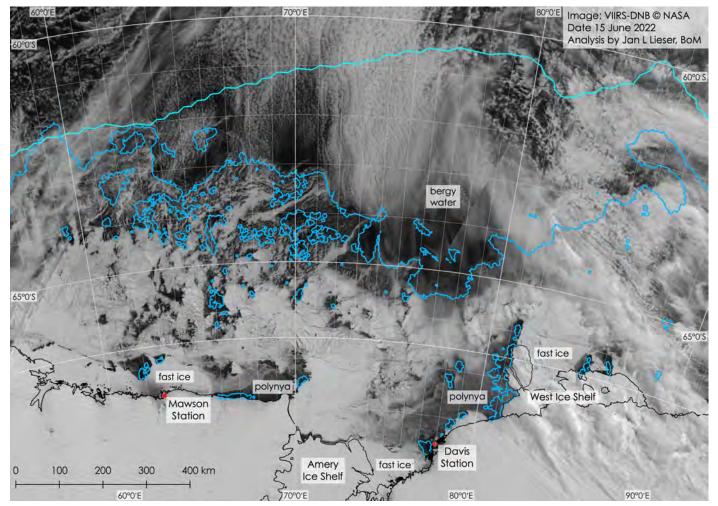
Figure 2: VIIRS DNB data acquired 15 June 2022 and provided by NASA.

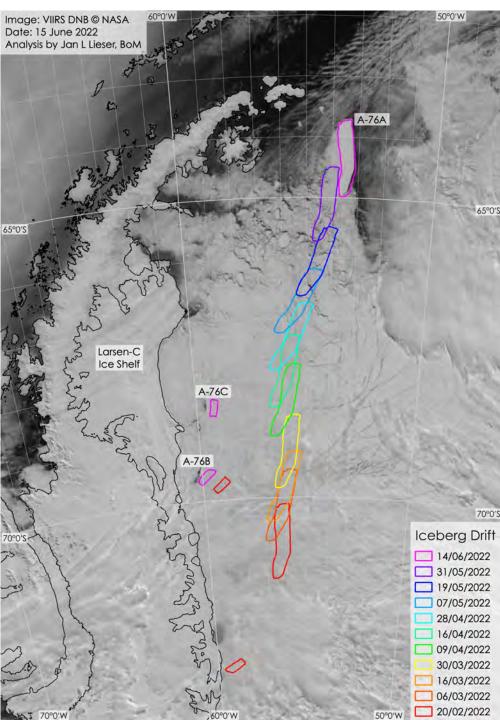
The iceberg calved off the Ronne Ice Shelf in mid-May 2021 and travelled northward roughly 510 km until mid-February 2022 (the red shape). Since January 2022, the iceberg appears to have gained momentum. During the early phase of the drift (between May 2021 and the end of 2021), the iceberg drifted at roughly 2 km per day but is averaging more than 6 km per day since February 2022.

The smaller fragments of the iceberg (A-76B and A-76C) have remained closer to the coast and exhibit much slower drift speeds since February 2022, even though A-76B travelled significantly farther than A-76C, which had remained further north than A-76B.

Figure 1: VIIRS Day-Night-Band data acquired 15 June 2022 and provided by NASA.

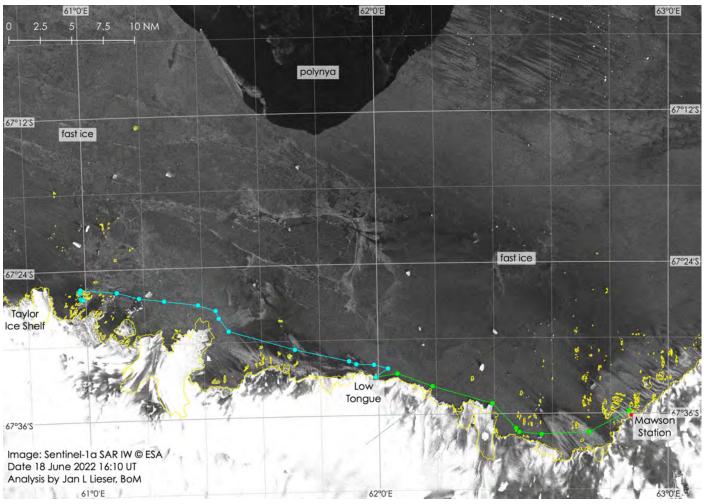
Figure 1 shows high-resolution SAR data of Mawson Station and surrounds. The typical route between the station and Colbeck Archipelago (east of the Taylor Ice Shelf) is marked by a green and cyan line. A black diagonal line is a stitching artefact where two consecutive scenes are joined.

Figure 1: Sentinel-1a SAR IW data acquired 18 June 2022 at 16:10 UT and provided by PolarView.

West of Mawson Station, mostly homogenous fast ice is present.

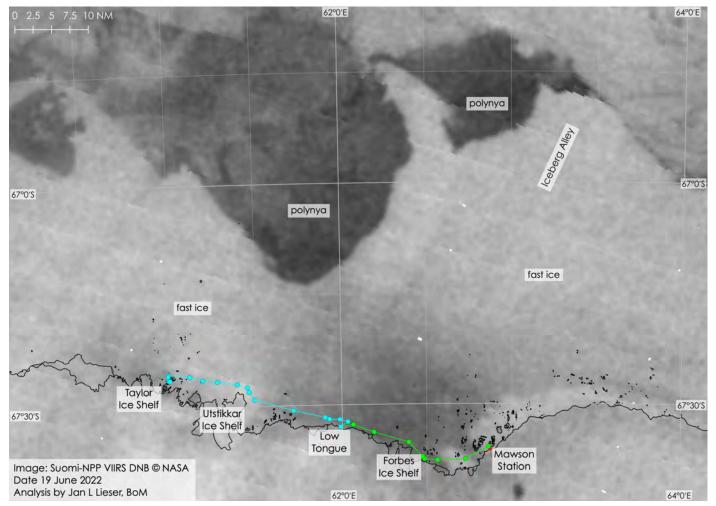
Off the Forbes Ice Shelf, Day-Night-Band data from the VIIRS instrument (see Figure 2) still show a significantly different signature to what 'established' fast ice would appear like. More established fast ice seems to be present nearshore northeast of the station and off Utstikkar Ice Shelf for example.

Figure 2: Suomi-NPP VIIRS Day-Night-Band data acquired 19 June 2022 and provided by NASA.

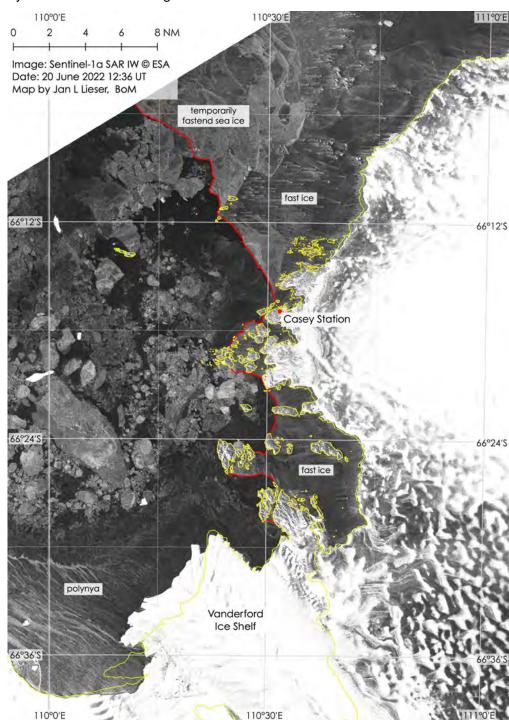
Off Casey Station, seasonal fast ice has formed nearshore and between the offshore islands.

South of the station, a polynya is currently maintained by strong offshore winds.

Figure 1: Sentinel-1a SAR EW data acquired 20 June 2022 at 12:36 UT and provided by PolarView.

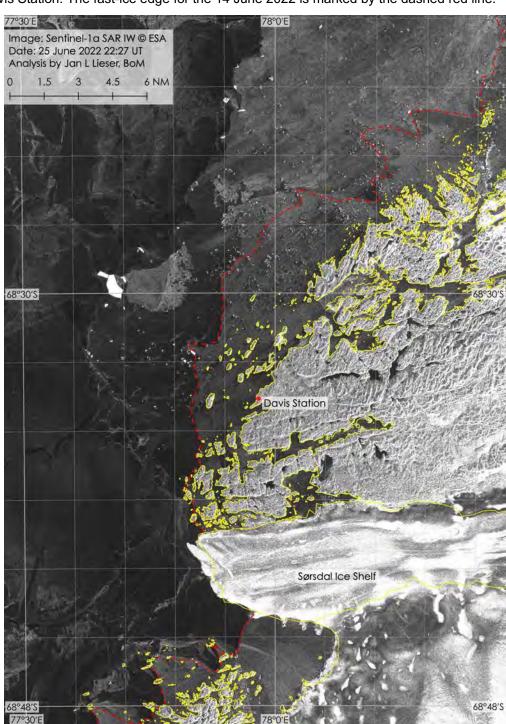
Figure 1: Sentinel1-a SAR IW data acquired 25 June 2022 at 22:27 UT and provided by Polar View.

Off Davis Station, the fast-ice edge has generally retained its shape over the last two weeks. New sea ice and nilas is now forming offshore to the west. In the north, the fast-ice edge has been more dynamic. Fast ice has started to consolidate further offshore but remains unstable west of the dashed line.

Off the Vestfold Hills, most icebergs are frozen in while off the fast-ice edge, some icebergs have shifted during dynamic periods resulting in ice breakout.

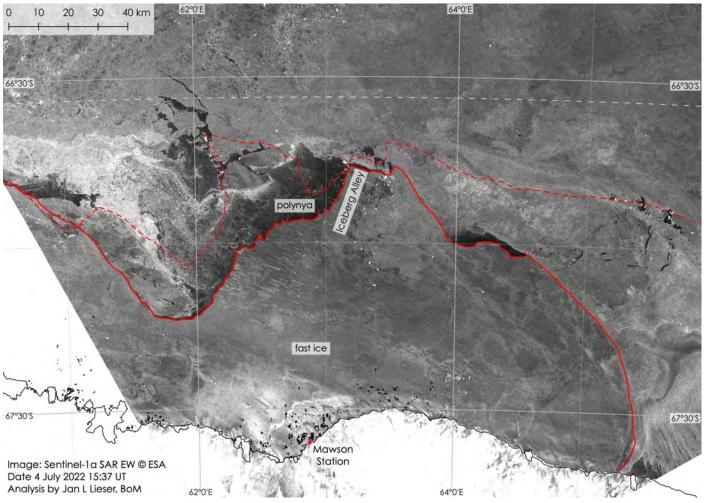
Figure 1: Sentinel-1a SAR EW data acquired 4 July 2022 at 15:37 UT and provided by PolarView.

Figure 1 shows SAR data of Mawson Station and surrounds. The fast-ice edge is marked by a red line (dashed red for 29 May 2022).

The fast-ice edge has been moving southward in recent weeks. North of Mawson Station, a polynya is now immediately west of Iceberg Alley. The shortest distance between the station and the polynya northwest of the station is currently roughly 31 nautical miles.

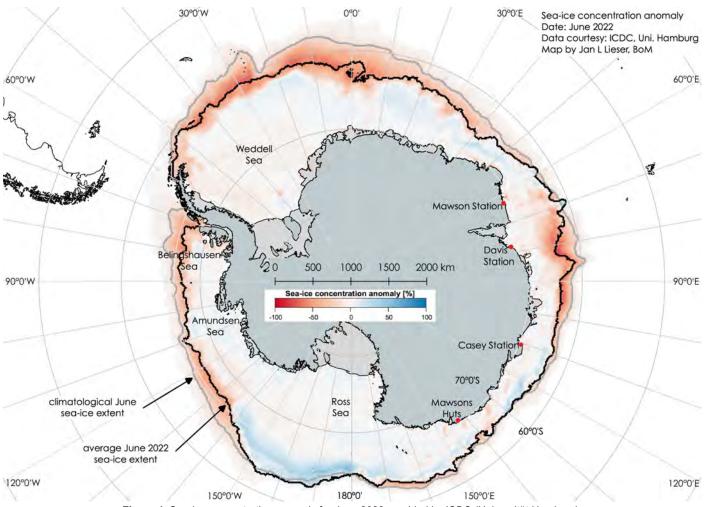
Figure 1: Sea-ice concentration anomaly for June 2022 provided by ICDC (Universität Hamburg).

Figure 1 shows the pan-Antarctic sea-ice concentration anomaly based on passive microwave remote sensing data.

In June 2022, pan-Antarctic sea-ice conditions reached the lowest June conditions since records began.

In the eastern Weddell Sea near Maud Rise (66°0'S, 3°0'E) and off the West Ice Shelf, the largest negative anomalies are found. It is also noted that the waters around the South Sandwich Islands (along 26°0'W in the northern Weddell Sea) were largely free of sea ice, which is anomalous for this time of year. East of Joinville Island (63°15'S, 55°45'W; at the northern tip of the Antarctic Peninsula), an elongated negative anomaly is understood to be associated with the drift of large iceberg A-76A, which creates a local polynya on its lee side while the iceberg is drifting northward into the southern South Atlantic.

Nearshore west of Mawson Station (at 66°50'S and 61°30'E), another negative anomaly is noted relating to a fast-ice edge that is farther south than typical.

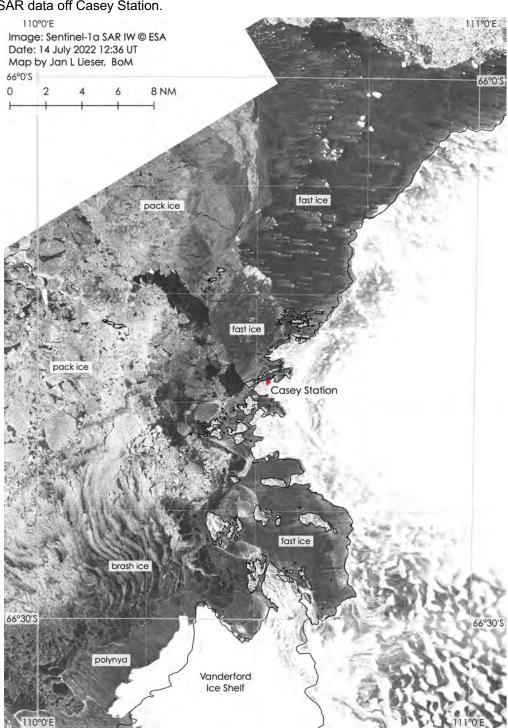
Figure 1: Sentinel-1a SAR IW data acquired 14 July 2022 at 12:36 UT and provided by PolarView.

The entire scene is covered by some form of ice. Off the Vanderford Ice Shelf, a small polynya is active and further north pack ice and fast ice have closed in.

Off Casey Station, seasonal fast ice has formed nearshore and between the offshore islands, but the fast-ice edge is not positively identified.

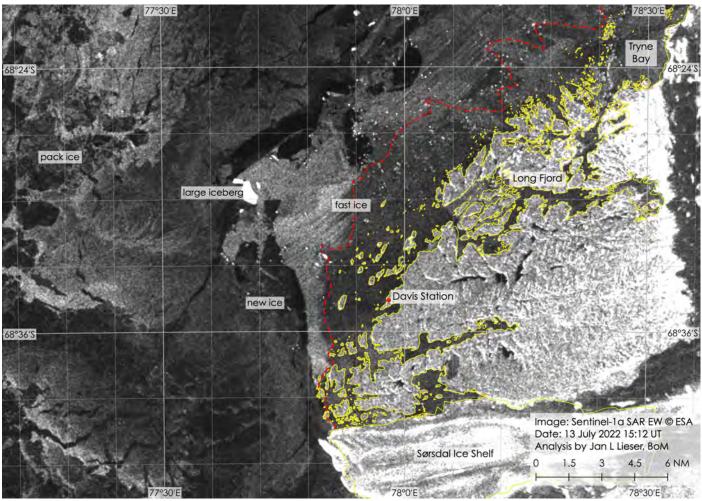
Figure 1: Sentinel-1a SAR EW data acquired 13 July 2022 at 15:12 UT and provided by PolarView.

Figure 1 shows SAR data of Davis Station and surrounds. The fast-ice edge on 13 June 2022 is outlined by a dashed red line.

The entire scene is covered by some form of ice. Off Davis Station, the fast-ice edge has progressed westward temporarily and is enclosing a large iceberg that is grounded offshore. Off the fast-ice edge, new sea ice has grown, and pack ice is present further offshore.

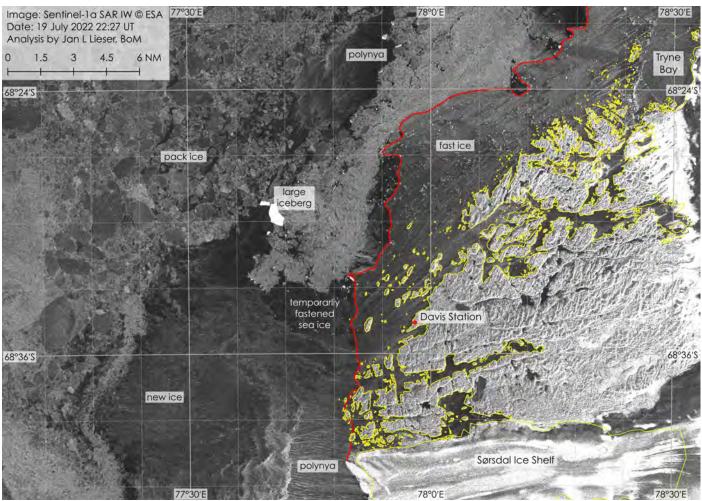
Figure 1: Sentinel-1a SAR IW data acquired 19 July 2022 at 22:27 UT and provided by PolarView.

Figure 1 shows high-resolution SAR data of Davis Station and surrounds. The fast-ice edge is marked by a red line.

Off Davis Station, the fast-ice edge had progressed westward temporarily but the ice that was enclosing a large iceberg grounded offshore is broken up again. Off the fast-ice edge, new sea ice is growing, and pack ice is present further offshore.

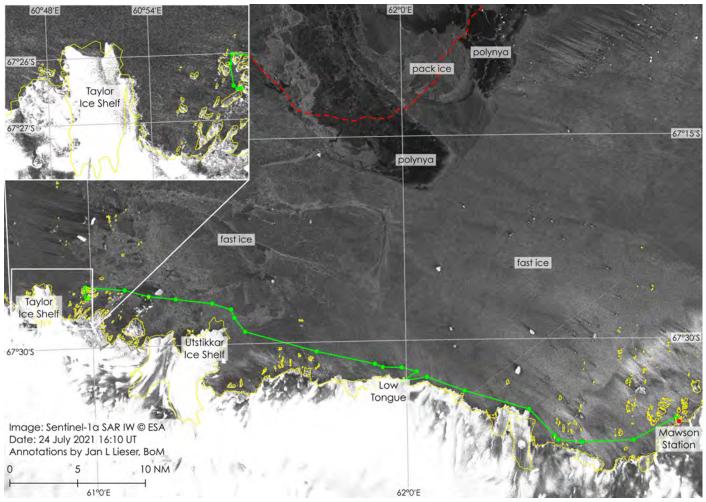
Figure 1: Sentinel-1a SAR IW data acquired 24 July 2022 at 16:10 UT and provided by PolarView.

Figure 1 shows high-resolution SAR data west of Mawson Station. The fast-ice edge on 4 July 2022 is marked by a dashed red line. A white diagonal hairline is a stitching artefact where two consecutive SAR scenes connect. The typical route between the station and the Colbeck Archipelago (east of Taylor Ice Shelf) is marked by a green line.

The fast-ice edge has been moving southward again in recent weeks. The shortest distance between the station and the polynya northwest of the station is currently roughly 25 nautical miles.

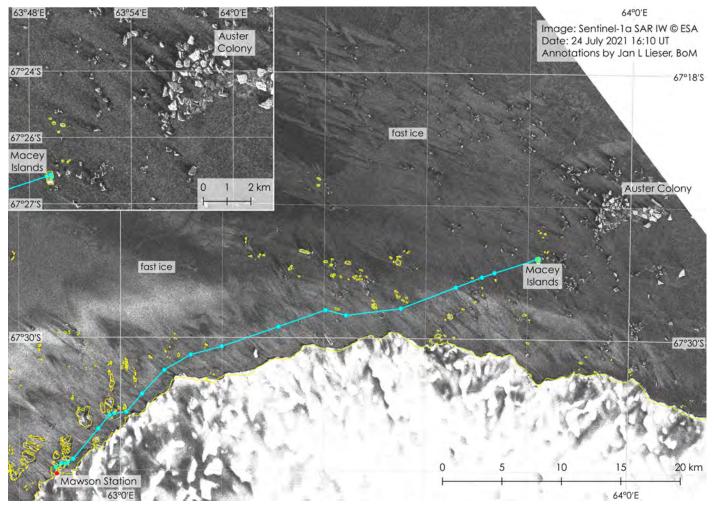
Figure 2: Sentinel-1a SAR IW data acquired 24 July 2022 at 16:10 UT and provided by PolarView.

Figure 2 shows the fast-ice conditions east of Mawson Station. The typical route between the station and the Macey Islands is marked by a cyan line. The Auster penguin colony is located between grounded icebergs northeast of the Macey Islands.

East and west of Mawson Station, the fast-ice surface appears largely homogenous but wind scouring remains a prominent feature nearshore and between the island off station.

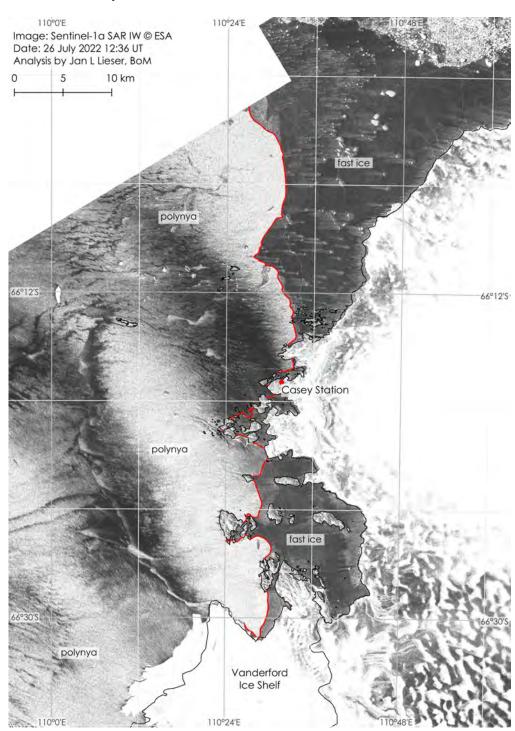
Figure 1: Sentinel-1a SAR IW data acquired 26 July 2022 at 12:36 UT and provided by PolarView.

North of the station, the outer fast ice shows already further signs of breaking some clear fractures are visible in the SAR data.

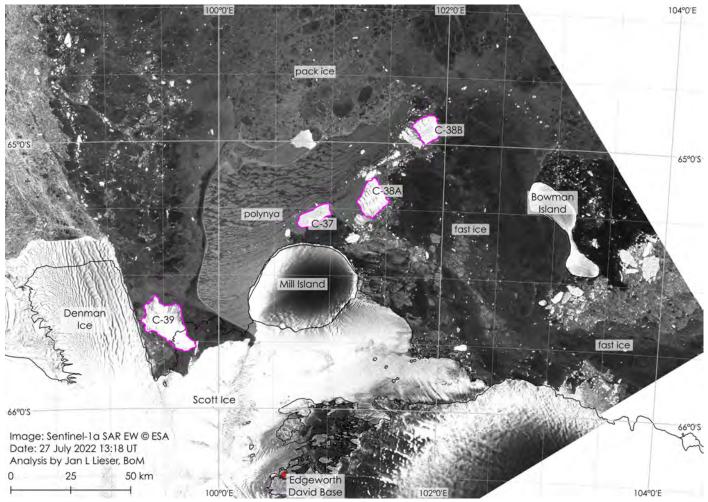
Figure 1: Sentinel-1a SAR EW data acquired 27 July 2022 at 13:18 UT and provided by PolarView.

Figure 1 shows SAR data of the eastern Shackleton Ice Shelf around Mill Island. The positions of four large icebergs in the vicinity are marked by pink shapes.

Since the sea ice consolidated largely in the region, the four large icebergs have not moved significantly but the C-38 icebergs show signs of breakup by spawning smaller icebergs.

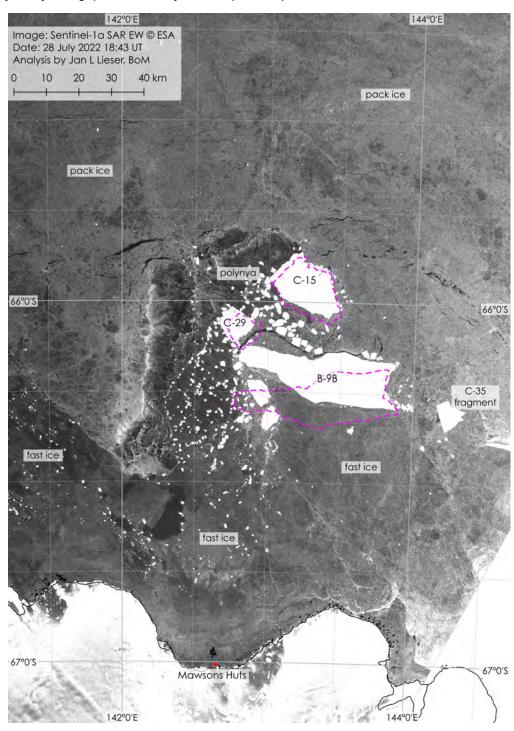
Figure 1: Sentinel-1a SAR EW data acquired 28 July 2021 at 18:43 UT and provided by PolarView.

Further north, the northern sea-ice edge is between 50 and 100 nautical miles below (south of) the median sea-ice extent for July (not shown in the figure).

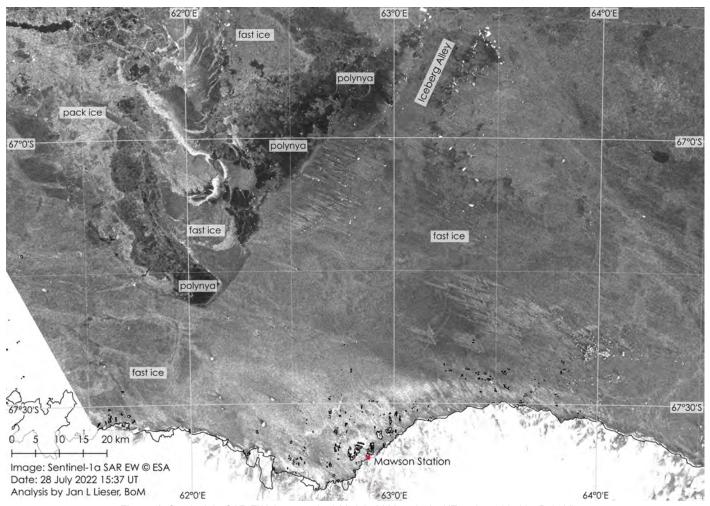
Figure 1: Sentinel-1a SAR EW data acquired 28 July 2022 at 15:37 UT and provided by PolarView.

Figure 1 shows SAR data off Mawson Station.

Northwest of the station, small polynyas are reduced in size but active. The shortest distance to open water is roughly 25 km.

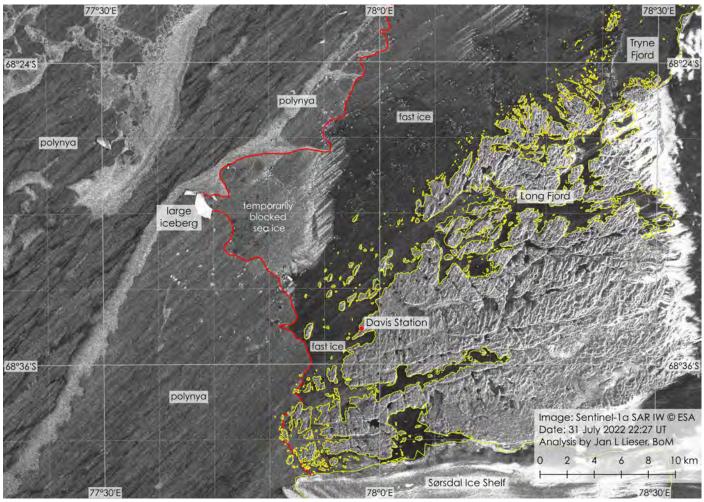
Figure 1: Sentinel-1a SAR IW data acquired 31 July 2022 at 22:27 UT and provided by PolarView.

Figure 1 shows high-resolution SAR data of Davis Station and the Vestfold Hills. Fast-ice areas are outlined by red lines.

West of Davis Station, some fast ice has broken up recently due to strong wind forcing. Some sea ice and ex-fast ice is temporarily blocked in its south-westward drift by grounded icebergs (including one large one). Off the fast-ice edge, a large polynya is present and new sea ice is forming as grease ice.

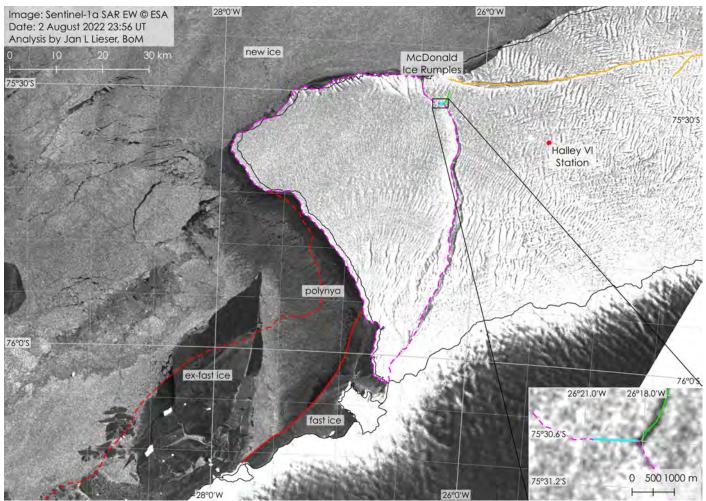
Figure 1: Sentinel-1a SAR EW data acquired 2 August 2022 at 23:56 UT and provided by PolarView.

Figure 1 shows SAR data off the Brunt Ice Shelf in the south-eastern Weddell Sea.

Cracks continue to develop at the Brunt Ice Shelf. A potential new iceberg (outlined by a dashed pink shape west of Halley-VI Station) has not yet separated from the shelf but a new fissure opened south of the McDonald Ice Rumples north-eastward (marked in green). The last remaining connection between the potential iceberg and the ice shelf is less than 1 km (marked in cyan; see inset). When this last nexus fails, the new iceberg could be roughly 1700 km², which compares to the area of Greater Hobart, Tasmania.

During autumn and winter, fast ice had been forming at the southwestern edge of the ice shelf but a large portion of it has recently broken off (the red dashed line marks the fast-ice edge on 23 July 2022 and the solid red the current edge).

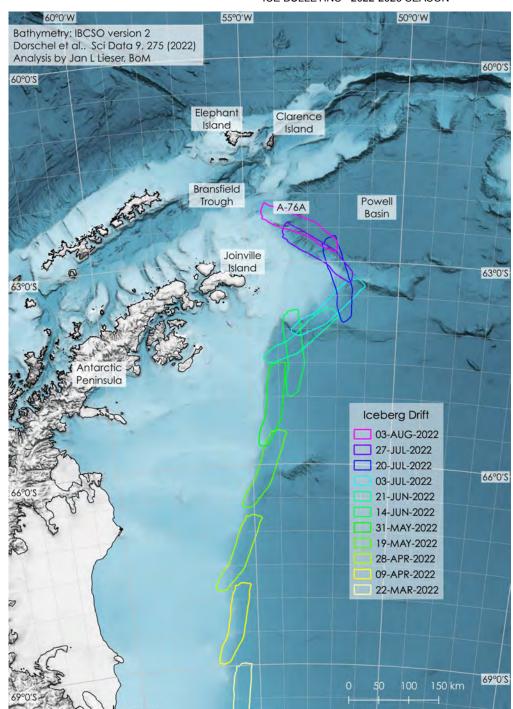
Figure 2 illustrates the bathymetry along which the iceberg has been travelling since March 2022. The iceberg's drift followed closely the peninsula's continental shelf break at the western side of the Weddell Abyssal Plain. Currently, the iceberg is along the western side of the Powell Basin.

In 2020, the large iceberg A-68A followed a similar path and turned north-eastward south of Clarence Island and continued on a north-eastern trajectory from there.

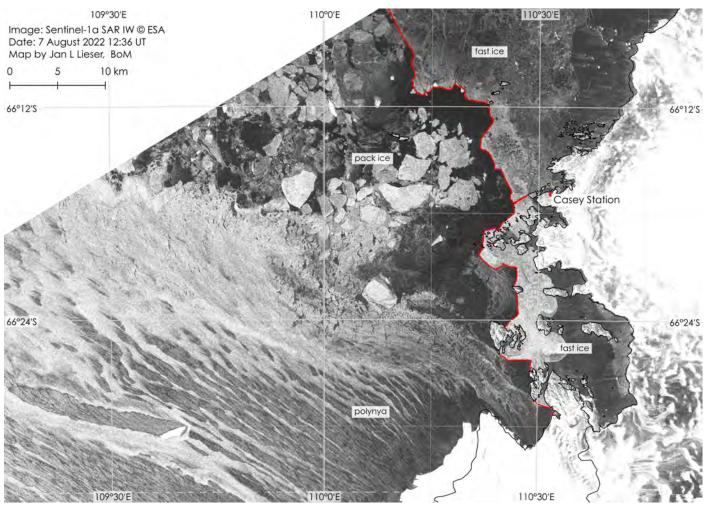
Figure 1: Sentinel-1a SAR IW data acquired 7 August 2022 at 12:36 UT and provided by PolarView.

Figure 1 shows high-resolution SAR data off Casey Station. The fast-ice edge is marked by a red line.

West of Casey Station, the fast-ice edge has progressed westward during the past two weeks. Two different types of fast ice can be identified offshore, where nearshore fast ice appears smooth (dark) and outer fast ice appears rough (lighter grey). This outer fast ice is prone to break out under stormy conditions.

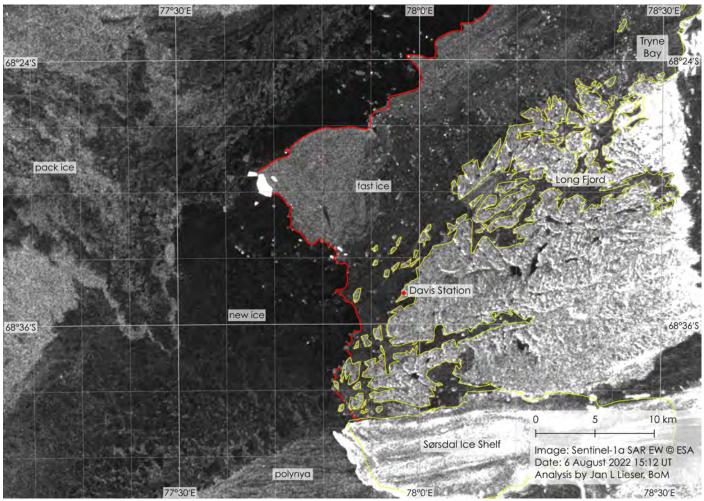
Figure 1: Sentinel-1a SAR EW data acquired 6 August 2022 at 15:12 UT and provided by PolarView.

Figure 1 shows SAR data off Davis Station. The fast-ice edge is marked by a red line.

West of the station, the fast-ice edge is only 2.5 nautical miles away from the shore. North of the Vestfold Hills, the fast-ice edge has not changed significantly during the past week.

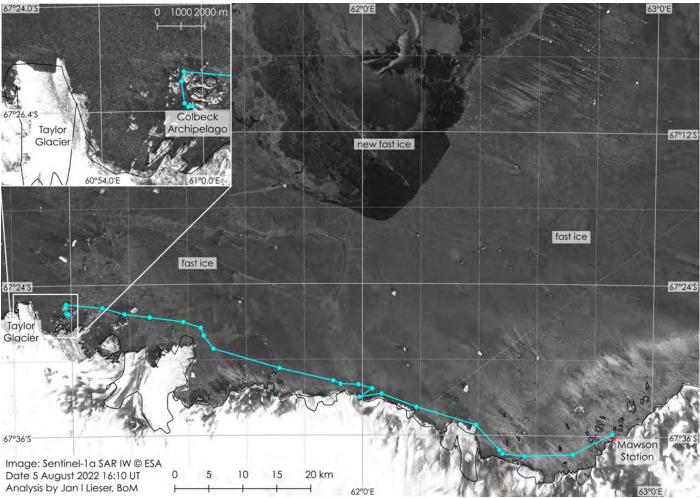
Figure 1: Sentinel-1a SAR IW data acquired 5 August 2022 at 16:10 UT and provided by PolarView.

Figure 1 shows high-resolution SAR data off Mawson Station. A diagonal hairline is a stitching artefact where two consecutive scenes join.

Northwest of the station, the southern polynya is temporarily frozen over by new ice that is locked in place. The distance to the nearest open water further north (outside of the figure) is roughly 39 nautical miles.

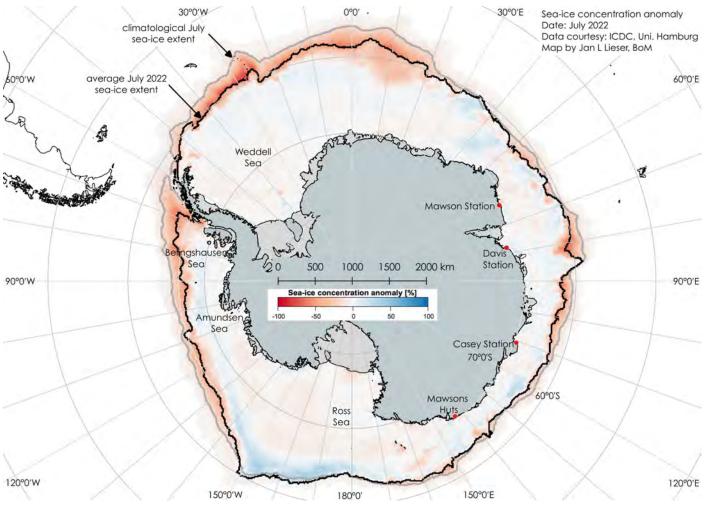
Figure 1: Sea-ice concentration anomaly for July 2022 provided by ICDC (Universität Hamburg).

Figure 1 shows the pan-Antarctic sea-ice concentration anomaly based on passive microwave remote sensing data.

In July 2022, pan-Antarctic sea-ice conditions ranked again the lowest monthly (July) conditions since records began.

The largest negative anomalies are found in the northern Weddell Sea, in East Antarctic between 70°0'E and 110°0'E and west of the Antarctic Peninsula. It is again noted that the waters around the South Sandwich Islands (along 26°0'W in the northern Weddell Sea) were largely free of sea ice, which is still anomalous for this time of year. Northeast of Joinville Island (63°15'S, 55°45'W; at the northern tip of the Antarctic Peninsula), an elongated negative anomaly is understood to be associated with the drift of large iceberg A-76A, which creates a local polynya on its lee side while the iceberg is drifting northward into the southern South Atlantic.

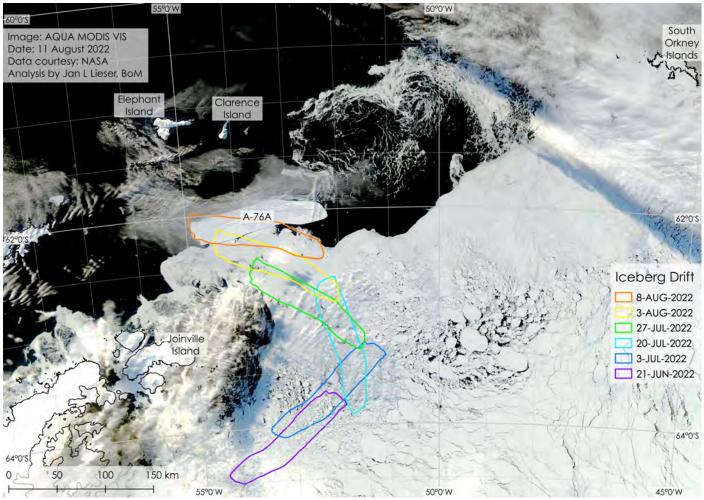
Figure 1: AQUA MODIS VIS data acquired 11 August 2022 and provided by NASA.

Figure 1 shows visible data off the northern tip of the Antarctic Peninsula in the north-western Weddell Sea.

As previously anticipated, iceberg A-76A has now exited the marginal ice zone and and is entering the southern South Atlantic Ocean but remains along the western side of the Powell Basin (centred roughly at 50°0'W and 62°0'S).

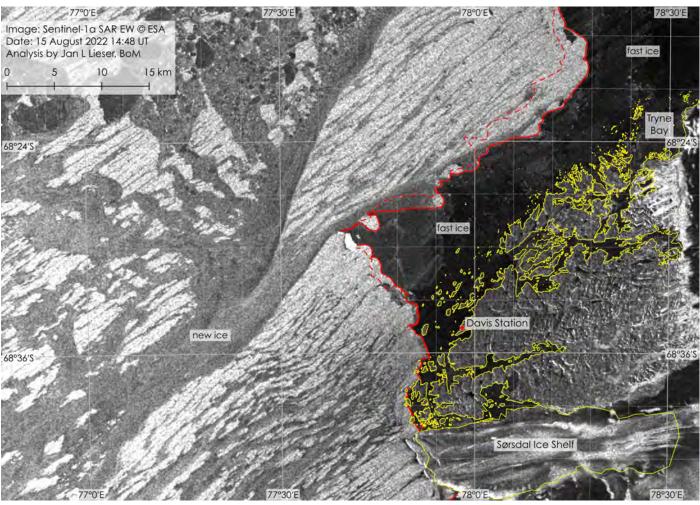
Figure 1: Sentinel-1a SAR EW data acquired 14 August 2022 at 14:48 UT and provided by PolarView.

Figure 1 shows SAR data off Davis Station. The fast-ice edge is marked by a red line (dashed red for 6 August 2022).

West of the station, the fast-ice edge remains only 2.5 nautical miles away from the shore. North of the Vestfold Hills, the fast-ice edge has moved closer to the shore during the past week.

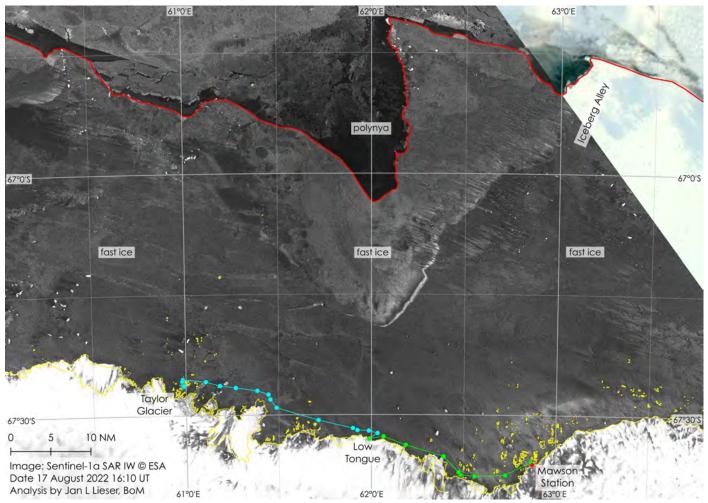
Figure 1: Sentinel-1a SAR IW data acquired 17 August 2022 at 16:10 UT and provided by PolarView; complemented by AQUA MODIS VIS data acquired 17 August 2022 and provided by NASA.

Figure 1 shows high-resolution SAR data off Mawson Station. The fast-ice edge is marked by a red line.

West of Mawson Station, the fast ice appears largely homogenous and not many icebergs are frozen in nearshore. Northwest of the station, the distance to nearest open water of the polynya is roughly 38 nautical miles.

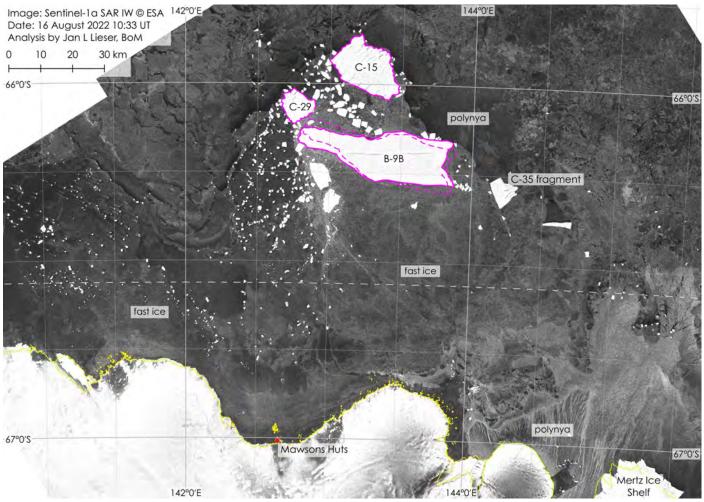
Figure 1: Sentinel-1a SAR IW data acquired 16 August 2022 at 10:33 UT and provided by PolarView.

Figure 1 shows high-resolution SAR data of southern D'Urville Sea off Mawson's Huts/Cape Denison. The positions of three large icebergs on 5 July 2022 are shown by dashed pink shapes.

Off Mawson's Huts, fast ice has grown. Further north, icebergs C-15 and C-29 remain grounded but iceberg B-9B appears mobile even though it is surrounded and trapped by grounded smaller icebergs and fast ice. South of the western side of the iceberg, two larger icebergs are also slightly mobile within the fast ice. Furthermore, iceberg B-9B is pushing small but grounded icebergs at its north-eastern side northward and therefore working to eventually free itself from the trap of small icebergs it is surrounded by.

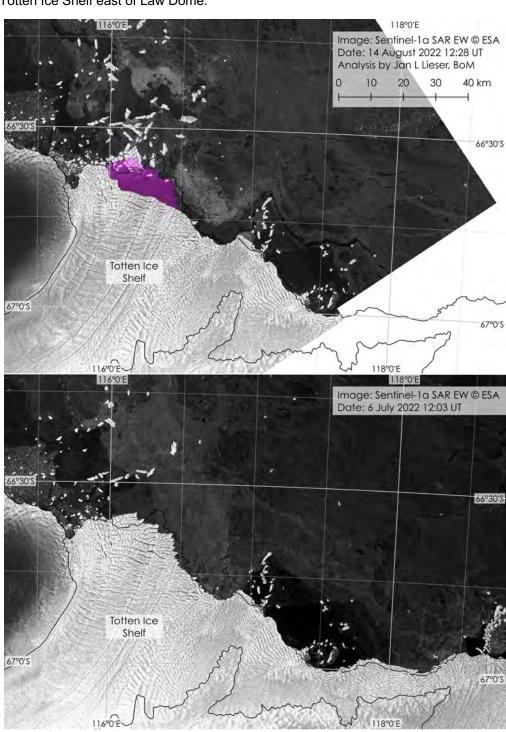
Figure 1: Top Panel: Sentinel-1a SAR EW data acquired 14 August 2022 at 12:28 UT; Bottom Panel: Sentinel-1a SAR EW data acquired 6 July 2022 at 12:28 UT; both provided by PolarView.

During late-July 2022, roughly 173 km² of the north-western front of the ice shelf broke off (shaded pink in the top panel of the figure) and formed many small to medium-sized icebergs and only one larger iceberg (roughly 28 km²) that are all drifting northward.

So far this winter, fast ice has only been forming further west along the shore of Law Dome and further north between grounded icebergs. In front of the Totten Ice Shelf is drifting pack ice and occasionally a small temporary polynya that is formed by offshore winds.

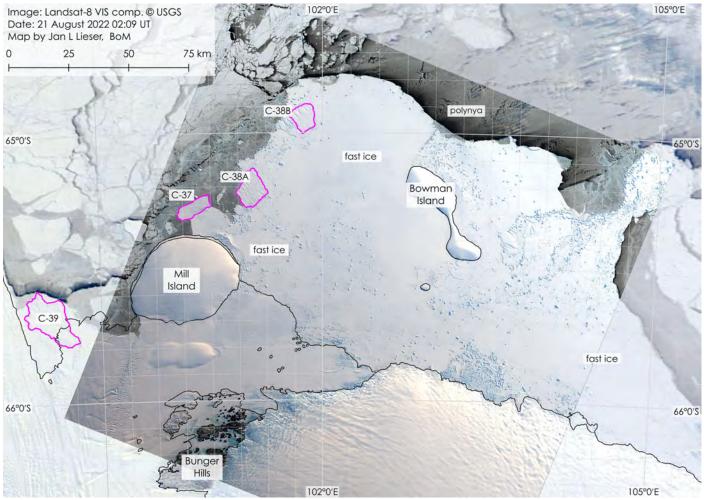
Figure 1: Landsat-8 visible composite data acquired 21 August 2022 at 02:09 UT and provided by USGS; Background: TERRA MODIS VIS data acquired 21 August 2022 and provided by NASA.

Figure 1 shows high-resolution visible data of the eastern Shackleton Ice Shelf around Mill Island. The positions of four large icebergs in the vicinity are marked by pink shapes.

Since the fast ice consolidated between Mill Island and Bowman Island, the four large icebergs have not moved but the C-38 icebergs show signs of breakup by spawning smaller icebergs.

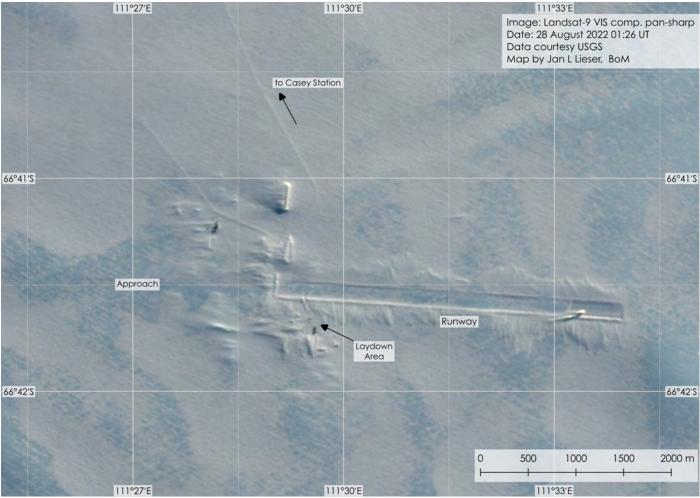
Figure 1 shows high-resolution (15 m horizontal) visible data of Wilkins Aerodrome.

Figure 1: Landsat-9 visible composite data acquired 28 August 2022 at 01:26 UT and provided by USGS.

The ice runway is clearly visible. North and south of the runway, snow dunes are left from previous clearing the runway.
