Ice Bulletins for the Antarctic Shipping Season 2022 – 2023

Prepared by Dr Jan L Lieser

Antarctic Meteorology Section — Bureau of Meteorology

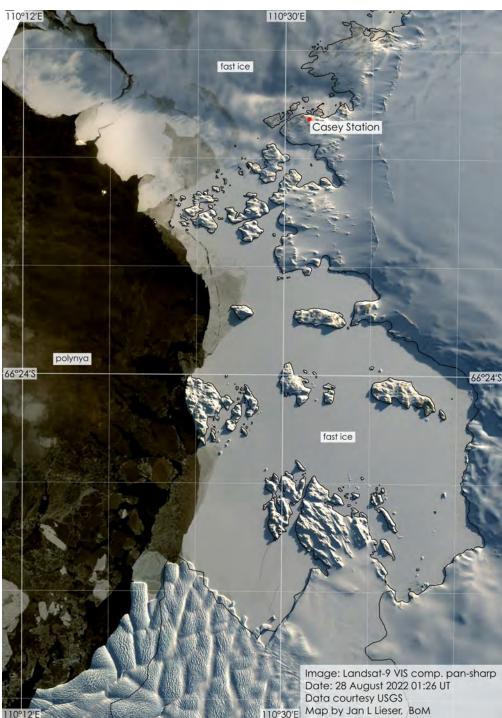
West of Casey Station, the fast-ice edge has progressed westward temporarily. Two different types of fast ice can be identified offshore, where nearshore fast ice appears firmer (white) and outer fast ice appears thinner (grey). This outer fast ice is prone to break out under stormy conditions.

Figure 1: Landsat-9 visible composite data pan-sharpened acquired 28 August 2022 at 01:26 UT and provided by USGS.

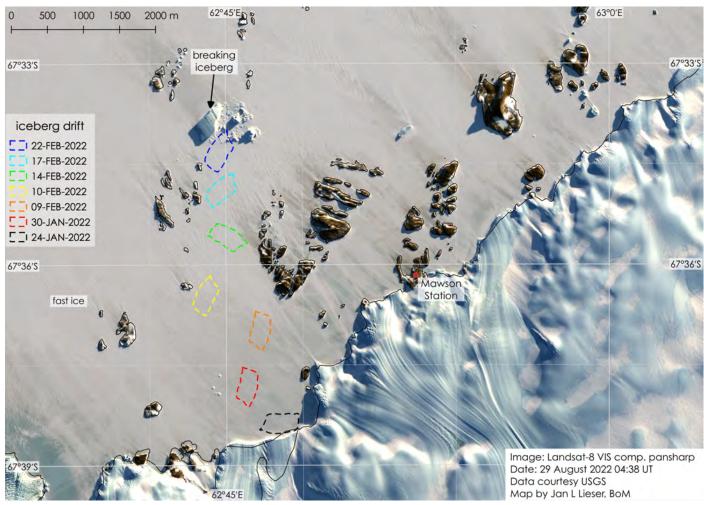
Figure 1 shows high-resolution visible data off Mawson Station.

Figure 1: Landsat-8 visible composite pan-sharpened data acquired 29 August 2022 at 04:38 UT and provided by USGS.

Off Mawson Station, the fast ice appears largely homogenous. One large iceberg that broke off an ice shelf southwest of the station in January this year remains trapped in the fast ice and is crumbling now in situ.

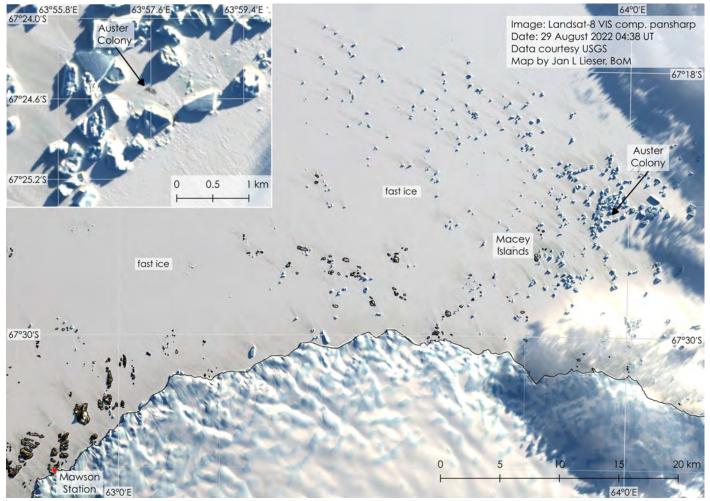
Figure 2 shows a different section of the same data shown in Figure 1. The location of the Auster penguin colony is visible by the stained patch of fast ice between icebergs (see inset).

Figure 2: Landsat-8 visible composite pan-sharpened data acquired 29 August 2022 at 04:38 UT and provided by USGS.

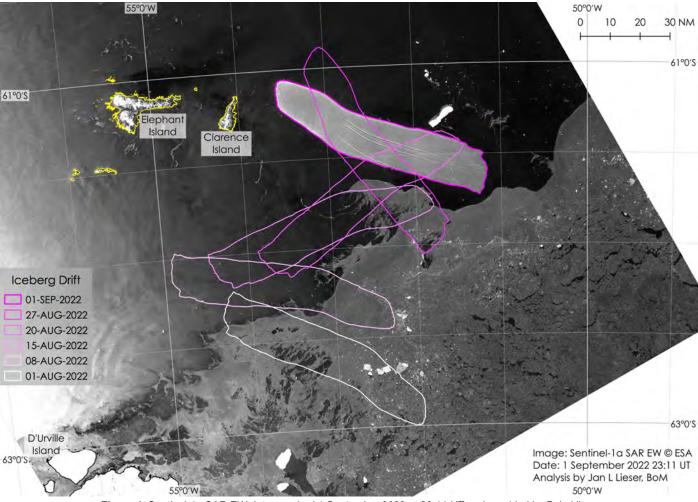
Figure 1 shows SAR data off the northern tip of the Antarctic Peninsula in the north-western Weddell Sea.

Figure 1: Sentinel-1a SAR EW data acquired 1 September 2022 at 23:11 UT and provided by PolarView.

As previously confirmed, iceberg A-76A has exited the marginal ice zone and is drifting in the southern South Atlantic Ocean but remains along the northern side of the Powell Basin (centred roughly at 50°0'W and 62°0'S; see Figure 2). During August, the iceberg completed a turn of 180 degrees while generally drifting north-eastward.

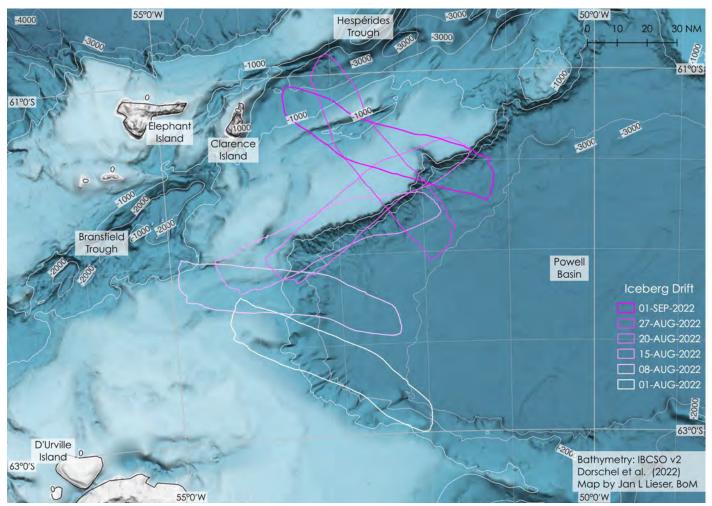
Figure 2: Bathymetry [metres] data provided by IBCSO (Dorschel et al., 2022).

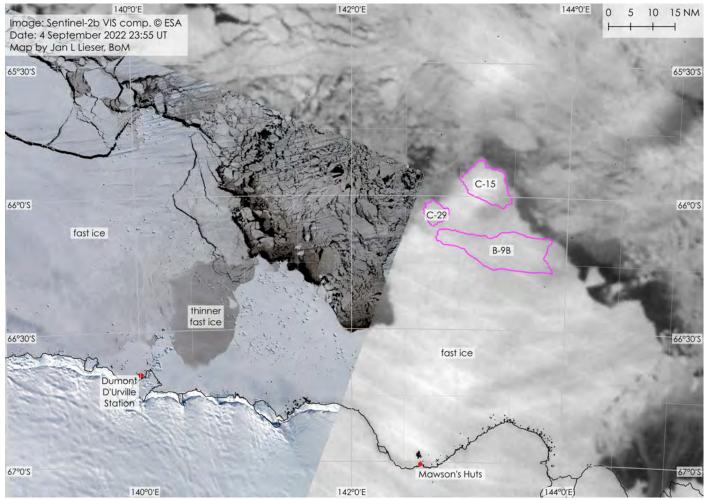
Figure 1 shows VIS and DNB composite data of southern D'Urville Sea off Mawson's Huts/Cape Denison. The positions of three large icebergs are shown by pink shapes.

Figure 1: Sentinel-2b visible composite data acquired 4 September 2022 at 23:55 UT and provided by ESA; background of VIIRS Day-Night-Band data acquired 5 September 2022 and provided by NASA.

Off Mawson's Huts and Dumont D'Urville Station, fast ice has grown. Icebergs C-15 and C-29 remain grounded and iceberg B-9B is now surrounded and trapped by grounded smaller icebergs and fast ice.

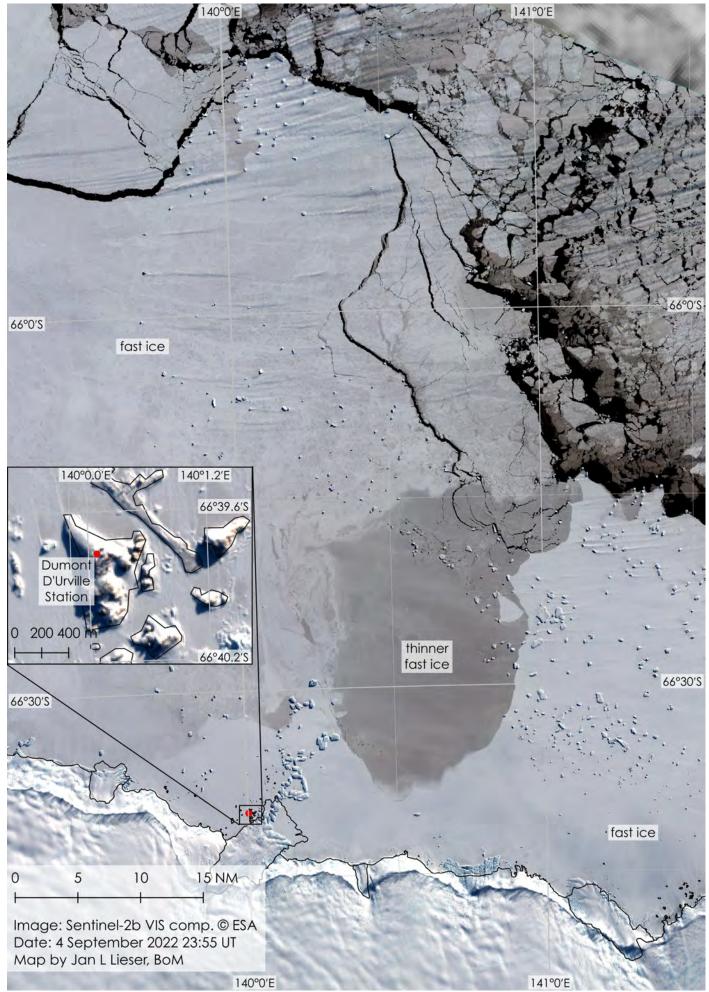
Figure 2 shows a closer zoom of the region off Dumont D'Urville Station as seen by the high-resolution (10 m horizontal) visible data.

Figure 2: Sentinel-2b visible composite data acquired 4 September 2022 at 23:55 UT and provided by ESA.

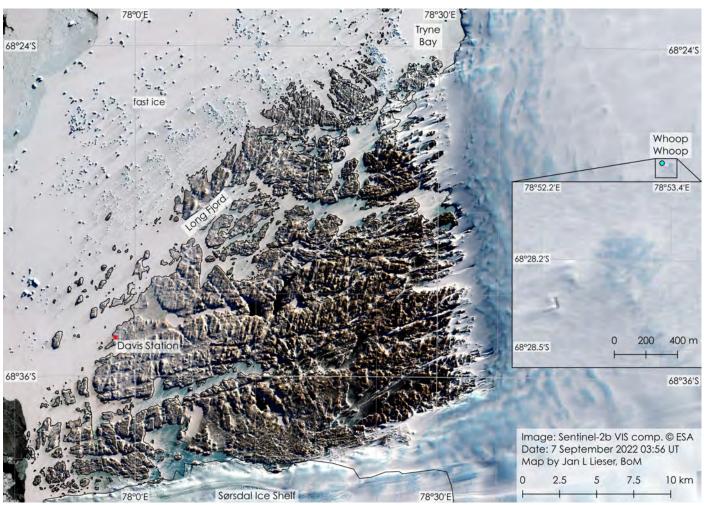
Figure 1 and Figure 2 show high-resolution (10 m horizontal) VIS data off Davis Station.

Figure 1: Sentinel-2b VIS data acquired 7 September 2022 at 03:56 UT and provided by USGS.

The hinterland airfield Whoop Whoop is marked by a cyan dot (see inset for full resolution).

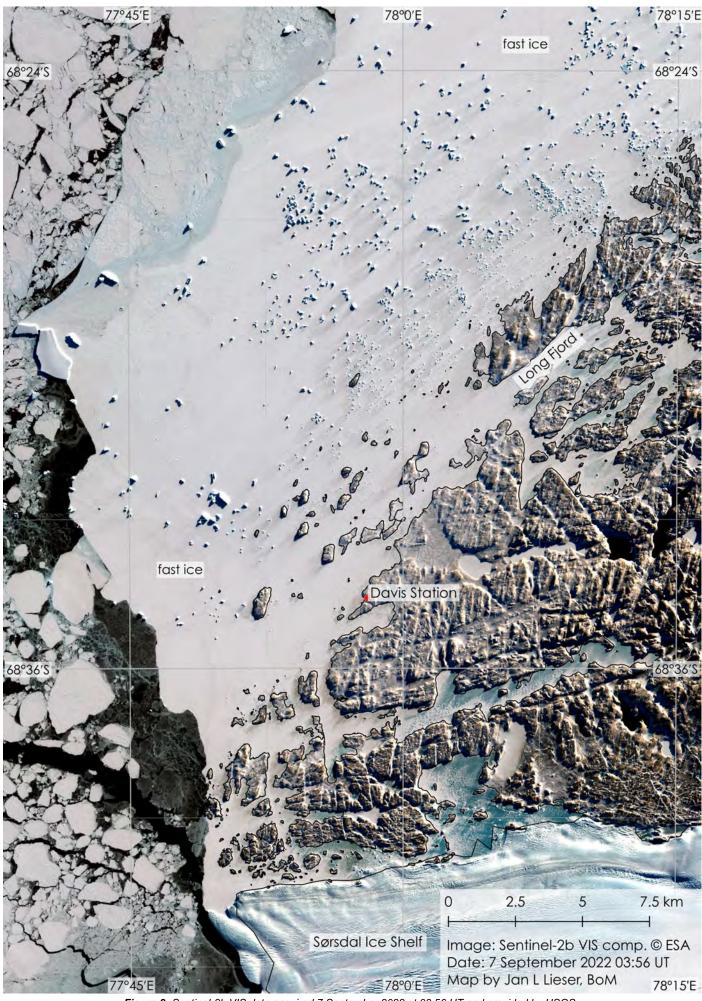
Figure 2: Sentinel-2b VIS data acquired 7 September 2022 at 03:56 UT and provided by USGS.

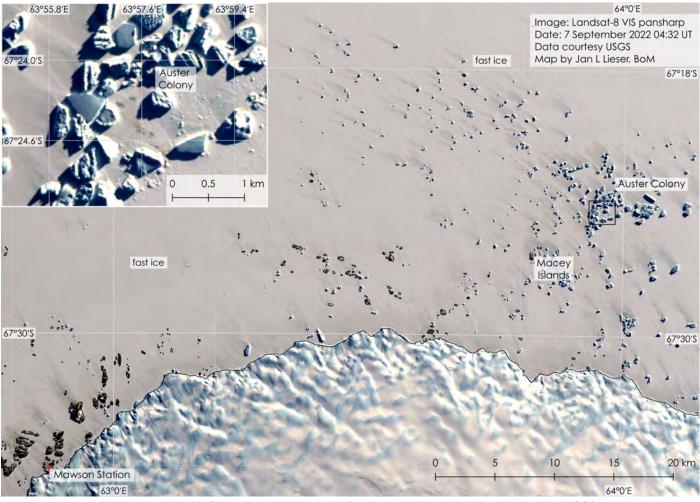
Figure 1 shows high-resolution (15 m horizontal) VIS data off Mawson Station.

Figure 1: Landsat-8 VIS pan-sharp data acquired 7 September 2022 at 04:32 UT and provided by USGS.

The Auster penguin colony can be seen between grounded icebergs east of the station (see discoloured surface patches in the inset for full resolution).

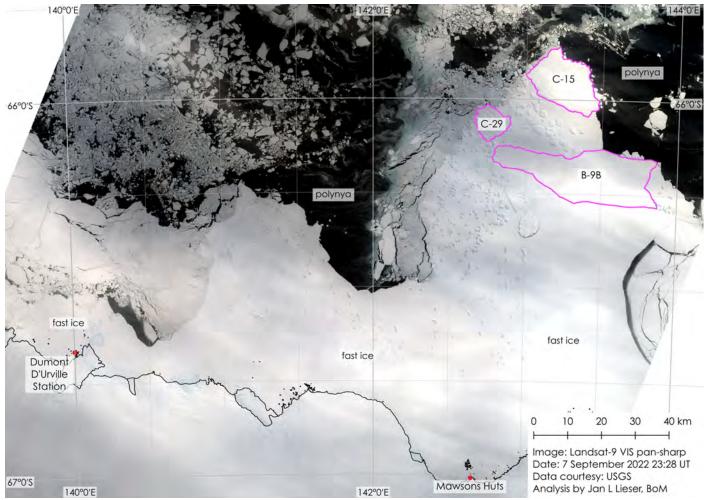
Figure 1 shows high-resolution (15 m horizontal) VIS data of southern D'Urville Sea between Dumont D'Urville Station and Mawson's Huts/Cape Denison. The scene is partly obscured by thin clouds. The positions of three large icebergs are shown by pink shapes.

Figure 1: Landsat-9 visible composite data acquired 7 September 2022 at 23:28 UT and provided by USGS.

Off Mawson's Huts and Dumont D'Urville Station, fast ice has grown. Icebergs B-9B, C-15 and C-29 remain grounded and surrounded and trapped by grounded smaller icebergs and fast ice.

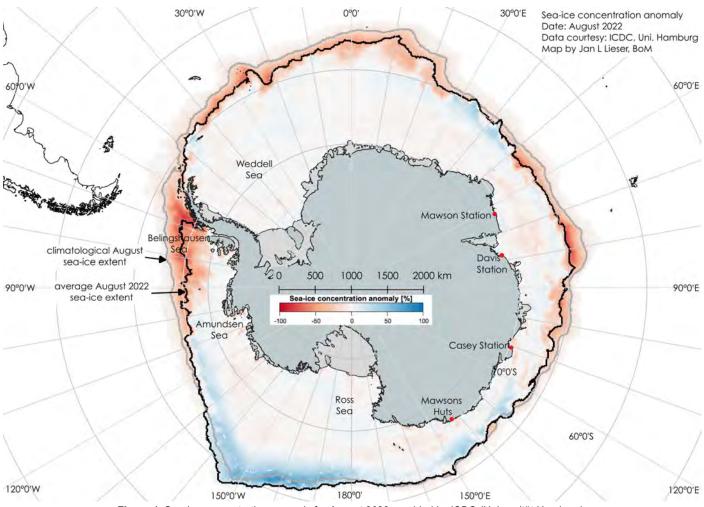
Figure 1 shows the pan-Antarctic sea-ice concentration anomaly based on passive microwave remote sensing data.

Figure 1: Sea-ice concentration anomaly for August 2022 provided by ICDC (Universität Hamburg).

In August 2022, pan-Antarctic sea-ice conditions ranked third-lowest monthly (August) conditions since records began.

Negative extent anomalies are found in the entire Weddell Sea, in East Antarctic between 50°0'E and 120°0'E and west of the Antarctic Peninsula. It is again noted that the northern part the South Sandwich Islands (along 26°0'W in the northern Weddell Sea) remains largely free of sea ice, which is still anomalous for this time of year. Northeast of Joinville Island (63°15'S, 55°45'W; at the northern tip of the Antarctic Peninsula), a negative anomaly is associated with the drift of large iceberg A-76A, which creates a local polynya in its lee while the iceberg is drifting northward into the southern South Atlantic.

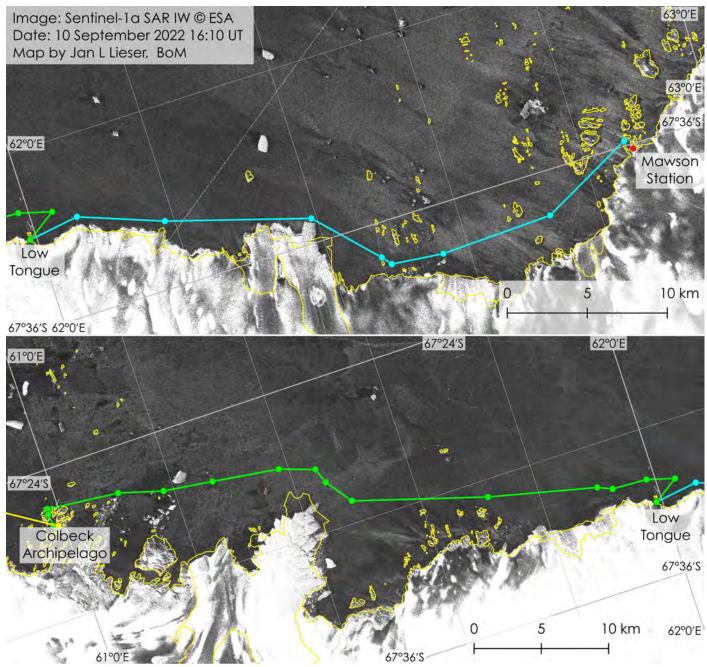
Figure 1 and Figure 2 show high-resolution (15 m horizontal) SAR data west off Mawson Station. The typical route between the station and Depot Island is marked by colour-coded segments. The upper panel of Figure 1 has a white diagonal hairline, which is a stitching artefact where two consecutive scenes join.

Figure 1: Sentinel-1a SAR IW data acquired 10 September 2022 at 16:10 UT and provided by PolarView.

The route between the station and Depot Island is covered by largely homogenous fast ice and only a few icebergs are trapped nearshore. The entire coast was free of fast ice by mid-March 2022 and the present fast ice has been growing in-situ since April 2022.

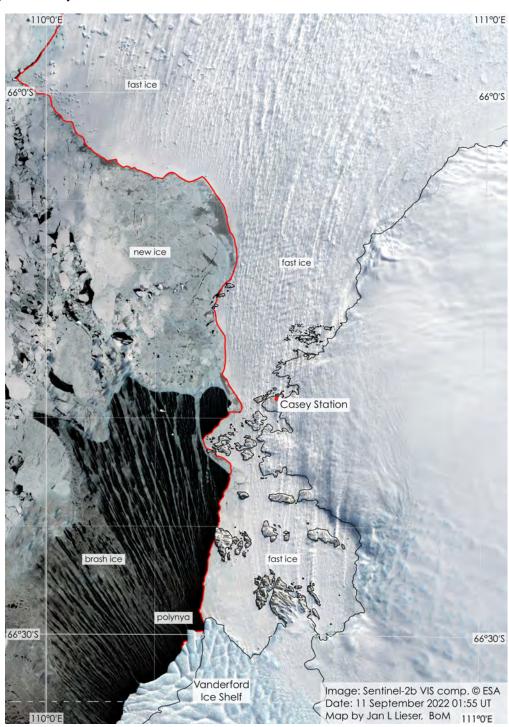
Southerly winds have reopened the polynya off the
Vanderford Ice Shelf and new
sea ice is being formed there
in strips and patches. New ice
accumulates along the
southern edge of the fast ice
north of the station.

Figure 1: Sentinel-2b visible composite data acquired
11 September 2022 at 01:55 UT and provided by USGS.

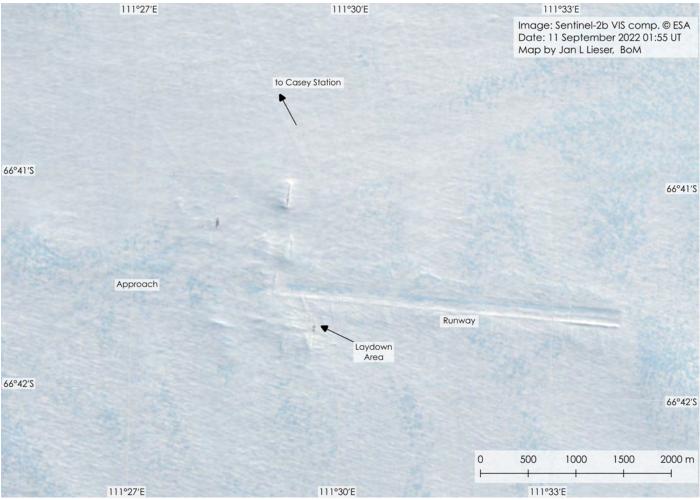
Figure 1 shows high-resolution (10 m horizontal) visible data of Wilkins Aerodrome.

Figure 1: Sentinel-2b visible composite data acquired 11 September 2022 at 01:55 UT and provided by USGS.

The ice runway appears covered by fresh snow. North and south of the runway, snow dunes are left from previous clearing the runway.

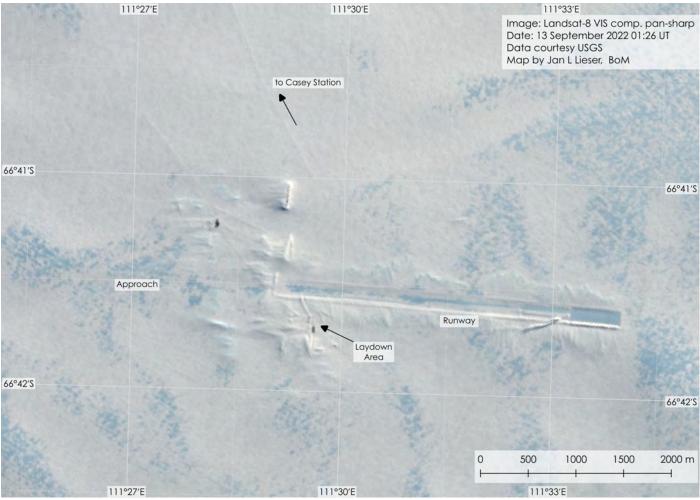
Figure 1 shows high-resolution (15 m horizontal) visible data of Wilkins Aerodrome.

Figure 1: Landsat-8 visible composite pan-sharpened data acquired 13 September 2022 at 01:26 UT and provided by USGS.

The ice runway appears covered by fresh snow. North and south of the runway, snow dunes are left from previous clearing the runway.

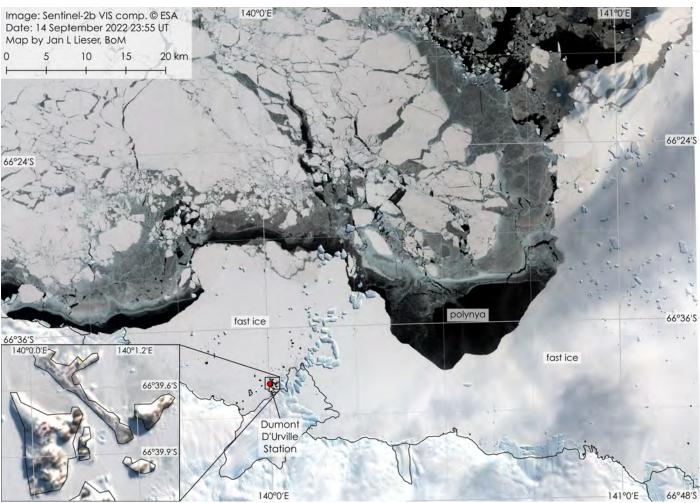
Figure 1 shows high-resolution (10 m horizontal) VIS data of southern D'Urville Sea around Dumont D'Urville Station.

Figure 1: Sentinel-2b visible composite data acquired 14 September 2022 at 23:55 UT and provided by USGS.

Off Dumont D'Urville Station, the nearest open water is roughly 10 nautical miles away.

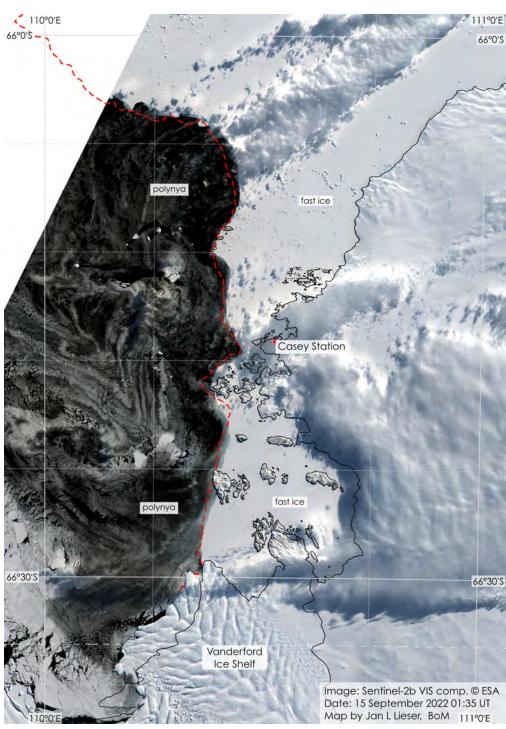
Southerly winds had reopened the polynya off the Vanderford Ice Shelf and new sea ice is forming there in strips and patches. This new ice is currently being redistributed in the polynya.

Figure 1: Sentinel-2b visible composite data acquired 15 September 2022 at 01:35 UT and provided by USGS.

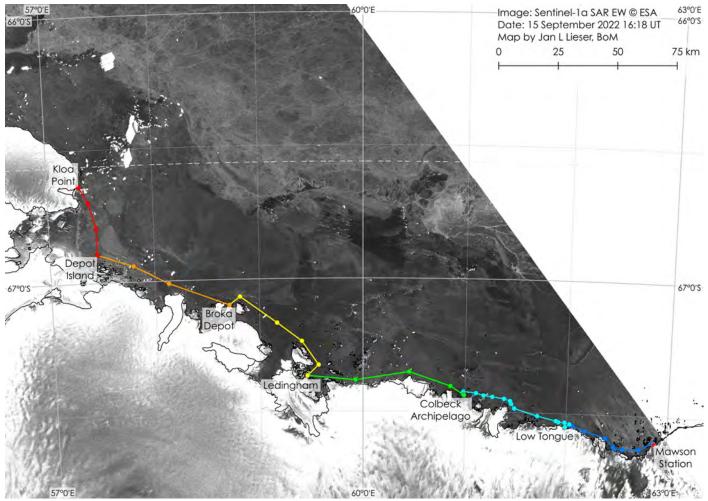
The figures of this Bulletin show SAR data west off Mawson Station. The typical route between the station and Kloa Point is marked by colour-coded segments. The middle panel of Figure 2 has a white diagonal hairline, which is a stitching artefact where two consecutive scenes join.

Figure 1: Sentinel-1a SAR EW data acquired 15 September 2022 at 16:18 UT and provided by PolarView.

The route between the station and Kloa Point is over largely homogenous fast ice and only a few icebergs are trapped nearshore. Note: immediately east of Kloa Point, a group of large icebergs is trapped close to the shore (see inset of Figure 3 lower panel for details).

North of the region shown in Figure 1, the northern sea-ice edge (not shown in the figure) is 50–70 nautical miles below (south of) the median sea-ice extent for September.

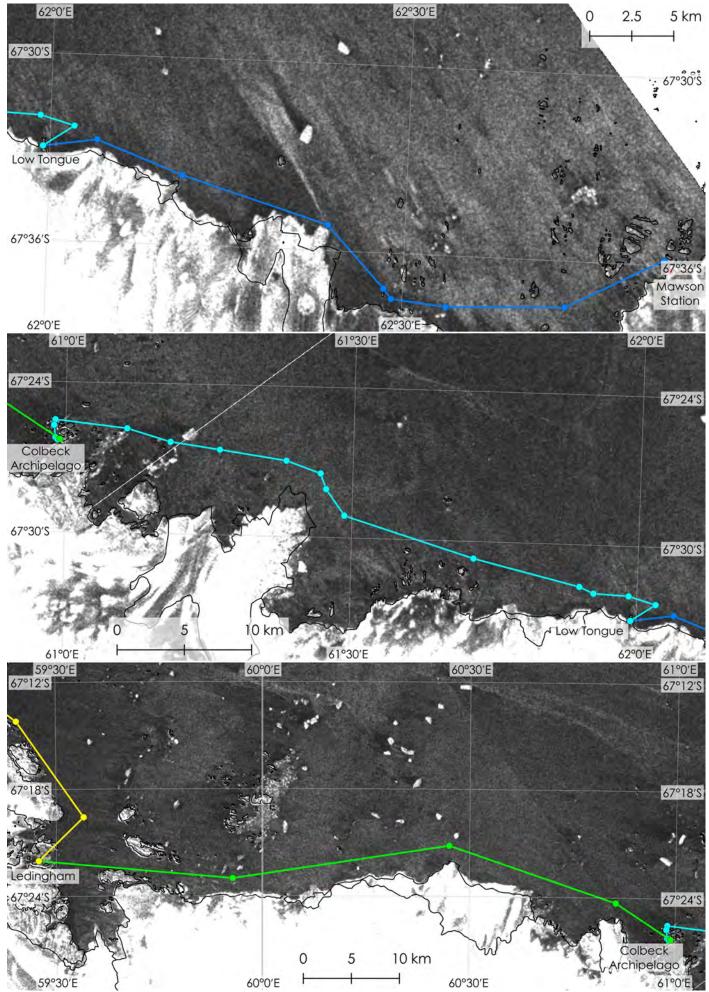
Figure 2: Sentinel-1a SAR EW data acquired 15 September 2022 at 16:18 UT and provided by PolarView.

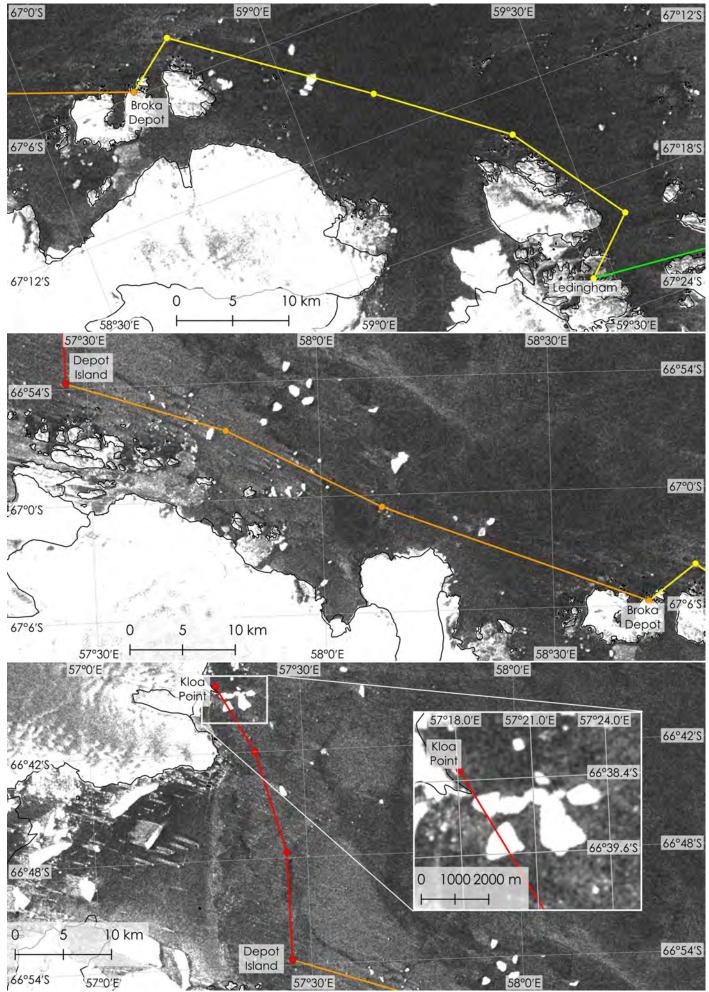
Figure 3: Sentinel-1a SAR EW data acquired 15 September 2022 at 16:18 UT and provided by PolarView.

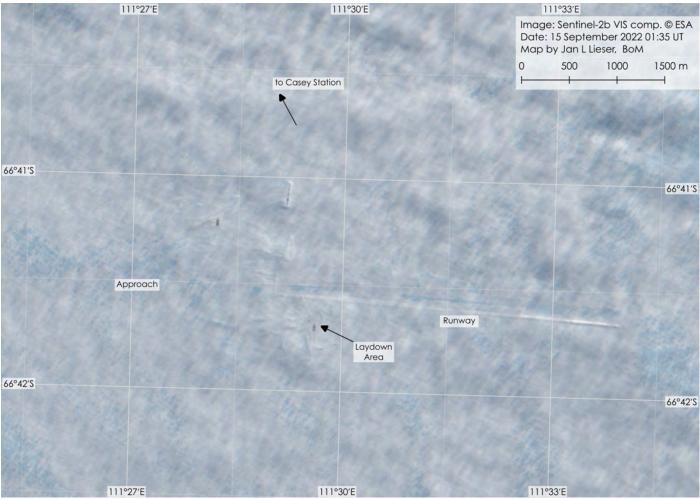
Figure 1 shows high-resolution (10 m horizontal) visible data of Wilkins Aerodrome.

Figure 1: Sentinel-2b visible composite data acquired 15 September 2022 at 01:35 UT and provided by USGS.

The scene is slightly obscured by thin clouds. North and south of the runway, snow dunes are left from previous clearing the runway.

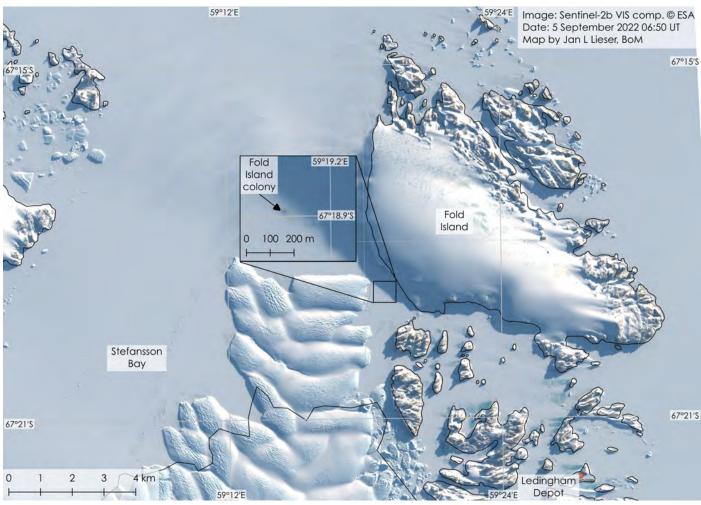
Figure 1 shows high-resolution (10 m horizontal) visible data around Fold Island west of Mawson Station.

Figure 1: Sentinel-2b VIS composite data acquired 5 September 2022 at 06:50 UT and provided by USGS.

A penguin colony is southwest of Fold Island and a discoloured spot can be seen.

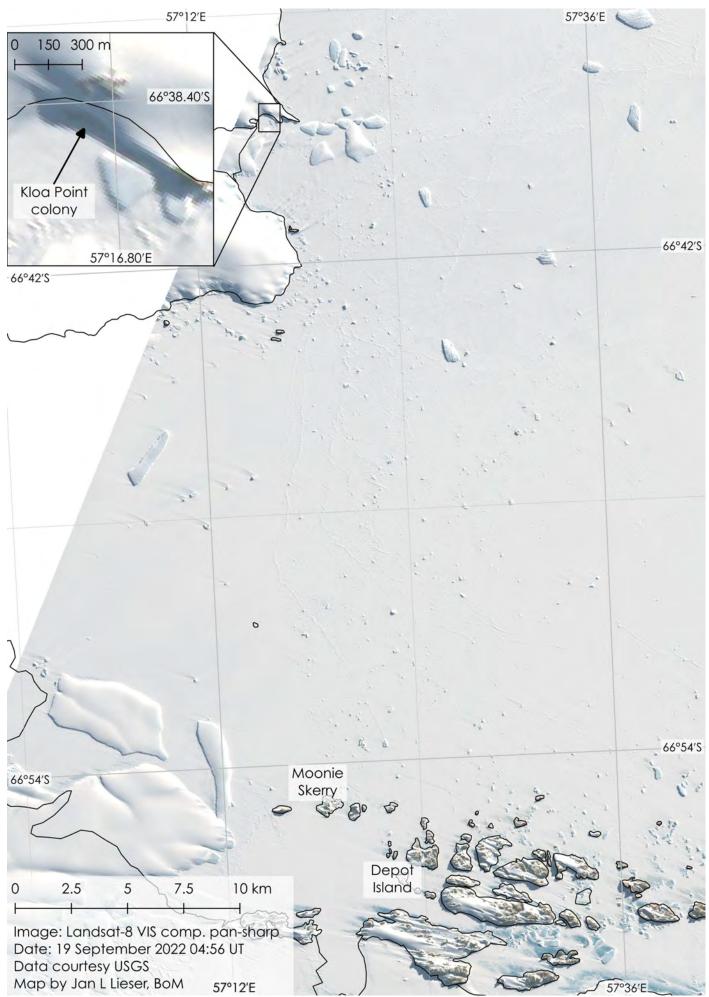
Figure 2: Landsat-8 VIS composite pansharpened data acquired 19 September 2022 at 04:56 UT and provided by USGS.

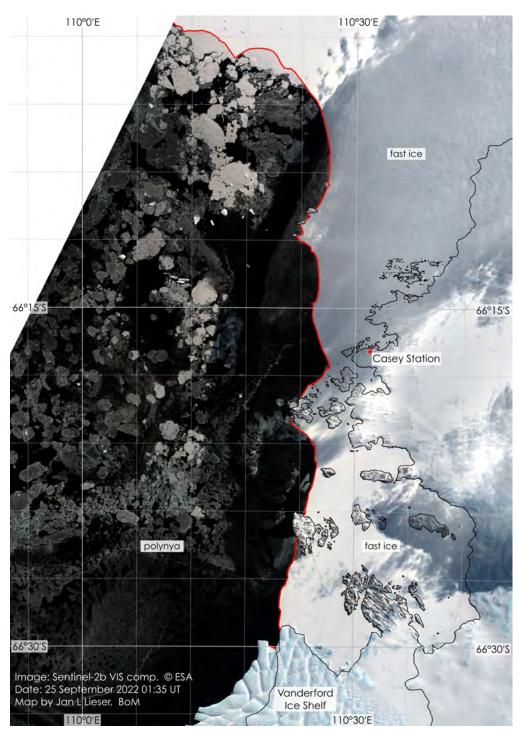
Off the Vanderford Ice Shelf, a polynya is active and new sea ice is forming there in strips and patches. This new ice is currently being pushed northward in the polynya.

Figure 1: Sentinel-2b visible composite data acquired 25 September 2022 at 01:35 UT and provided by USGS.

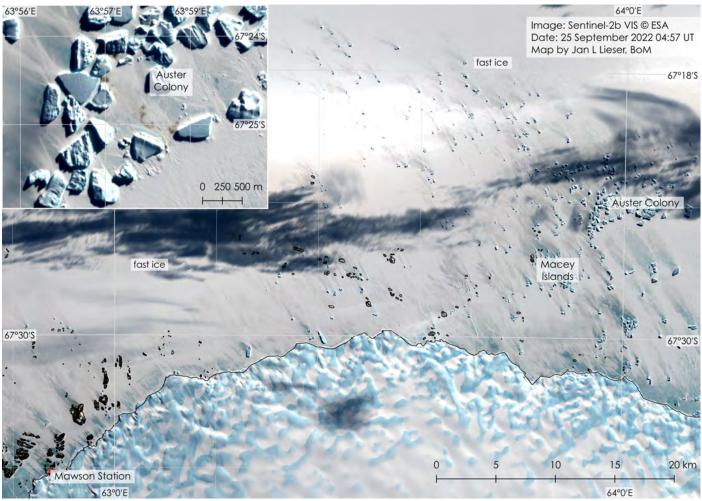
Figure 1 shows high-resolution (10 m horizontal) visible data east of Mawson Station.

Figure 1: Sentinel-2b VIS composite data acquired 25 September 2022 at 04:57 UT and provided by USGS.

The Auster penguin colony is between icebergs east of the station and discoloured spots can be seen. Figure 2 shows high-resolution (15 m horizontal) data southeast of Kloa Point west of Mawson Station. A penguin colony is south of a land promontory around Kloa Point and a discoloured spot can be seen. North of Mawson Station, the northern sea-ice edge (not shown in the figures) remains roughly 45 nautical miles below (south of) the median sea-ice extent for September.

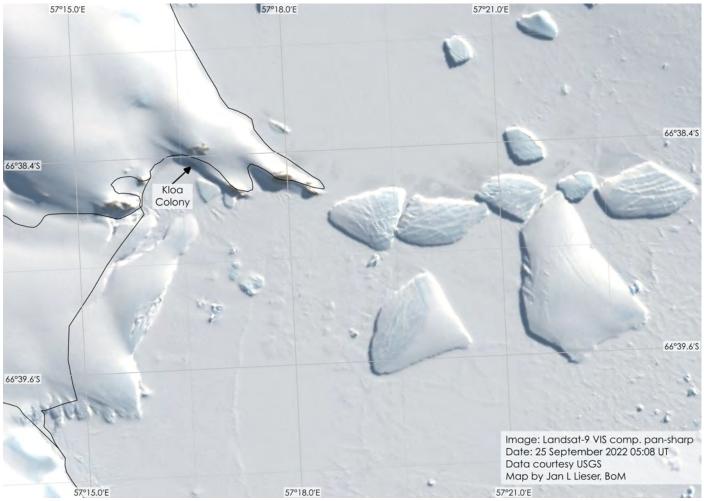
Figure 2: Landsat-9 VIS composite pansharpened data acquired 25 September 2022 at 05:08 UT and provided by USGS.

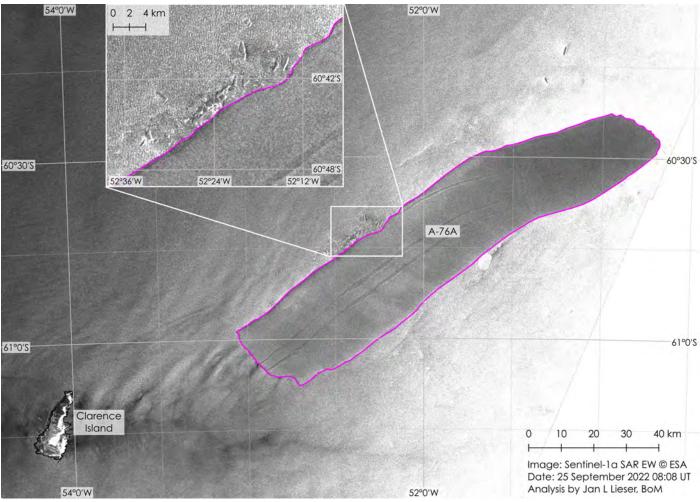
Figure 1 shows SAR data off the northern tip of the Antarctic Peninsula in the north-western Weddell Sea.

Figure 1: Sentinel-1a SAR EW data acquired 25 September 2022 at 08:08 UT and provided by PolarView.

Iceberg A-76A has exited the marginal ice zone and is drifting in the southern South Atlantic Ocean. The iceberg is now roughly 150 nautical miles north of the sea-ice edge. During September, the iceberg completed another turn of 90 degrees while generally drifting north-eastward.

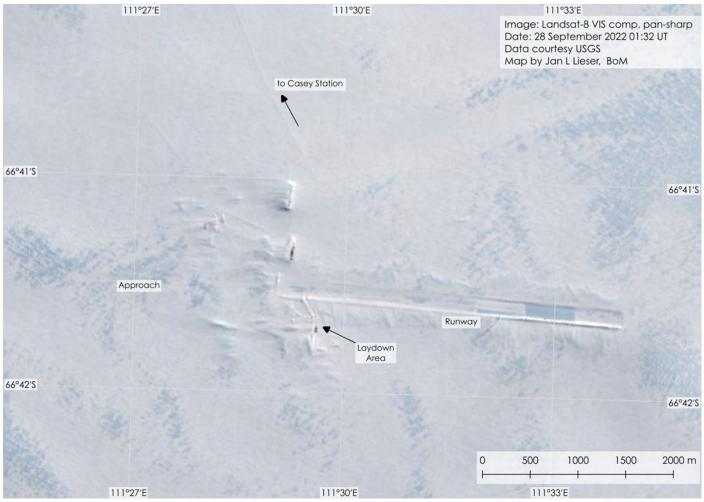
Figure 1 shows high-resolution (15 m horizontal) visible data of Wilkins Aerodrome.

Figure 1: Landsat-8 visible composite pan-sharpened data acquired 28 September 2022 at 01:32 UT and provided by USGS.

The ice runway appears covered by fresh snow. North and south of the runway, snow dunes are left from previous clearing the runway.

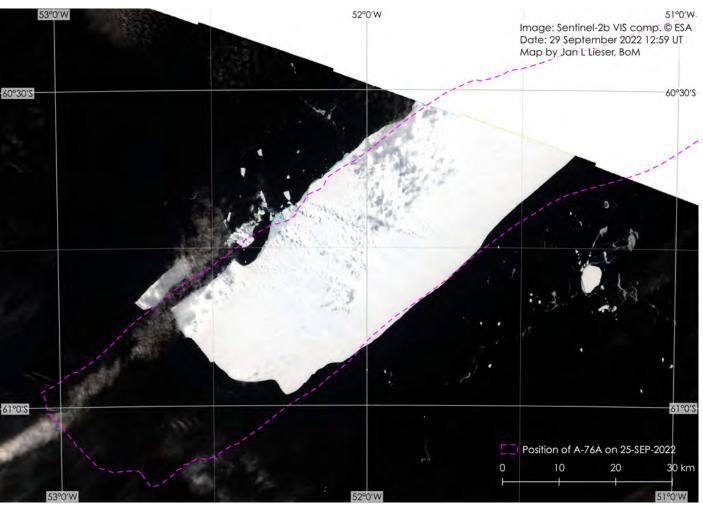
Figure 1 shows high-resolution visible data off the northern tip of the Antarctic Peninsula in the north-western Weddell Sea.

Figure 1: Sentinel-2b VIS composite data acquired 29 September 2022 at 12:59 UT and provided by USGS.

Iceberg A-76A continues drifting in the southern South Atlantic Ocean. The iceberg is now roughly 130 nautical miles north of the sea-ice edge and is generally drifting north-eastward, since 25 September 15 nautical miles.

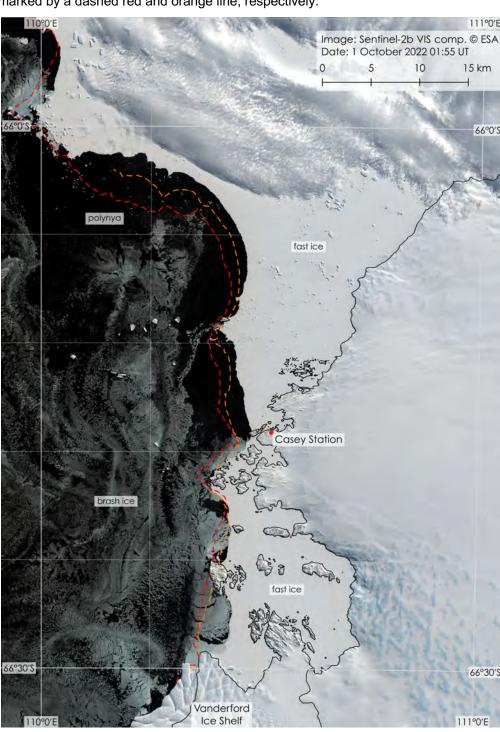
West of the station, the fast-ice edge is slowly retreating towards the shore.

Figure 1: Sentinel-2b visible composite data acquired
1 October 2022 at 01:55 UT and provided by USGS.

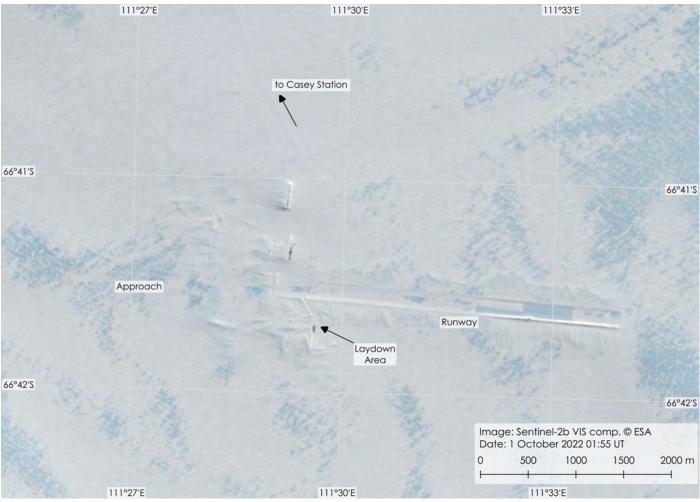
Figure 1 shows high-resolution (10 m horizontal) visible data of Wilkins Aerodrome.

Figure 1: Sentinel-2b visible composite data acquired 1 October 2022 at 01:55 UT and provided by USGS.

The ice runway appears partly covered by fresh snow. North and south of the runway, snow dunes are left from previous clearing the runway.

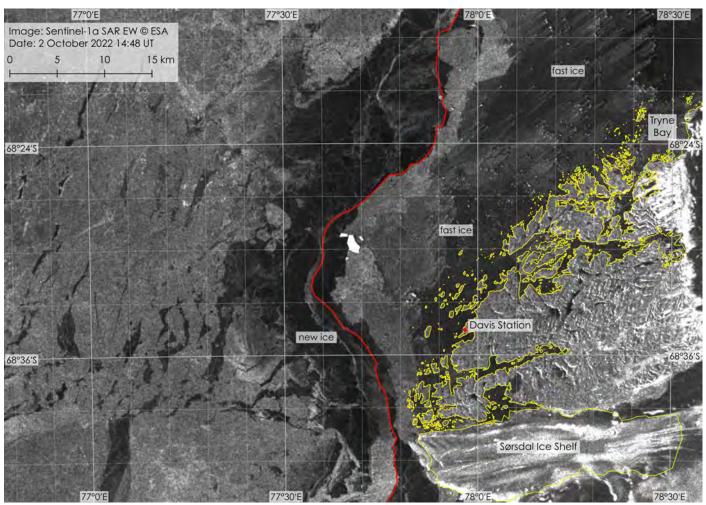
Figure 1 shows SAR data off Davis Station. The fast-ice edge is marked by a red line.

Figure 1: Sentinel-1a SAR data acquired 2 October 2022 at 14:48 UT and provided by PolarView.

West of the station, the fast-ice edge is roughly 7.5 nautical miles away from the shore. North of the Vestfold Hills, more fast ice has consolidated offshore during the past few weeks.

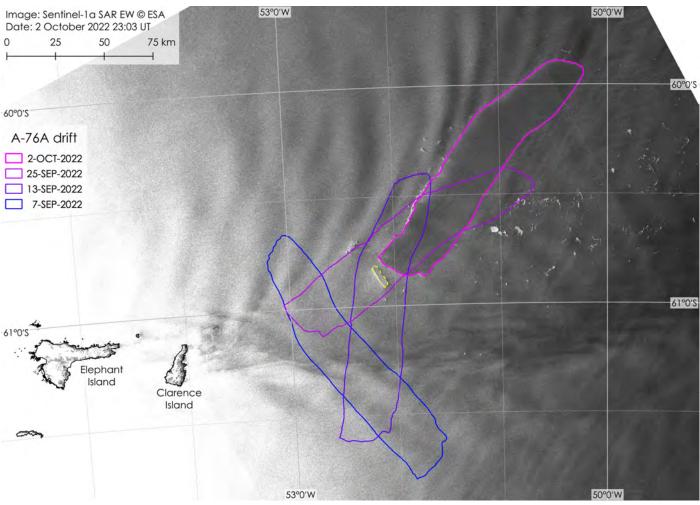
Figure 1 shows SAR data off the northern tip of the Antarctic Peninsula in the north-western Weddell Sea.

Figure 1: Sentinel-1a SAR EW data acquired 2 October 2022 at 23:03 UT and provided by PolarView.

After exiting the marginal ice zone earlier, iceberg A-76A is now crossing the Hespérides Trough into the Scotia Sea and drifting in the southern South Atlantic Ocean. The iceberg is roughly 150 nautical miles north of the sea-ice edge.

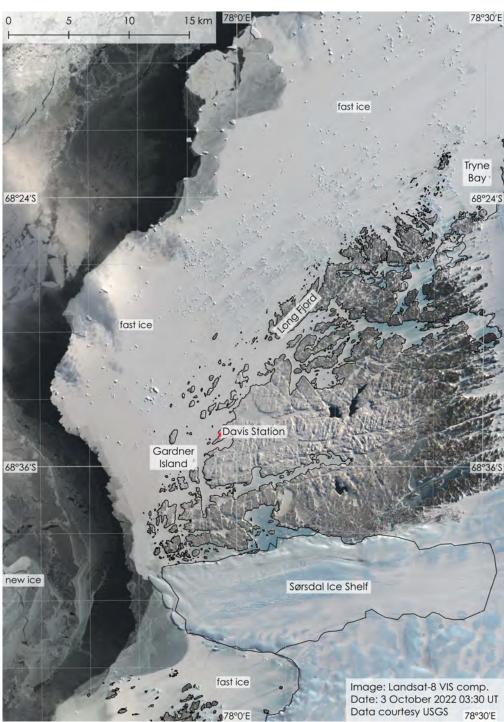
West of the station, the fastice edge remains roughly 7.5 nautical miles away from the shore. Three different fastice types can be identified offshore, where the oldest fastice near the shore extends to roughly 1 nautical mile west of Gardner Island, secondary (thinner) fast ice extending roughly further 2 nautical miles westward and a very thin outer edge of fast ice close to the open water.

Figure 1: Landsat-8 VIS composite data acquired 3 October 2022 at 03:30 UT and provided by USGS.

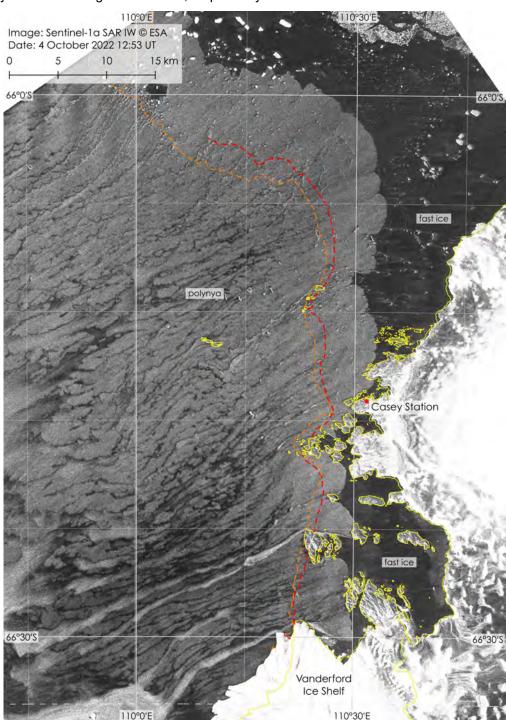
North of the Vanderford Ice Shelf, a very large polynya is active and new brash ice is forming there in strips and patches.

Figure 1: Sentinel-1a SAR IW data acquired 4 October 2022 at 12:53 UT and provided by USGS.

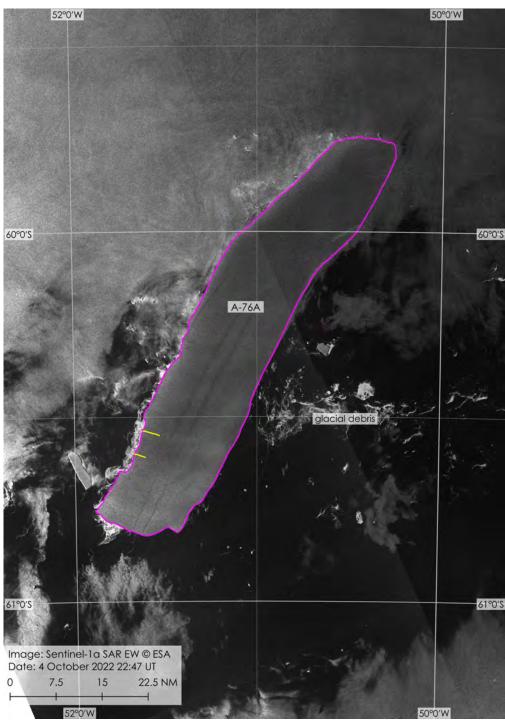
After exiting the marginal ice zone earlier, iceberg A-76A continues to cross the Hespérides Trough into the Scotia Sea and drifting in the southern South Atlantic Ocean. The iceberg remains roughly 150 nautical miles north of the sea-ice edge.

The iceberg is increasingly starting the show signs of breaking up. Yellow lines indicate new fault lines (3 and 5 nautical miles, respectively) radiating from the location where a substantial fragment broke away in late September. Smaller icebergs and glacial debris are surrounding the iceberg.

Figure 1: Sentinel-1a SAR EW data acquired 4 October 2022 at 22:47 UT and provided by PolarView.

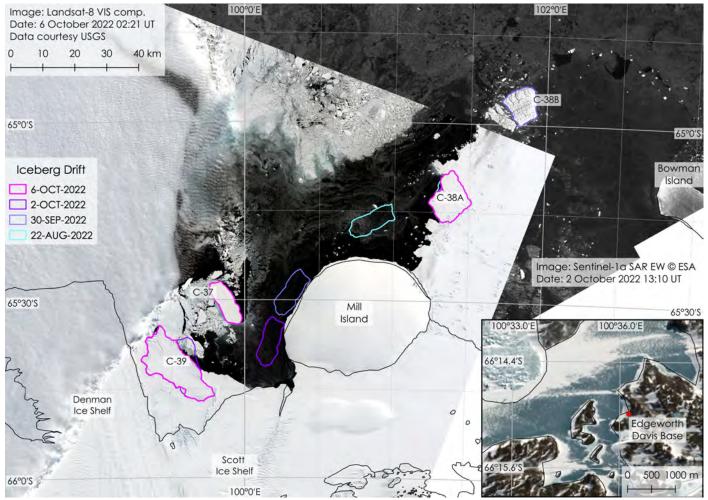
Figure 1 shows a composite of high-resolution (15 m horizontal) visible data and SAR data around Mill Island. The positions of four large icebergs are marked by colour-coded outlines.

The inset shows high-resolution (15 m horizontal) visible data around Edgeworth David Base of the Bunger Hills south of Mill Island (just outside of the mainframe of the figure).

Figure 1: Landsat-8 visible composite pan-sharpened data acquired 6 October 2022 at 02:21 UT and provided by USGS; complemented by Sentinel-1a SAR EW data acquired 2 October 2022 at 13:10 UT and provided by PolarView.

Northeast of Mill Island, three large icebergs were enclosed by fast ice in late August 2022. During September 2022, iceberg C-37 was released again and drifted south-westward along the island before turning north-westward in early October 2022. Icebergs C-38A and C-38B remain grounded and enclosed by fast ice but iceberg C-38A has lost a bit of mass on its western flank. Since 2 October 2022, iceberg C-39 has lost roughly 34 km² on its north-eastern flank but remains enclosed by fast ice between the Denman Ice Shelf and the Scott Ice Shelf west of Mill Island.

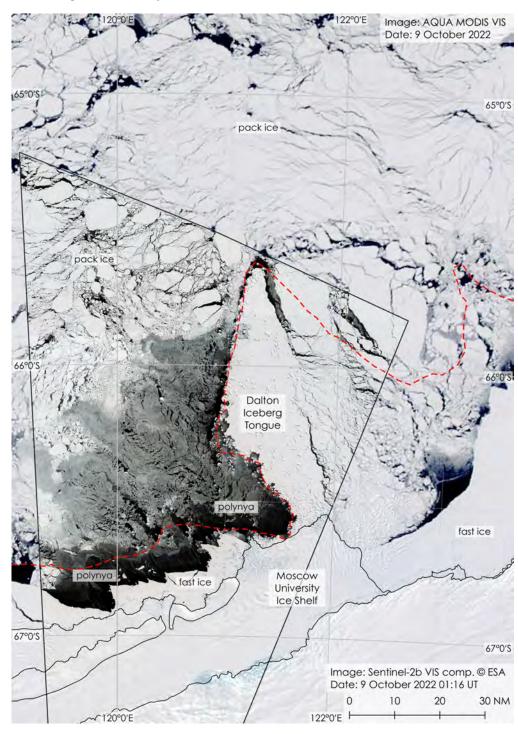
Up until mid-September, the fast ice east of the iceberg tongue was showing close to typical extent for the time of year. During the recent weeks, the fast ice has been eroded from the east and the cloud-free scene of the figure shows the extent to which the fast ice has been shattered now. Compared to the typical extent, the fast ice has been reduced by roughly 5200 km² east of the iceberg tongue.

Figure 1: Sentinel-2b visible data acquired 9 October 2022 at 01:16 UT and provided by USGS; complemented by AQUA MODIS VIS data acquired 9 October 2022 and provided by NASA.

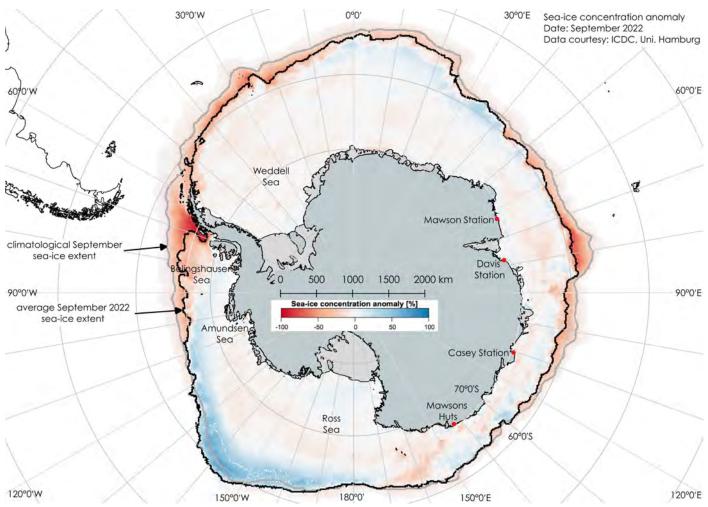
Figure 1 shows the pan-Antarctic sea-ice concentration anomaly based on passive microwave remote sensing data.

Figure 1: Sea-ice concentration anomaly for September 2022 provided by ICDC (Universität Hamburg).

Pan-Antarctic sea-ice conditions continue to be overall low but not record-breaking during September.

The most pronounced negative anomaly is found west of the Antarctic Peninsula and negative extent anomalies stretch the entire Weddell Sea and are continuing throughout East Antarctica.

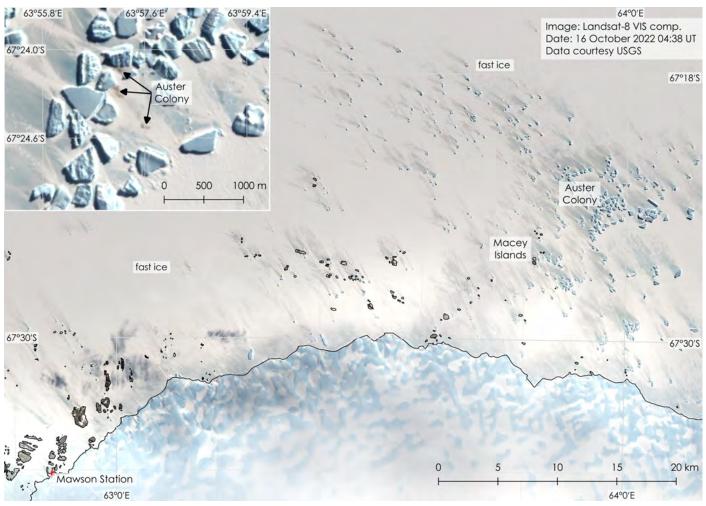
Figure 1 and Figure 2 show high-resolution (15 m horizontal) visible data off Mawson Station. Due to multiple cloud reflections, the region around the station is over-saturated.

Figure 1: Landsat-8 VIS composite pan-sharpened data acquired 16 October 2022 at 04:38 UT and provided by USGS.

The Auster penguin colony is between icebergs northeast of the station and discoloured spots can be seen.

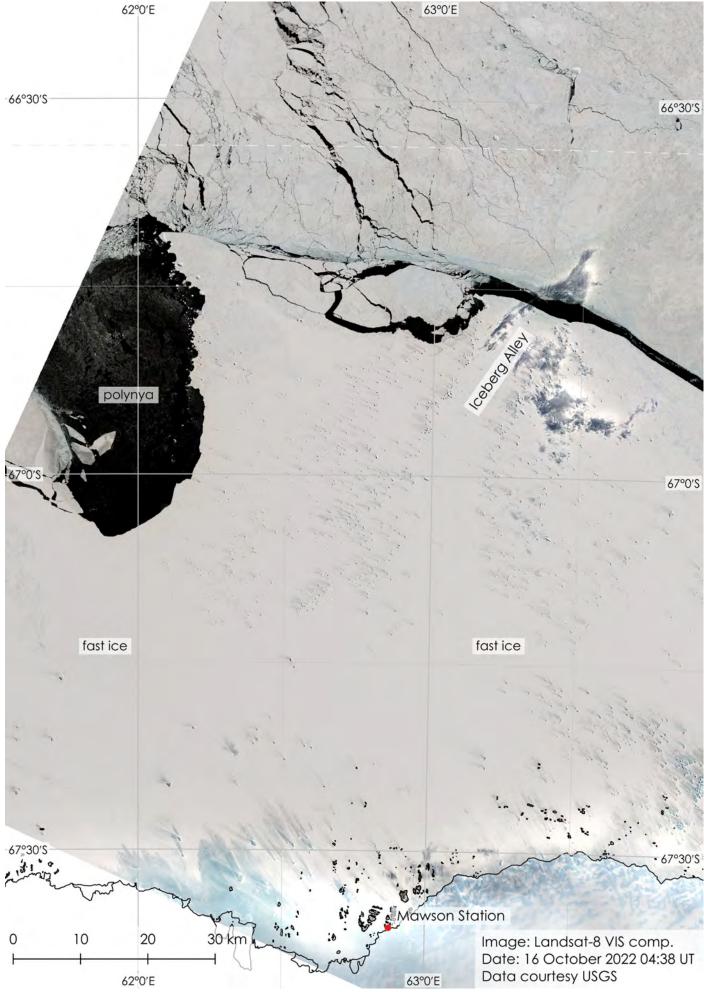
Figure 2: Landsat-8 VIS composite pan-sharpened data acquired 16 October 2022 at 04:38 UT and provided by USGS.

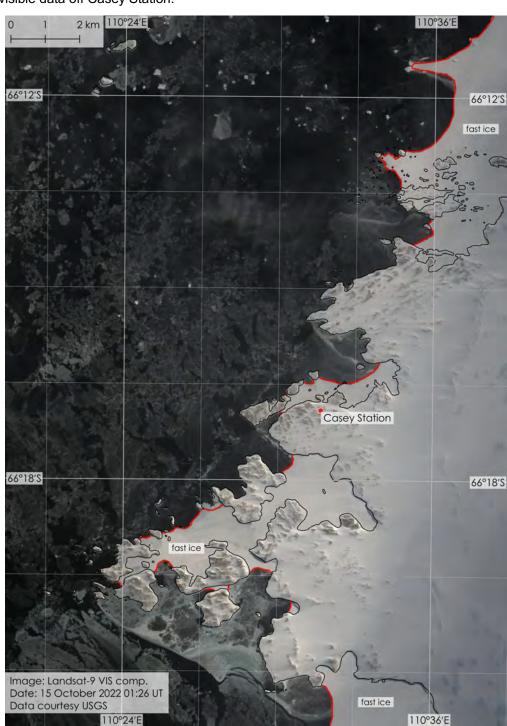
Off the fast-ice edge, a very large polynya is active and new brash ice is forming there.

Figure 1: Landsat-9 visible composite pansharpened data acquired 15 October 2022 at 01:26 UT and provided by USGS.

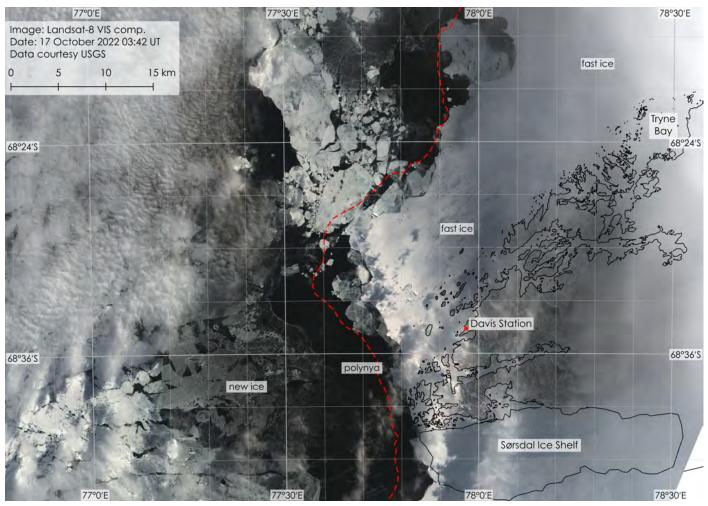
Figure 1 shows high-resolution (15 m horizontal) visible data off Davis Station. The scene is slightly obscured by clouds. The fast-ice edge on 2 October 2022 is indicated by the dashed red line.

Figure 1: Landsat-8 VIS composite pan-sharpened data acquired 17 October 2022 at 03:42 UT and provided by USGS.

West of the station, the fast-ice edge has been progressing eastward during October and is roughly 5 nautical miles away from the shore. A small polynya has opened off the fast-ice edge and some new ice is forming there.
