Ice Bulletins for the Antarctic Shipping Season 2022 – 2023

Prepared by Dr Jan L Lieser

Antarctic Meteorology Section — Bureau of Meteorology

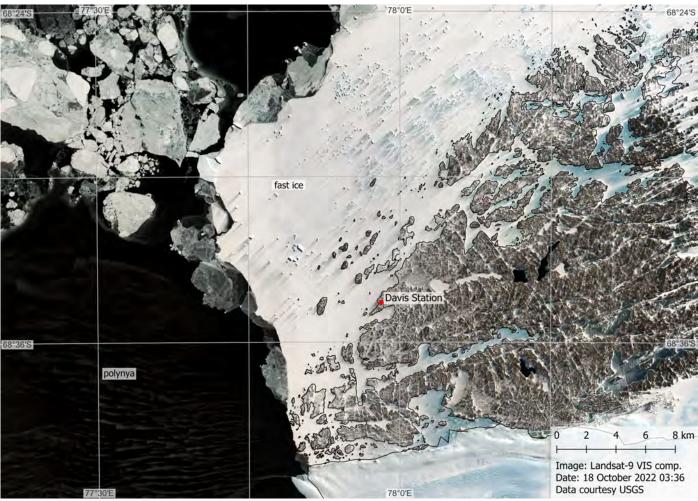
Figure 1 shows high-resolution (15 m horizontal) visible data off Davis Station.

Figure 1: Landsat-9 visible composite pansharpened data acquired 18 October 2022 at 03:06 UT and provided by USGS.

West of the station, the fast-ice edge remains 5 nautical miles away from the shore. The polynya has grown, and new ice is forming in there.

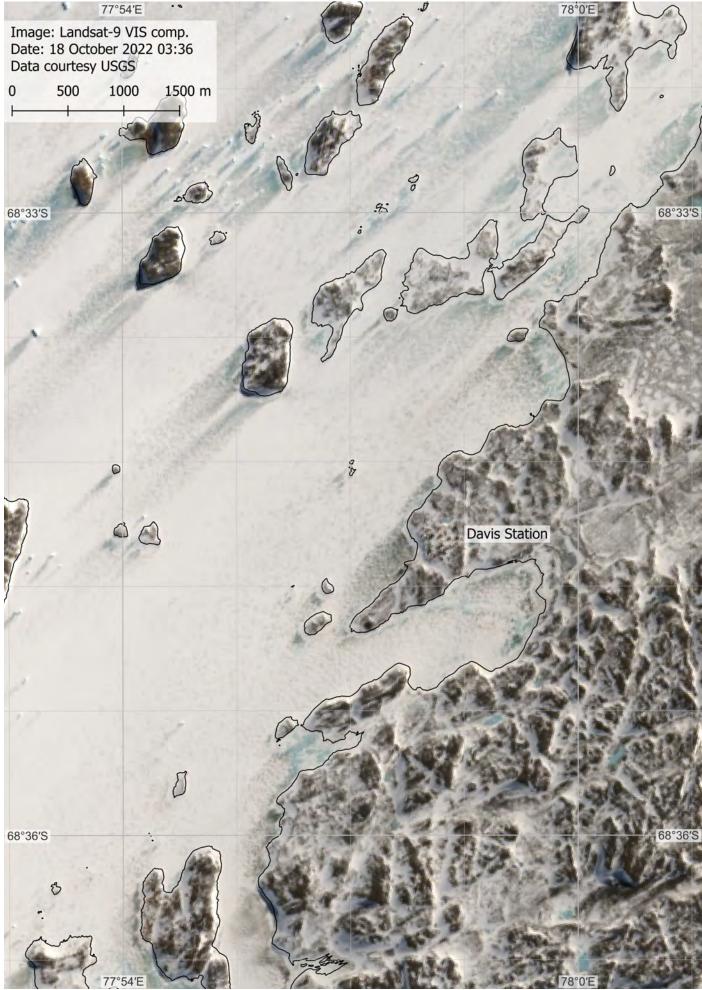
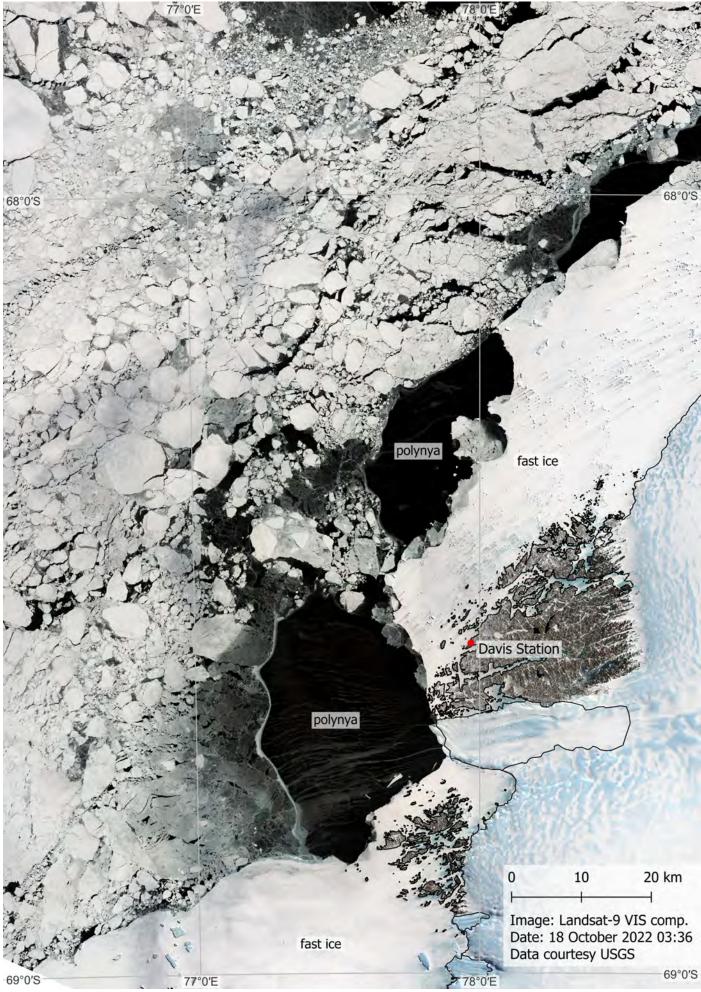
Figure 2 and Figure 3 show different scales of the same data as Figure 1.

Figure 2: Landsat-9 visible composite pansharpened data acquired 18 October 2022 at 03:06 UT and provided by USGS.

Figure 3: Landsat-9 visible composite pansharpened data acquired 18 October 2022 at 03:06 UT and provided by USGS.

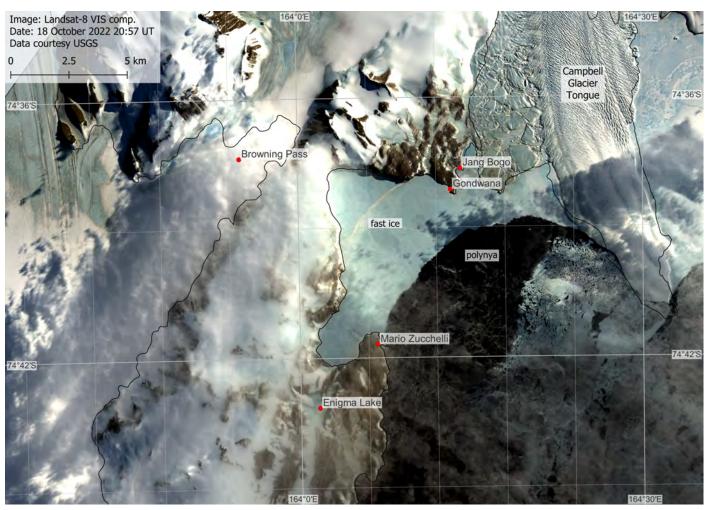
Figure 1 shows high-resolution (15 m horizontal) visible data of Terra Nova Bay. The scene is slightly obscured by thin clouds.

Figure 1: Landsat-8 visible composite pansharpened data acquired 18 October 2022 at 20:57 UT and provided by USGS.

North of Mario Zucchelli Station, some fast ice is anchored in Gerlache Inlet. A small polynya is offshore, and new ice is forming in there.

North of the Drygalski Glacier Tongue, a larger polynya is active and new ice is forming there.

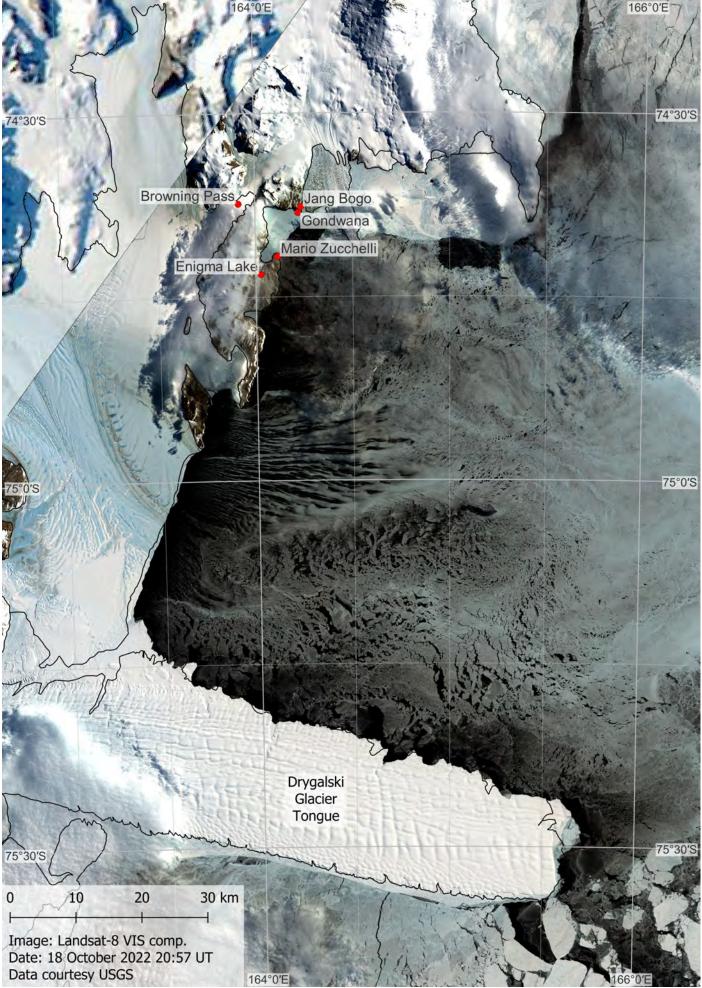
Figure 2: Landsat-8 visible composite pansharpened data acquired 18 October 2022 at 20:57 UT and provided by USGS.

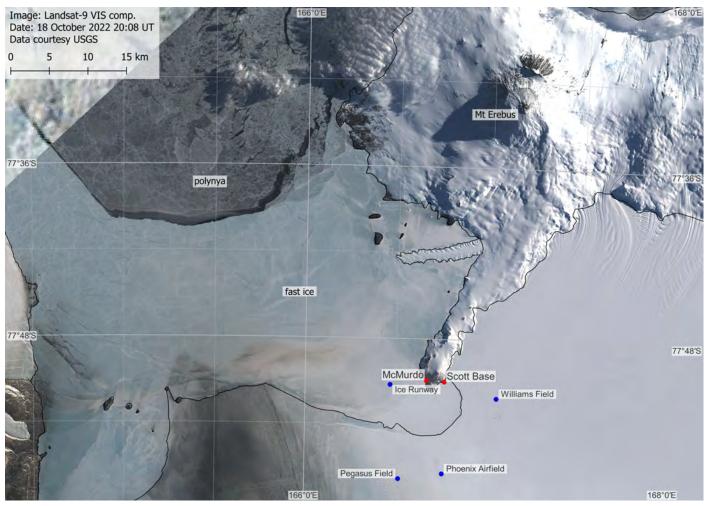
Figure 1 shows high-resolution (15 m horizontal) visible data of McMurdo Sound. Airfields near McMurdo Station are marked by blue dots.

Figure 1: Landsat-9 visible composite pansharpened data acquired 18 October 2022 at 20:08 UT and provided by USGS.

North of the fast ice anchored in southern part of McMurdo Sound, a polynya is offshore and currently frozen over.

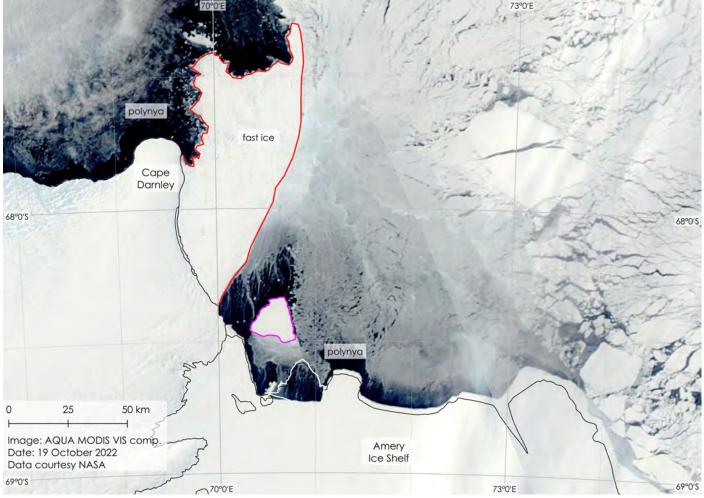
Figure 1: AQUA MODIS VIS composite data acquired 19 October 2022 and provided by NASA.

Figure 1 shows visible data off the Amery Ice Shelf in East Antarctica.

A new iceberg (the pink shape, expected D-32) calved off the Amery Ice Shelf on 15 October 2022; its initial position is indicated by the white line at the western side of the ice-shelf front. The iceberg is roughly 225 km² and has drifted roughly 30 km north-westward since breaking away while rotating 90 degrees anti-clockwise.

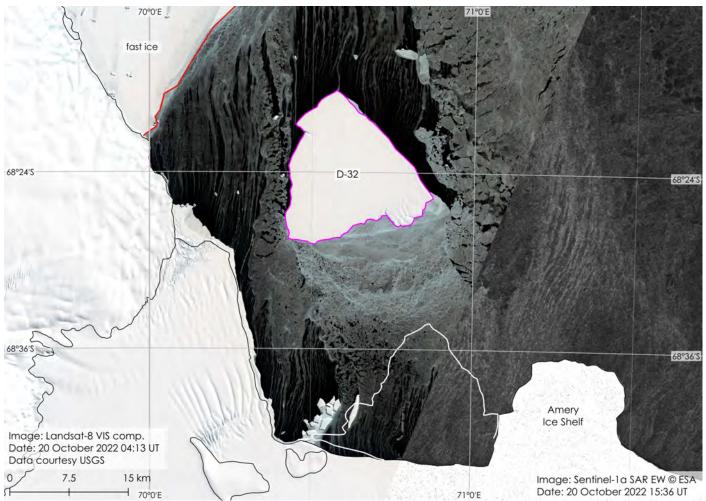
Figure 1: Composite of visible and SAR data acquired 20 October 2022 and provided by USGS and PolarView, respectively.

Figure 1 shows composite visible and SAR data off the Amery Ice Shelf in East Antarctica.

Newly identified iceberg D-32 (the pink shape) continues its drift north of the Amery Ice Shelf; its initial position is indicated by the white outline in the central part of the figure (at the western side of the ice-shelf front). The iceberg is roughly half the size of Cape Barren Island (of the Furneaux Group, Tasmania).

The iceberg has almost completed a 180 degrees turn during the five days since calving.

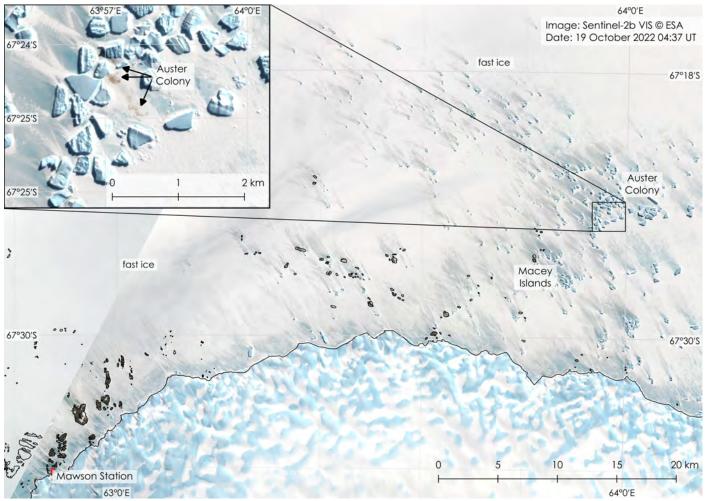
Figure 1: Sentinel-2b VIS composite data acquired 19 October 2022 at 04:37 UT and provided by ESA.

Figure 1 shows high-resolution (10 m horizontal) visible data off Mawson Station.

The Auster penguin colony is between icebergs northeast of the station and discoloured spots can be seen.

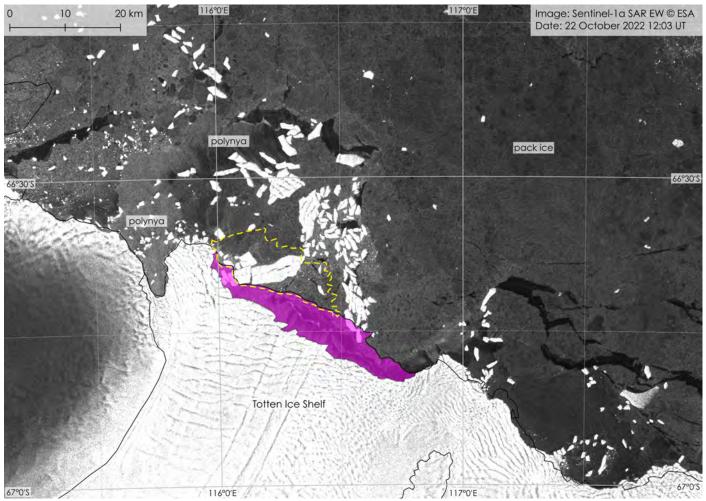
Figure 1: Sentinel-1a SAR EW data acquired 22 October 2022 at 12:03 UT and provided by PolarView.

Figure 1 shows SAR data off the Totten Ice Shelf east of Casey Station.

On 14 October 2022, a 180 km² section of the front of the Totten Ice Shelf (indicated by the pink shape) calved and created predominantly many small icebergs. The largest fragment is roughly 31.5 km² and off the western flank of the shelf front. Overall, an area roughly one third larger than sub-Antarctic Macquarie Island has broken off the shelf.

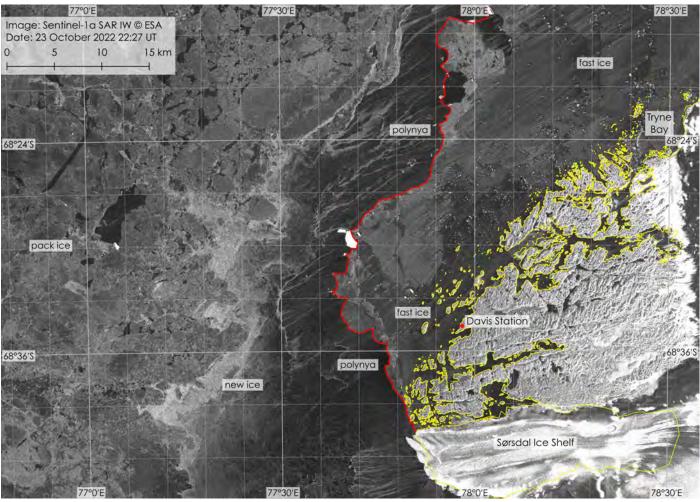
Figure 1: Sentinel-1a SAR IW data acquired 23 October 2022 at 22:27 UT and provided by PolarView.

Figure 1 shows high-resolution SAR data off Davis Station.

West of the station, the fast-ice edge has temporarily progressed westward and is now roughly 7 nautical miles away from the shore. New ice is forming in the polynya offshore.

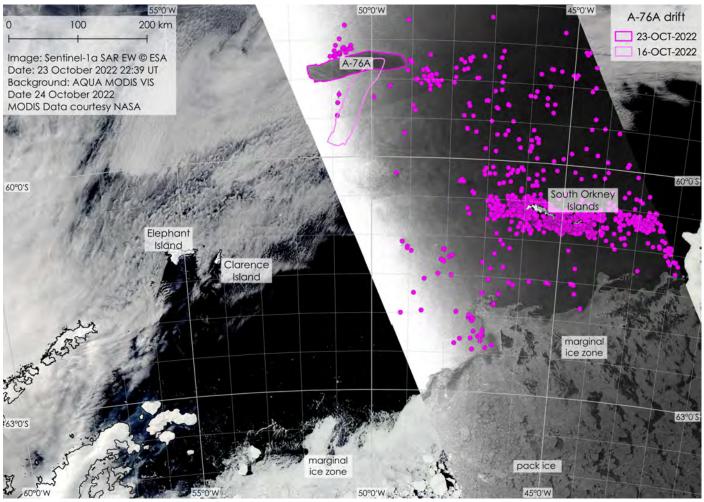
Figure 1: Sentinel-1a SAR EW data acquired 23 October 2022 at 22:39 UT and provided by PolarView; Background: AQUA MODIS VIS data acquired 24 October 2022 and provided by NASA.

Figure 1 shows composite visible and SAR data northeast of the Antarctic Peninsula in the north-western Weddell Sea.

Iceberg A-76A has crossed the Hespérides Trough into the Scotia Sea and drifting in the southern South Atlantic Ocean. Since mid-October, the iceberg has turned 50 degrees clockwise and is now roughly 280 nautical miles north of the sea-ice edge.

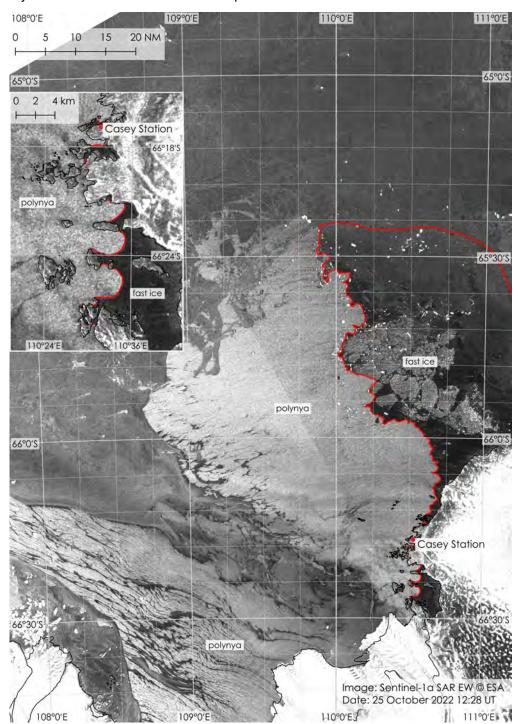
Figure 1: Sentinel-1a SAR EW data acquired 25 October 2022 at 12:28 UT and provided by PolarView.

North of the station, the northern sea-ice edge (not shown in the figure) is up to 180 nautical miles below (south of) median sea-ice extent for October.

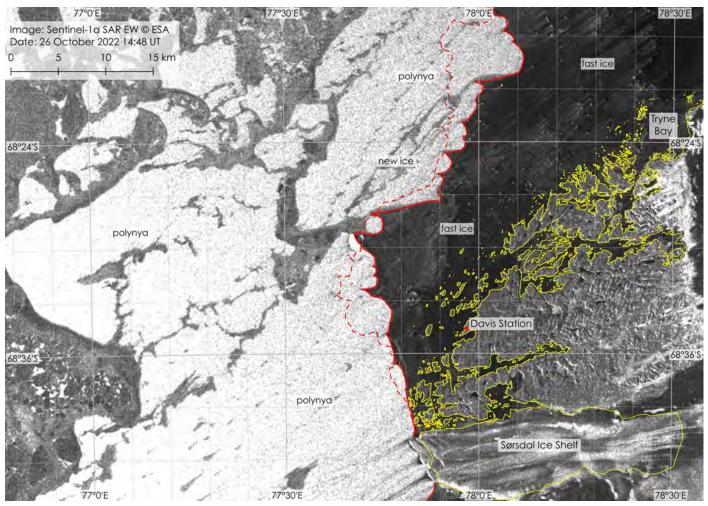
Figure 1: Sentinel-1a SAR EW data acquired 26 October 2022 at 14:48 UT and provided by PolarView.

Figure 1 shows SAR data off Davis Station. The fast-ice edge is marked by a red line (dashed red for 23 October 2022).

West of the station, the fast-ice edge has progressed eastward and is now roughly 4.5 nautical miles away from the shore. New ice is forming in the polynya offshore.

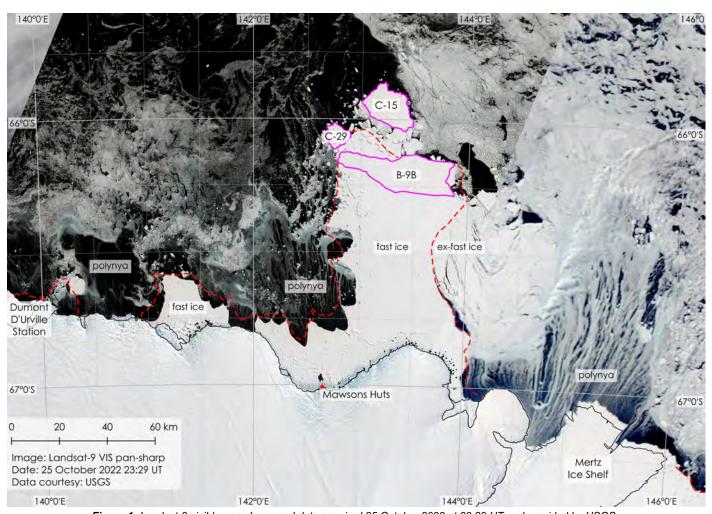
Figure 1: Landsat-9 visible pan-sharpened data acquired 25 October 2022 at 23:29 UT and provided by USGS; Background of AQUA MODIS VIS data acquired 26 October 2022 and provided by NASA.

Figure 1 shows visible data composite of southern D'Urville Sea. The fast-ice edge on 20 October 2022 is marked by a dashed red line.

Off Dumont D'Urville Station, fast ice has completely disintegrated during the last week. Further east, the fast-ice edge is also retreating. Three large named icebergs remain grounded and partly enclosed by fast ice.

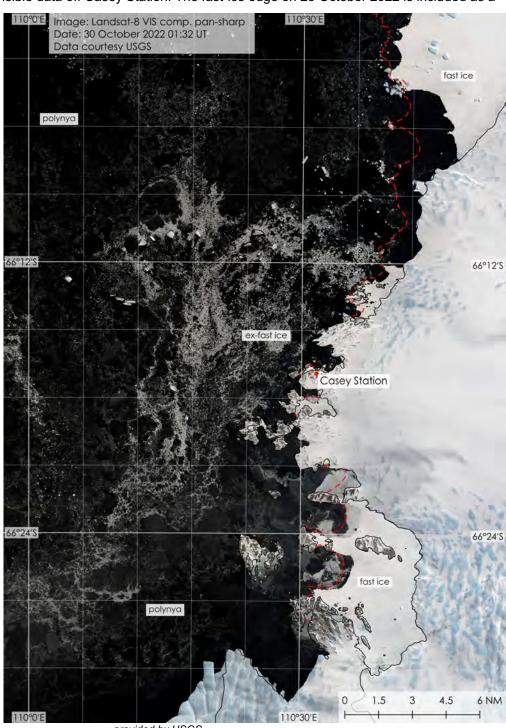
Figure 1: Landsat-8 visible composite pansharpened data acquired 30 October 2022 at 01:32 UT and

A very large polynya is active and a mixture of new brash ice and ex-fast ice is present.

North of the station, the northern sea-ice edge (not shown in the figure) is up to 190 nautical miles below (south of) median sea-ice extent for October and already roughly 115 nautical miles below (south of) the median sea-ice extent for November.

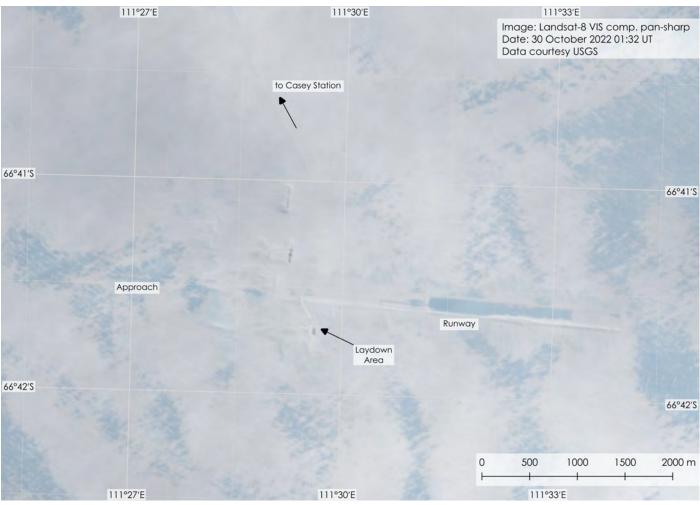
Figure 1: Landsat-8 visible composite pan-sharpened data acquired 30 October 2022 at 01:32 UT and provided by USGS.

Figure 1 shows high-resolution (15 m horizontal) visible data of Wilkins Aerodrome.

The ice runway appears partly covered by fresh snow. North and south of the runway, snow dunes are left from previous clearing the runway.

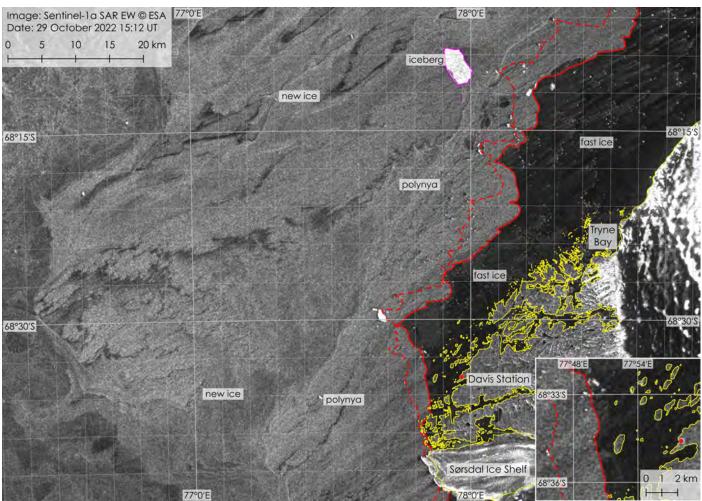
Figure 1: Sentinel-1a SAR EW data acquired 29 October 2022 at 15:12 UT and provided by PolarView.

Figure 1 shows SAR data off Davis Station. The fast-ice edge is marked by a red line (dashed red line for 26 October 2022).

West of the station, the fast-ice edge continues progressing eastward and is now roughly 2.5 nautical miles away from the shore. The inset shows a close-up of the region off station. New ice is forming in the polynya offshore.

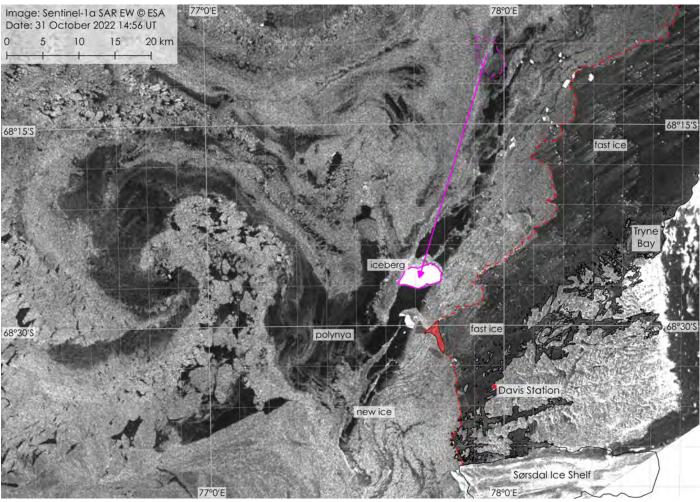
Figure 1: Sentinel-1a SAR EW data acquired 31 October 2022 at 14:56 UT and provided by PolarView.

Figure 1 shows SAR data off Davis Station. The fast-ice edge on 29 October 2022 is marked by a dashed red line.

West of the station, the fast-ice edge continues progressing eastward and is roughly 2.5 nautical miles away from the shore. The red shaded area at the fast-ice edge marks an area of roughly 3.8 km², which broke off since 29 October 2022. New ice is forming in the polynya offshore.

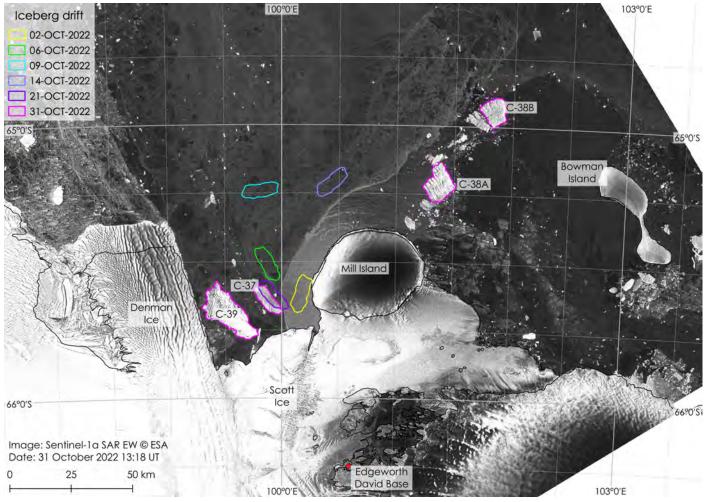
Figure 1: Sentinel-1a SAR EW data acquired 31 October 2022 at 13:18 UT and provided by PolarView.

Figure 1 shows SAR data off Mill Island west of Casey Station. The drift of large iceberg C-37 is marked by colour-coded shapes, the other named icebergs are grounded and did not move during October 2022.

Iceberg C-37 has been drifting northwest of Mill Island and is currently close to iceberg C-39. Only a small polynya is present north and west of the island and a bit further northeast.

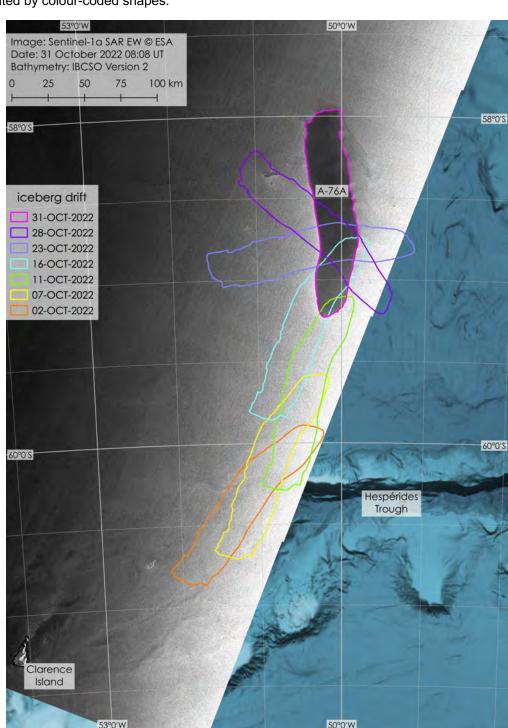
Figure 1: Sentinel-1a SAR EW data acquired 31 October 2022 at 08:08 UT and provided by PolarView;

Since 16 October, the iceberg turned almost 180 degrees clockwise and remains roughly 250 nautical miles north of the sea-ice edge (not shown in the figure).

The iceberg is increasingly showing signs of breaking up and smaller icebergs and glacial debris are surrounding the iceberg.

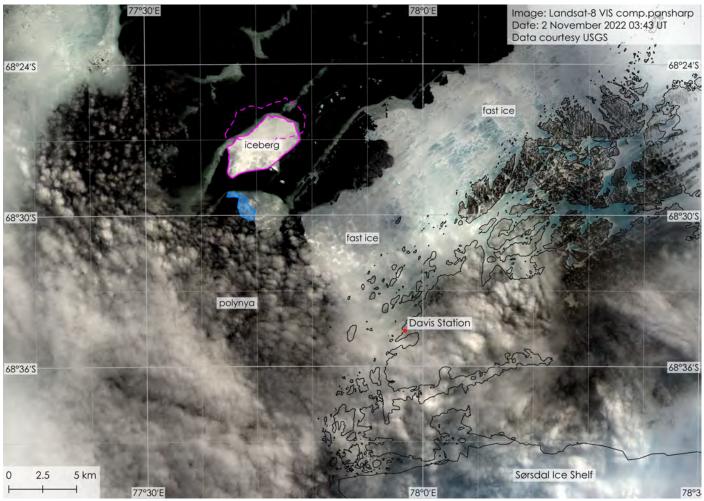
Figure 1: Landsat-8 visible composite pansharpened data acquired 2 November 2022 at 03:43 UT and provided by USGS.

Figure 1 shows high-resolution visible data off Davis Station. The scene is partly obscured by clouds.

West of the station, the fast-ice edge is obscured but remains roughly 2.5 nautical miles away from the shore. New ice is forming in the polynya offshore.

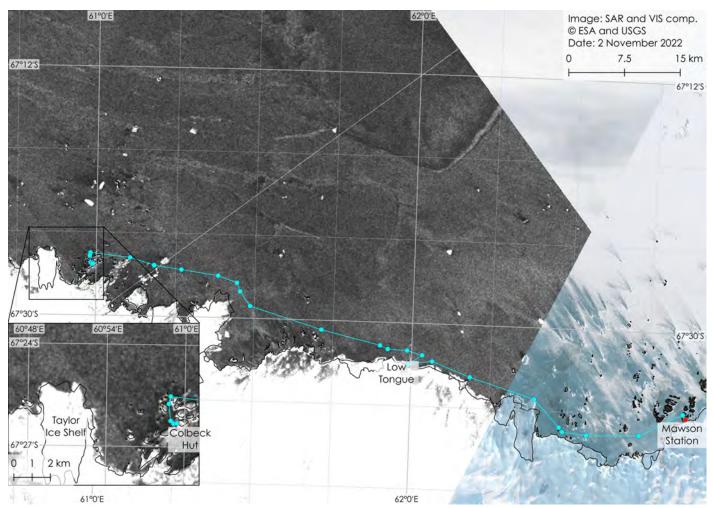
Figure 1: Western part: Sentinel-1a SAR EW data acquired 2 November 2022 at 16:17 UT and provided by PolarView; Eastern part: Landsat-9 visible composite pansharpened data acquired 2 November 2022 at 04:32 UT and provided by USGS.

Figure 1 shows a composite of SAR and high-resolution visible data off Mawson Station. The typical route between the station and Colbeck Hut is marked with a cyan line. The inset shows a close-up view of the area between the Colbeck Archipelago and the Taylor Ice Shelf.

Off station, the fast ice extends east and west along the coast. Isolated icebergs are trapped within the fast ice near shore. The northern fast-ice edge (not shown in the figure) has its typical shape for the time of year.

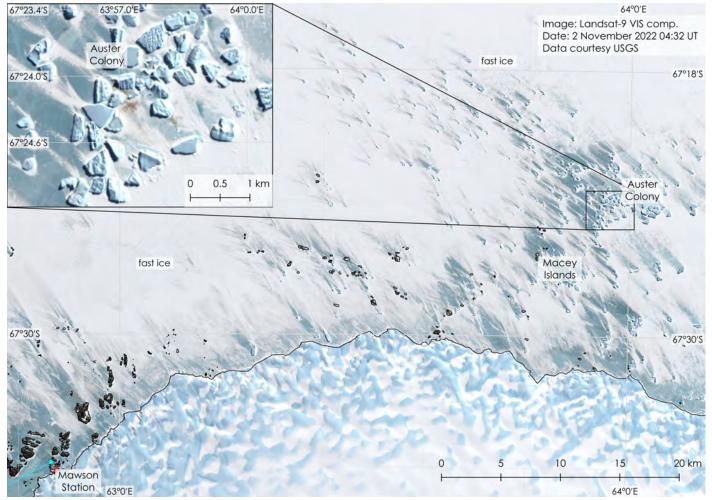
Figure 2: Landsat-9 visible composite pansharpened data acquired 2 November 2022 at 04:32 UT and provided by USGS.

Figure 2 shows high-resolution visible data northeast of the station. The inset shows the location of the Auster penguin colony between grounded icebergs.

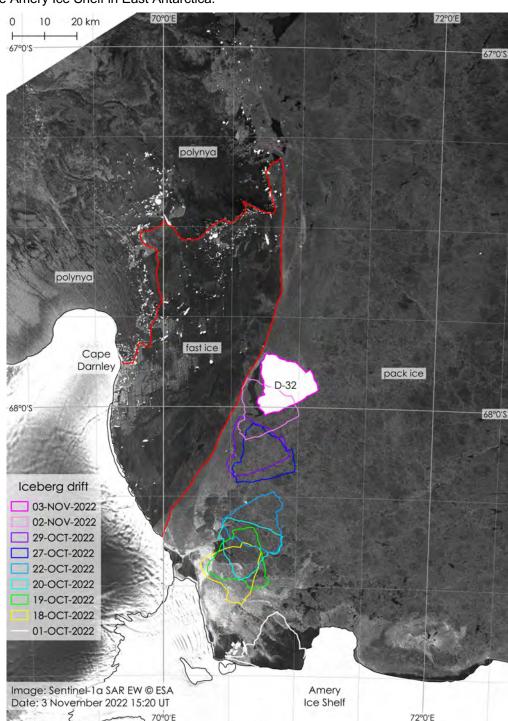
Figure 1: Sentinel-1a SAR EW data acquired 3 November 2022 at 15:20 UT and provided by PolarView.

The recently identified iceberg D-32 (the pink shape) continues drifting north of the Amery Ice Shelf. Its initial position is indicated by the white outline in the central part of the figure (at the western side of the ice-shelf front) and its drift is inicated by colour-coded shapes.

Since breaking away in mid-October, the iceberg has drifted roughly 45 nautical miles northward and has completed an anti-clockwise rotation and a bit more.

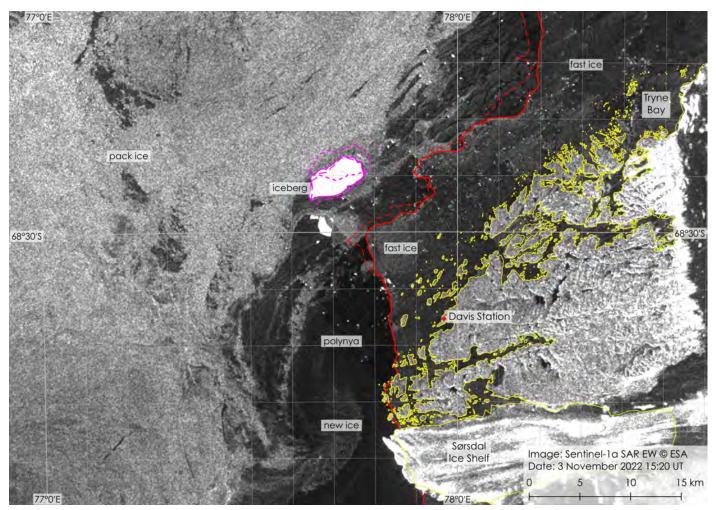
Figure 1: Sentinel-1a SAR EW data acquired 3 November 2022 at 15:20 UT and provided by PolarView.

Figure 1 shows SAR data off Davis Station. The fast-ice edge is marked by a red line (dashed red line for 29 October 2022).

West of the station, the fast-ice edge remains roughly 2.5 nautical miles away from the shore. New ice is forming in the polynya offshore. Further north off the Vestfold Hills, the fast-ice edge is retreating towards the shore.

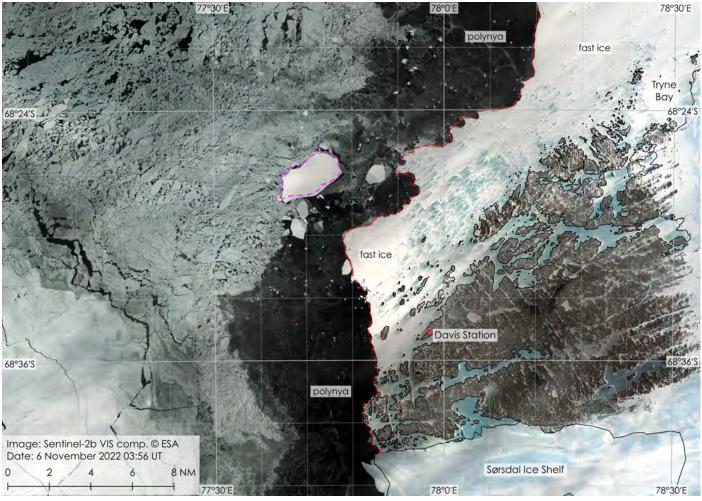
Figure 1: Sentinel-2b visible composite data acquired 6 November 2022 at 03:56 UT and provided by ESA.

Figure 1 shows high-resolution (10 m horizontal) visible data off Davis Station. The fast-ice edge on 3 November 2022 is marked by a dashed red line. The scene is slightly obscured by thin clouds.

West of the station, the fast-ice edge remains roughly 2.5 nautical miles away from the shore. New ice is forming in the small polynya offshore.

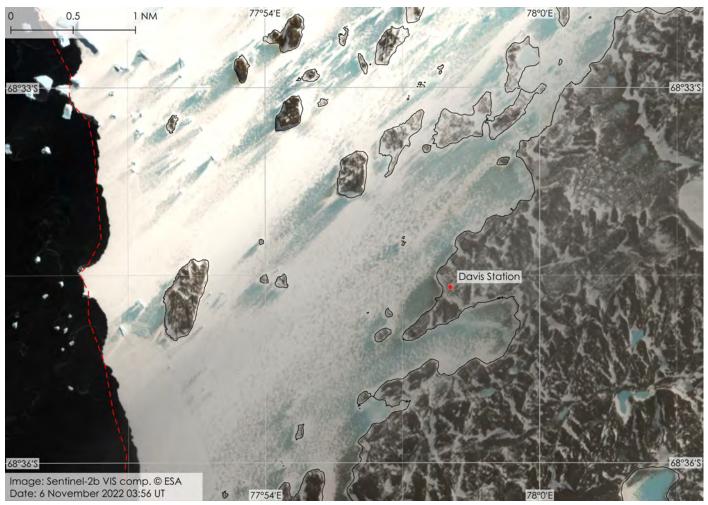
Figure 2: Sentinel-2b visible composite data acquired 6 November 2022 at 03:56 UT and provided by ESA.

Figure 2 provides a close-up view of the fast ice off Davis Station.

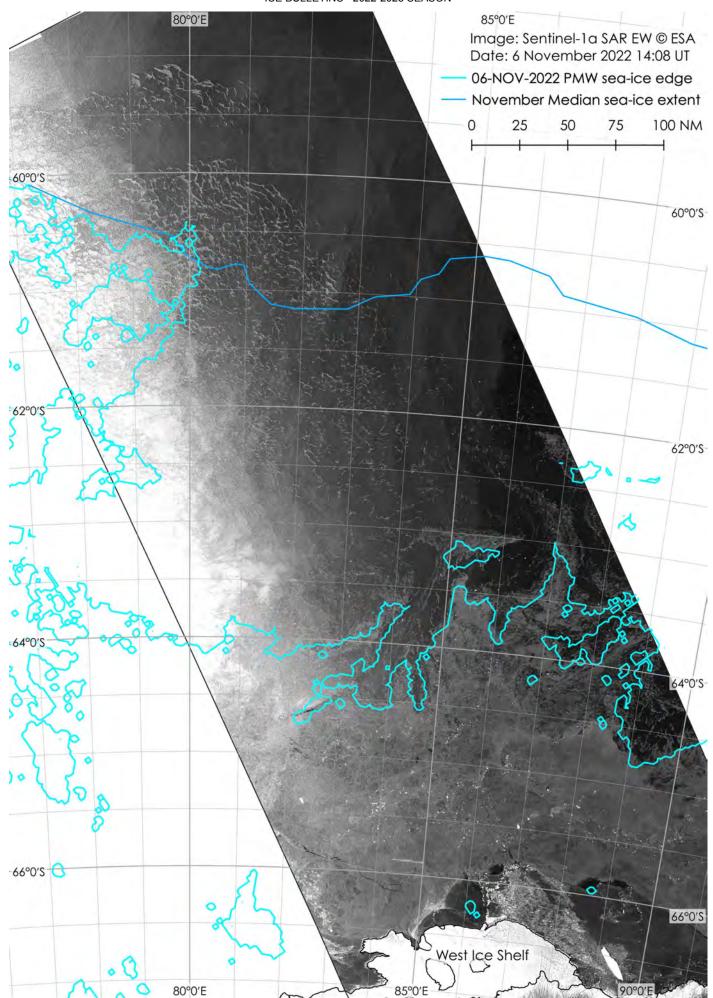
Figure 1: Sentinel-1a SAR EW data acquired 6 November 2022 at 14:08 UT and provided by PolarView.

The SAR data show clearly strips and patches of decaying sea ice and some small to the medium-sized icebergs north of the sea-ice edge as analysed from passive microwave data. This spread-out sea ice is below the detection limit of the passive microwave instrument and processing algorithm.

Notwithstanding what is stated above, East Antarctic sea-ice conditions in general are much below average for the time of year and higher concentration of sea ice is only found south of roughly 63°30'S in the region shown in Figure 1.

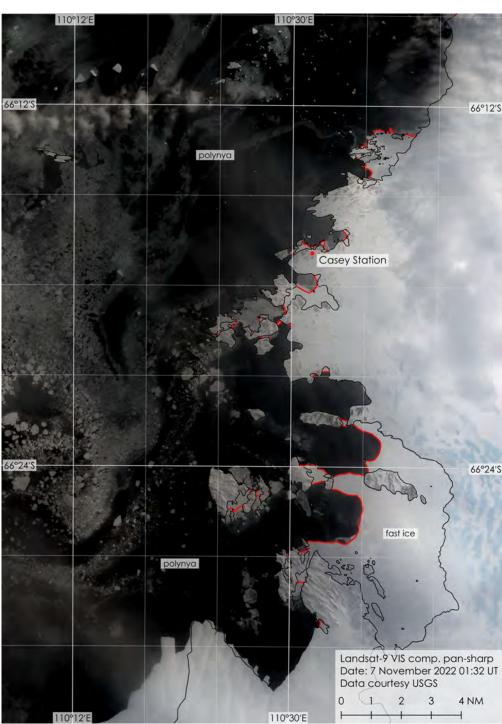
Figure 1: Landsat-9 visible composite pansharpened data acquired 7 November 2022 at 01:32 UT and provided by USGS.

A large polynya is active, and a mixture of new brash ice and ex-fast ice is present.

North of the station, the northern sea-ice edge (not shown in the figure) is roughly 135 nautical miles below (south of) the median sea-ice extent for November.

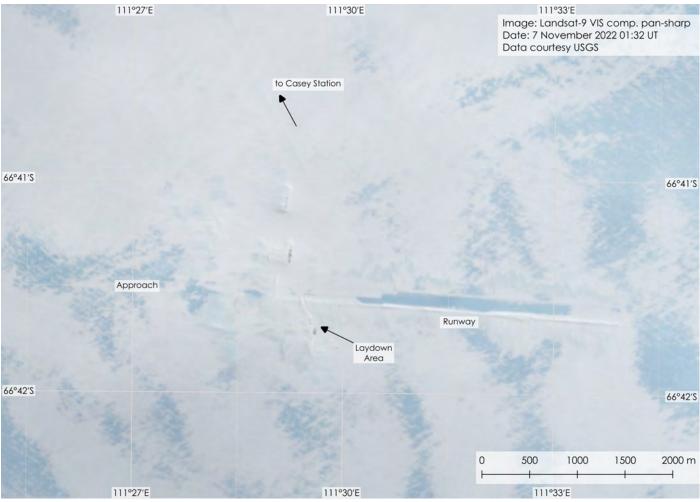
Figure 1: Landsat-9 visible composite pan-sharpened data acquired 7 November 2022 at 01:32 UT and provided by USGS.

Figure 1 shows high-resolution (15 m horizontal) visible data of Wilkins Aerodrome.

The ice runway appears partly covered by fresh snow. North and south of the runway, snow dunes are left from previous clearing the runway.

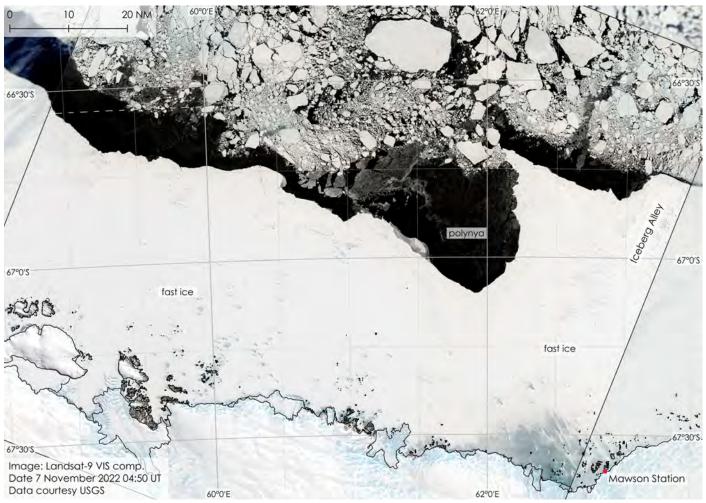
Figure 1 shows a composite of visible data off Mawson Station.

Figure 1: Landsat-9 visible composite data acquired 7 November 2022 at 04:50 UT and provided by USGS; complemented by AQUA MODIS VIS data acquired 7 November 2022 and provided by NASA.

Off station, the fast ice extends east and west along the coast. Isolated icebergs are trapped within the fast ice near shore. The northern fast-ice edge has its typical shape for the time of year and the nearest open water of the polynya northwest of the station is roughly 37.5 nautical miles away.

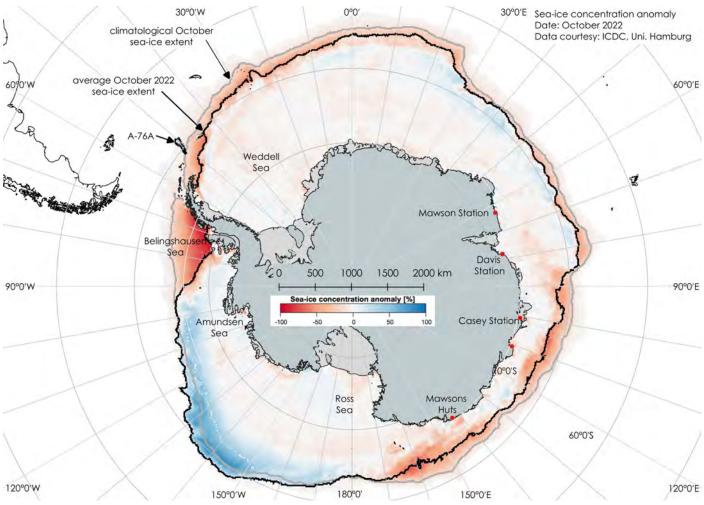
Figure 1 shows the pan-Antarctic sea-ice concentration anomaly based on passive microwave remote sensing data.

Figure 1: Sea-ice concentration anomaly for October 2022 provided by ICDC (Universität Hamburg).

Pan-Antarctic sea-ice conditions continue to be overall low but not record-breaking (4th lowest) during October.

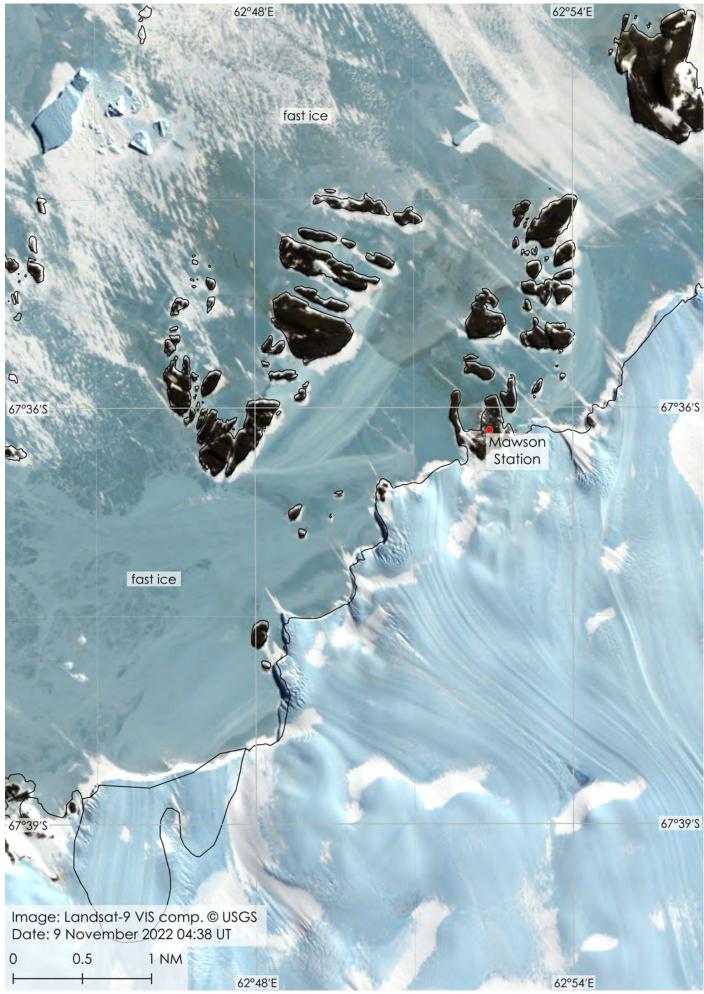
Figure 2 shows a close-up view around Mawson Station.

Figure 2: Landsat-9 visible composite pansharpened data acquired 9 November 2022 at 04:38 UT and provided by USGS.

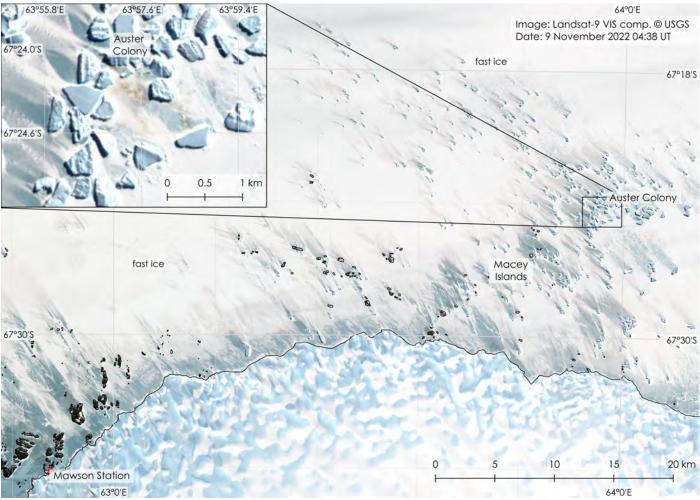
Figures 3 and 4 show the region east of the station towards the Auster penguin colony. Figure 4 shows high-resolution (10 m horizontal) visible data acquired a day earlier than the data of the other figures in this Bulletin.

Figure 3: Landsat-9 visible composite pansharpened data acquired 9 November 2022 at 04:38 UT and provided by USGS.

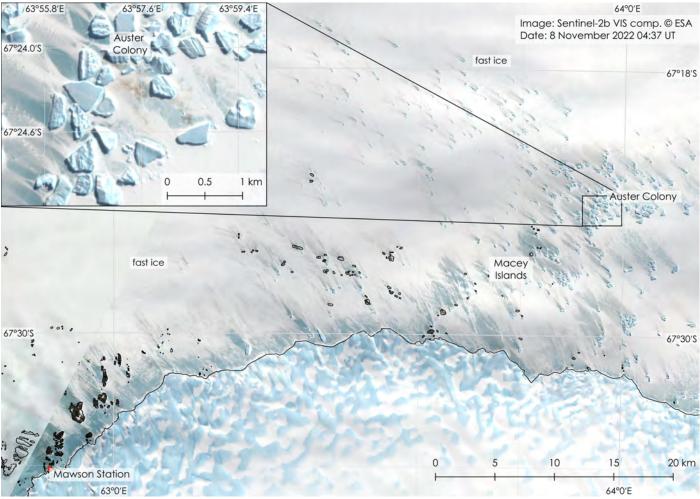
Figure 4: Sentinel-2b visible composite data acquired 8 November 2022 at 04:37 UT and provided by ESA.

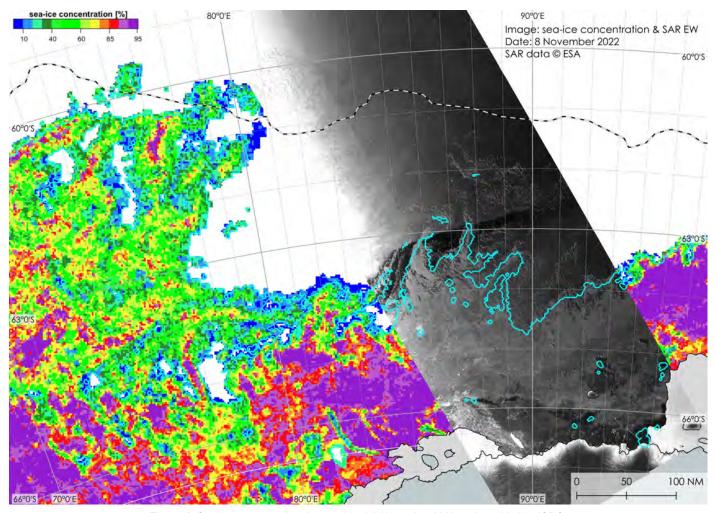
Figure 1 shows a composite of sea-ice concentration and SAR data north of the West Ice Shelf east of Davis Station. The sea-ice edge based on passive microwave (sea-ice concentration) data is marked by a cyan line. The November median sea-ice extent is provided by the dashed black/white line.

Figure 1: Sea-ice concentration data acquired 8 November 2022 and provided by ICDC; Sentinel-1a SAR EW data acquired 8 November 2022 at 13:53 UT and provided by PolarView.

The SAR data show strips and patches of decaying sea ice and some small to the medium-sized icebergs north of the sea-ice edge as analysed from passive microwave data. This spread-out sea ice is below the detection limit of the passive microwave instrument and processing algorithm.

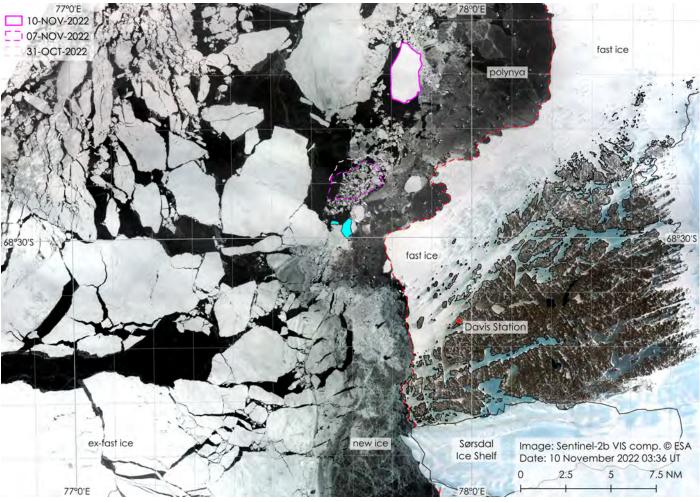
Figure 1 shows high-resolution (10 m horizontal) visible data off Davis Station. The fast-ice edge on 3 November 2022 is marked by a dashed red line. The scene is slightly obscured by thin clouds.

Figure 1: Sentinel-2b visible composite data acquired 10 November 2022 at 03:36 UT and provided by ESA.

West of the station, the fast-ice edge remains roughly 2.5 nautical miles away from the shore. New ice is present off the fast-ice edge.

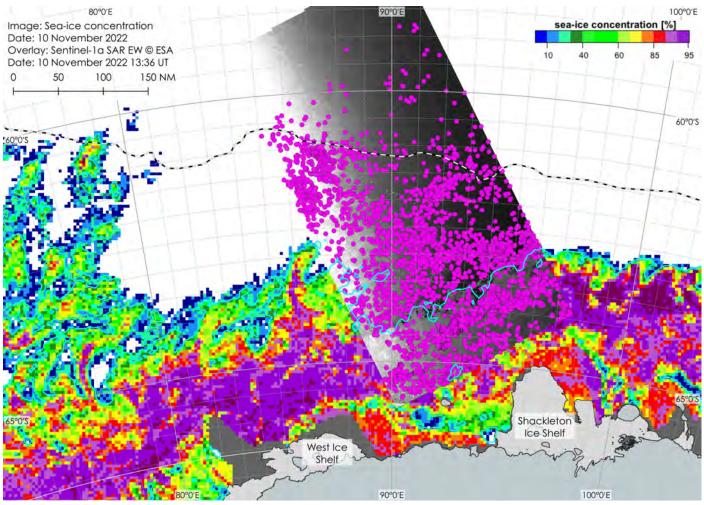
Figure 1 shows a composite of sea-ice concentration and SAR data north of the West Ice Shelf east of Davis Station. The sea-ice edge based on passive microwave (sea-ice concentration) data is marked by a cyan line. The November median sea-ice extent is provided by the dashed black/white line.

Figure 1: Sea-ice concentration data acquired 10 November 2022 and provided by Polarview; Sentinel-1a SAR EW data acquired 10 November 2022 at 13:36 UT and provided by PolarView.

The SAR data have been analysed for iceberg presence and more than 4000 features have been marked with pink dots. The SAR data also show strips and patches of decaying sea ice, which is below the detection limit of the passive microwave instrument and processing algorithm. Strips and patches of sea ice reach as far north as 62°0'S at 89°0'E.

Icebergs and strips and patches of sea ice are present north of the sea-ice edge that is based on passive microwave data. Icebergs are present as far north as 58°30'S.

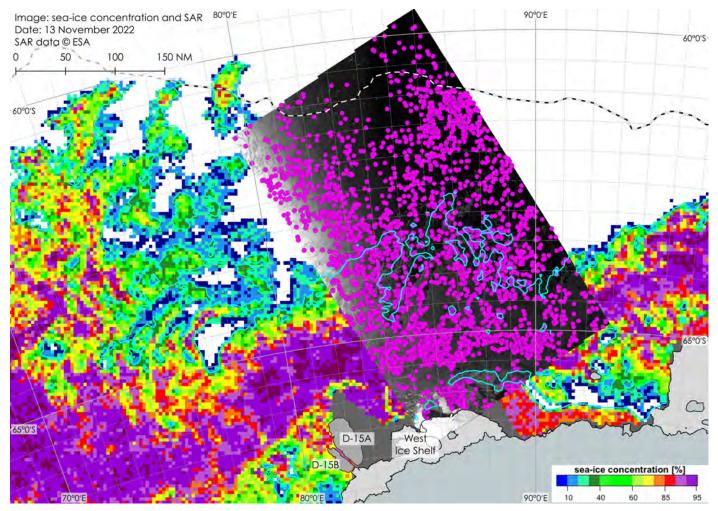
Figure 1 shows a composite of sea-ice concentration and SAR data north of the West Ice Shelf east of Davis Station. The sea-ice edge based on passive microwave (sea-ice concentration) data is marked by a cyan line. The November median sea-ice extent is provided by the dashed black/white line.

Figure 1: Sea-ice concentration data acquired 13 November 2022 and provided by Polarview; Sentinel-1a SAR EW data acquired 13 November 2022 at 14:00 UT and provided by PolarView.

The SAR data have been analysed for iceberg presence and more than 3500 features have been marked with pink dots. The SAR data also show strips and patches of decaying sea ice, which is below the detection limit of the passive microwave instrument and processing algorithm. Strips and patches of sea ice reach as far north as 60°30'S at 84°0'E.

Icebergs and strips and patches of sea ice are present north of the sea-ice edge that is based on passive microwave data. Icebergs are present as far north as 59°45'S.

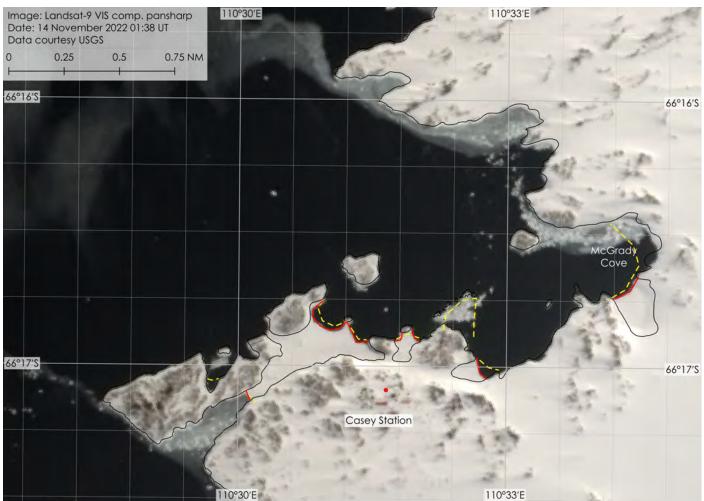
Figure 1 shows high-resolution (15 m horizontal) visible data off Casey Station. The fast-ice edge is marked by a red line (dashed yellow line for 7 November 2022).

Figure 1: Landsat-9 visible composite pansharpened data acquired 14 November 2022 at 01:38 UT and provided by USGS.

Off station, fast ice continues breaking up and ex-fast ice is floating in the polynya offshore.

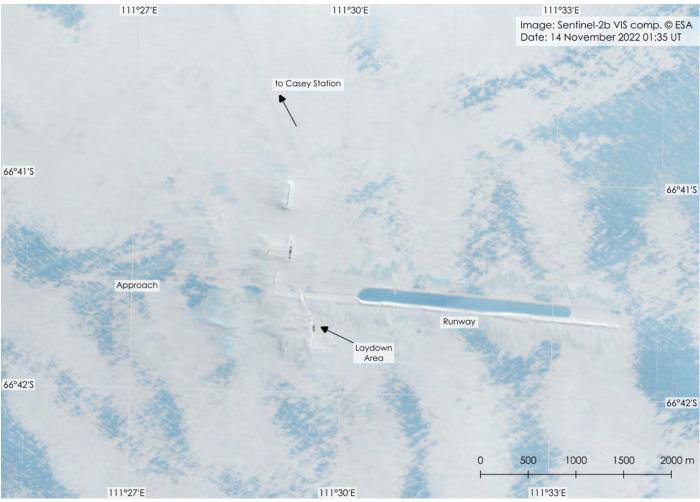
Figure 1 shows high-resolution (10 m horizontal) visible data of Wilkins Aerodrome.

Figure 1: Sentinel-2b visible composite data acquired 14 November 2022 at 01:35 UT and provided by ESA.

The ice runway is partly covered by fresh snow. North and south of the runway, snow dunes are left from previous clearing the runway.

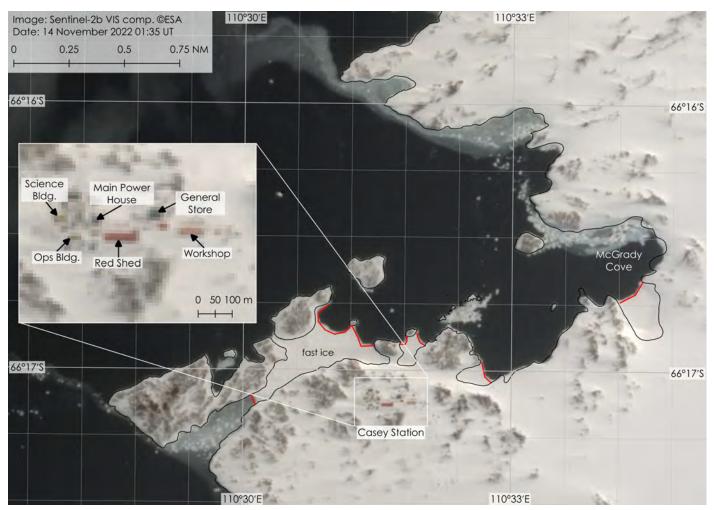
Figure 1 shows high-resolution (10 m horizontal) visible data off Casey Station. The fast-ice edge is marked by a red line.

Figure 1: Sentinel-2b visible composite data acquired 14 November 2022 at 01:35 UT and provided by ESA.

Off station, fast ice continues breaking up and ex-fast ice is floating in the polynya offshore.

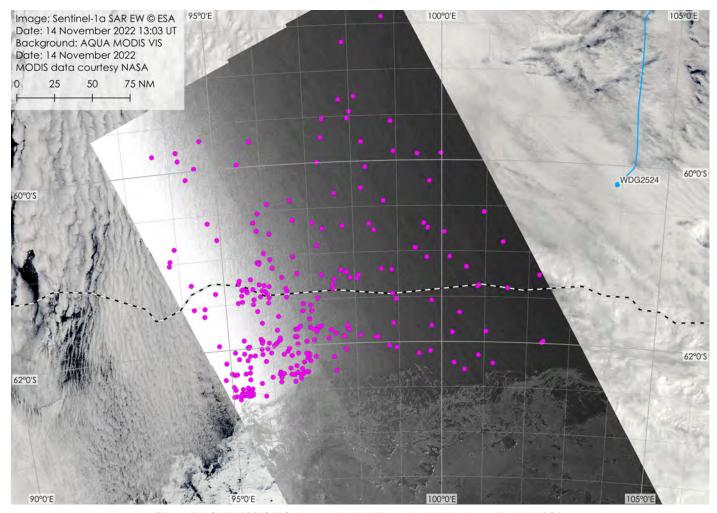
Figure 1 shows a composite of visible and SAR data north of the Shackleton Ice Shelf west of Casey Station. The November median sea-ice extent is provided by the dashed black/white line. The cruise track of MPOV *Aiviq* is included as a blue line (up until 14 November 2022 22:10 UT).

Figure 1: AQUA MODIS VIS data acquired 14 November 2022 and provided by NASA;

Overlay: Sentinel-1a SAR EW data acquired 14 November 2022 at 13:03 UT and provided by PolarView.
