Ice Bulletins for the Antarctic Shipping Season 2022 – 2023

Prepared by Dr Jan L Lieser

Antarctic Meteorology Section — Bureau of Meteorology

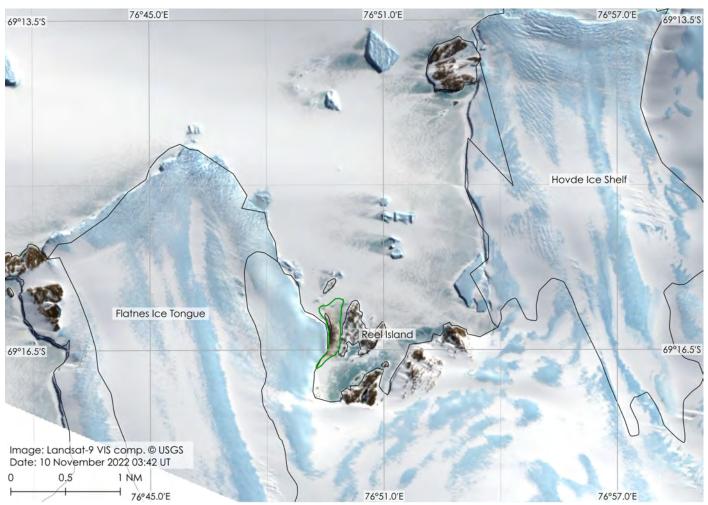
The figures of this report show the areas around proposed penguin colony surveys in the vicinity of Davis Station.

Figure 1: Landsat-9 visible composite pan-sharpened data acquired 10 November 2022 at 03:42 UT and provided by USGS.

Discoloured sea-ice surface (indicating recent penguin colony presence) has been outlined with green shapes.

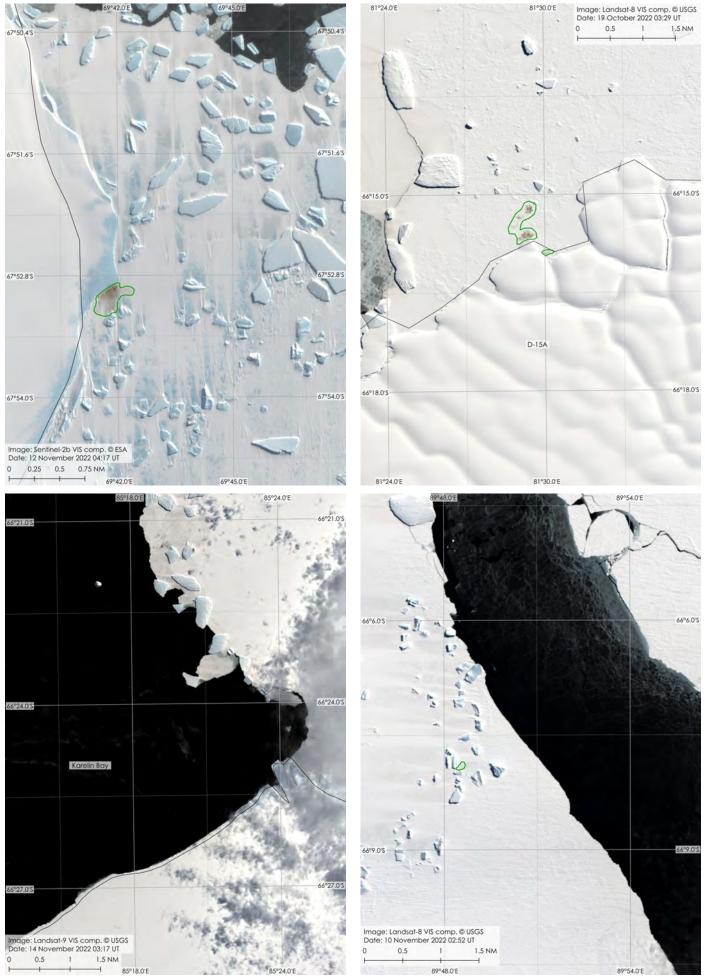
In Karelin Bay (Figure 2 lower left panel), no stain has been found and the location typically occupied by the local colony shows open water.

The latest clear-sky image of the region north of the West Ice Shelf/iceberg D-15A is only from 19 October 2022, which shows the discolouration clearly at that time.

Figure 2: Upper Left panel: Sentinel-2b visible composite data acquired 12 November 2022 at 04:17 UT and provided by ESA; Upper Right panel: Landsat-8 visible composite pan-sharpened data acquired 19 October 2022 at 03:29 UT and provided by USGS; Lower Left panel: Landsat-9 visible composite pan-sharpened data acquired 14 November 2022 at 03:17 UT and provided by USGS; Lower Right panel: Landsat-8 visible composite pan-sharpened data acquired 10 November 2022 at 02:52 UT and provided by USGS.

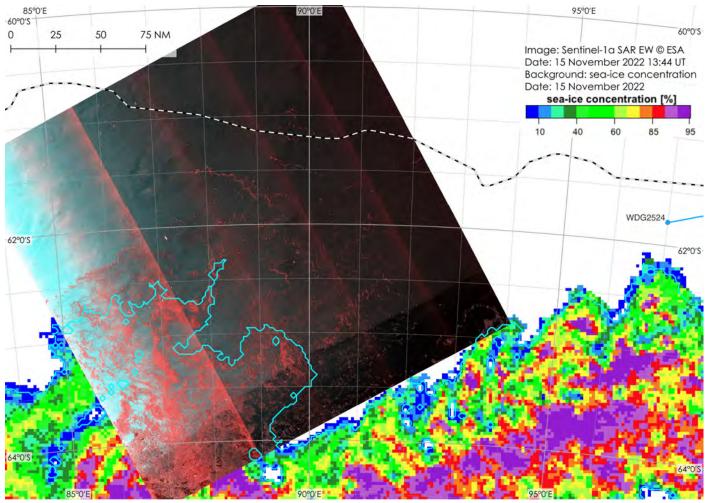
Figure 1 shows a composite of sea-ice concentration and SAR data north of the West Ice Shelf east of Davis Station. The sea-ice edge based on passive microwave (sea-ice concentration) data is marked by a cyan line. The November median sea-ice extent is provided by the dashed black/white line.

Figure 1: Sea-ice concentration data acquired 15 November 2022 and provided by PolarView; Sentinel-1a SAR EW data acquired 15 November 2022 at 13:44 UT and provided by ESA.

The SAR data has been processed into a pseudo-visible (RGB) data set through a combination of co-polarised amplitude and cross-polarised intensity data, which makes sea ice appear with a reddish tint and icebergs as almost white

The SAR data show strips and patches of decaying sea ice, which is below the detection limit of the passive microwave instrument and processing algorithm. Strips and patches of sea ice reach as far north as 61°45'S around 90°0'E.

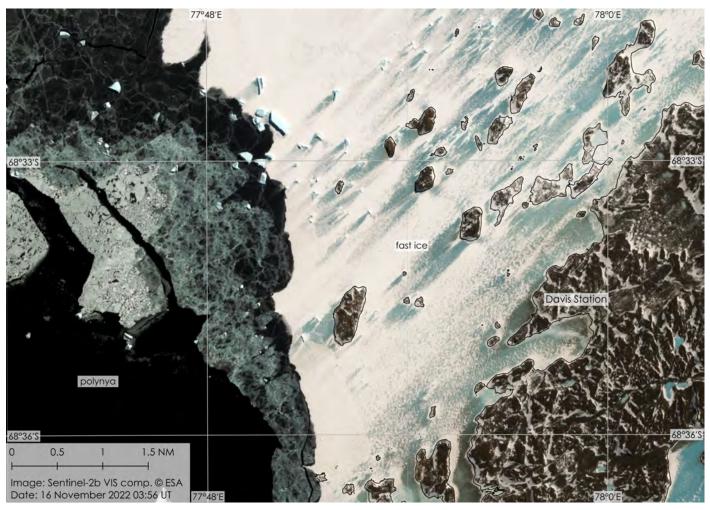
Figure 1 shows high-resolution (10 m horizontal) visible data off Davis Station.

Figure 1: Sentinel-2b visible composite data acquired 16 November 2022 at 03:56 UT and provided by ESA.

The fast-ice edge remains currently stable at roughly 3 nautical miles offshore. Some new ice has formed in the polynya off the fast ice.

North of the station, two patches of fast ice are not connected to any land features but have formed locally between grounded icebergs.

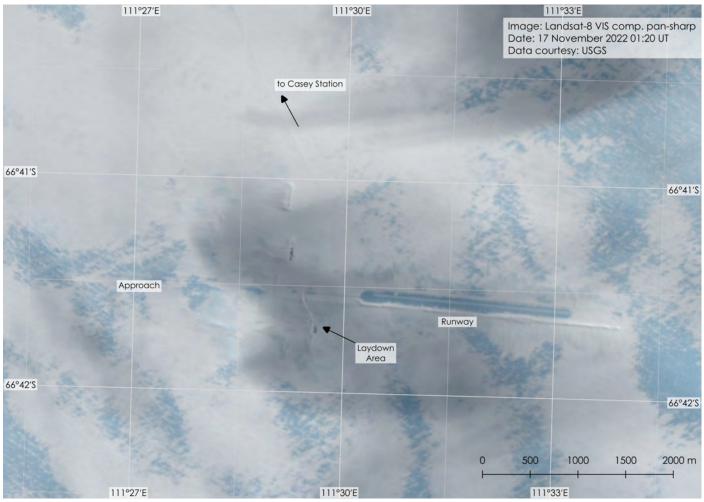
Figure 1 shows high-resolution (15 m horizontal) visible data of Wilkins Aerodrome. The scene is partly obscured by clouds.

Figure 1: Landsat-8 visible composite pansharpened data acquired 17 November 2022 at 01:20 UT and provided by USGS.

The ice runway is partly covered by fresh snow. North and south of the runway, snow dunes are left from previous clearing the runway.

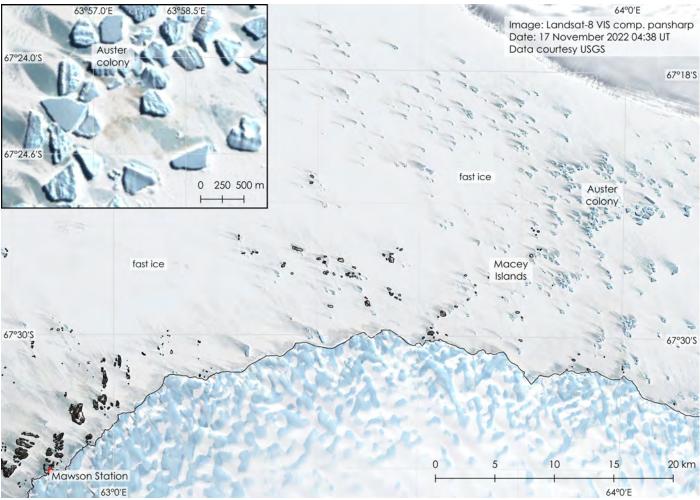
Figure 1 shows high-resolution (15 m horizontal) visible data off Mawson Station and to the east towards the Auster penguin colony.

Figure 1: Landsat-8 visible composite pansharpened data acquired 17 November 2022 at 04:38 UT and provided by USGS;

The penguin colony is moving around within the grounded icebergs at Auster.

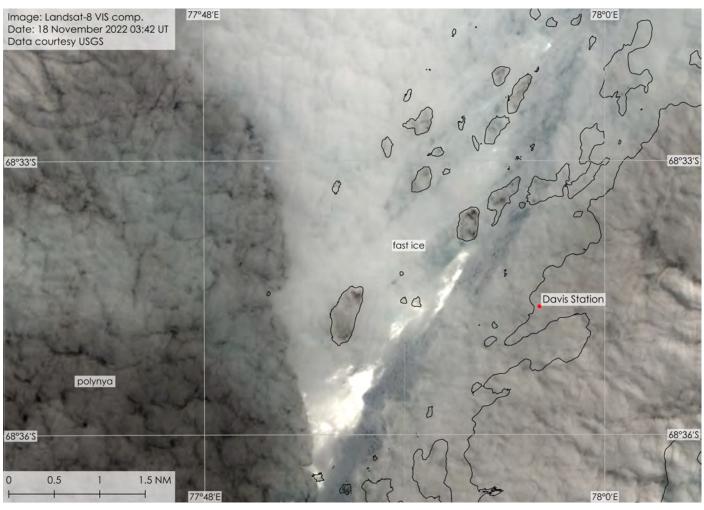
Figure 1: Landsat-8 visible composite pansharpened data acquired 18 November 2022 at 03:42 UT and provided by USGS.

Figure 1 shows high-resolution (15 m horizontal) visible data off Davis Station.

Although the scene is obscured by thin clouds it can be determined that the fast-ice edge has remained stable since 16 November 2022 and is roughly 3 nautical miles offshore.

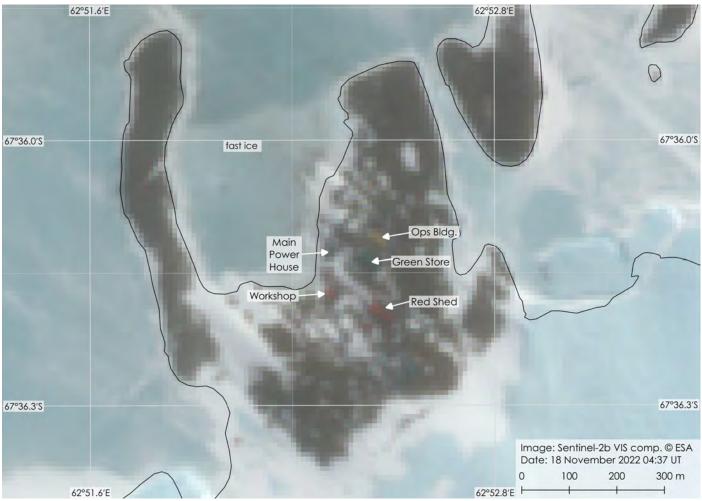
Figure 1: Sentinel-2b visible composite data acquired 18 November 2022 at 04:37 UT and provided by ESA.

Figure 1 shows high-resolution (10 m horizontal) visible data of Mawson Station.

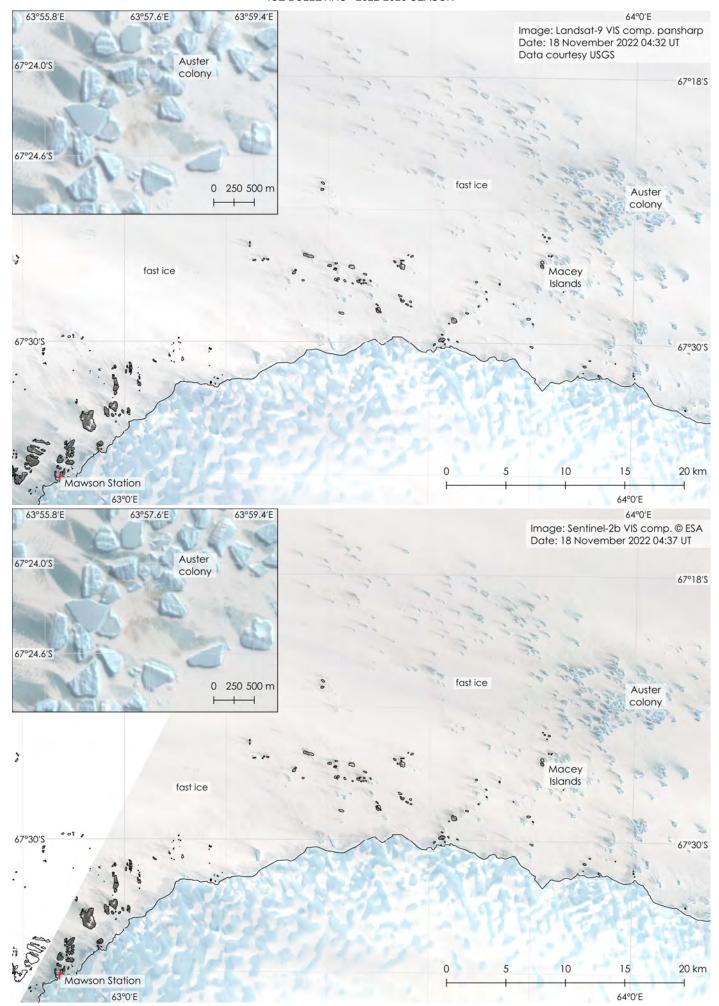
Figure 2: Upper panel: Landsat-9 visible composite pansharpened data acquired 18 November 2022 at 04:32 UT and provided by USGS; Lower panel: Sentinel-2b visible composite data acquired 18 November 2022 at 04:37 UT and provided by ESA.

Figure 2 shows a larger scale overview north and east of Mawson Station towards the Auster penguin colony. The upper panel shows high-resolution (15 m horizontal) visible data and the lower panel the same data as Figure 1. Off station, fast ice extends east and west along the coast. Isolated icebergs are trapped within the fast ice near shore.

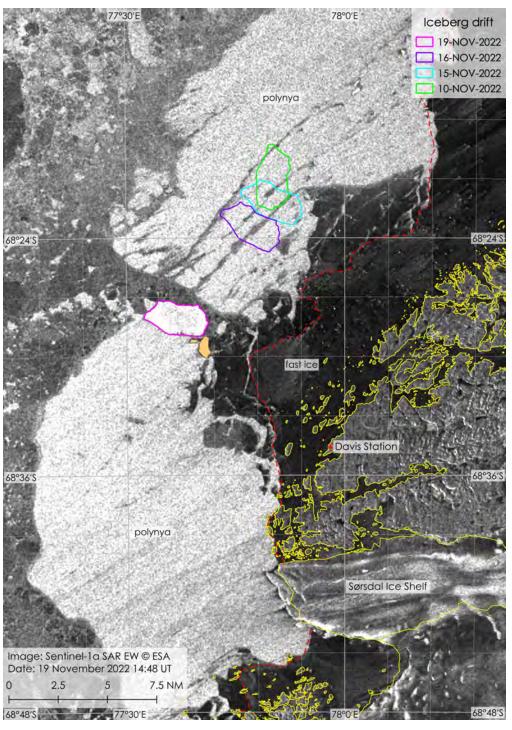
Figure 1: Sentinel-1a SAR EW data acquired 19 November 2022 at 14:48 UT and provided by PolarView.

Figure 1 shows SAR data off Davis Station. The drift of a large (unnamed) iceberg is indicated by colour-coded shapes. The fast-ice edge on 17 November 2022 has been included as a dashed red line.

Since mid-November, the iceberg has drifted south again after a brief northward excursion. This iceberg had been grounded north of two smaller grounded icebergs (marked with orange shapes) but re-floated northward in early-November and appears to have a more westerly course now and may be clearing the local seafloor topography this time.

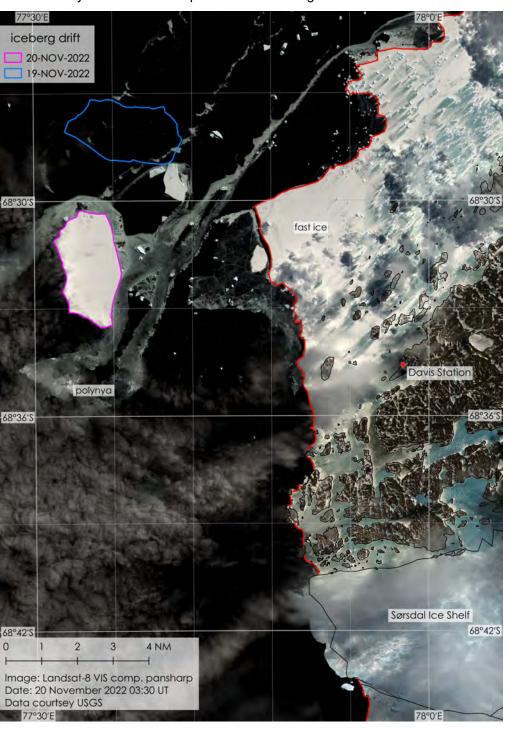
Figure 1 shows high-resolution (15 m horizontal) visible data off Davis Station. The drift of a large (unnamed) iceberg is indicated by colour-coded shapes. The fast-ice edge has been included as a red line.

The large iceberg appears to have cleared the local seafloor topography now as it drifted west of two grounded icebergs off Davis Station that have been grounded since autumn 2022.

The fast-ice edge appears generally stable but small pieces of fast ice are breaking off the edge and floating in the polynya westward.

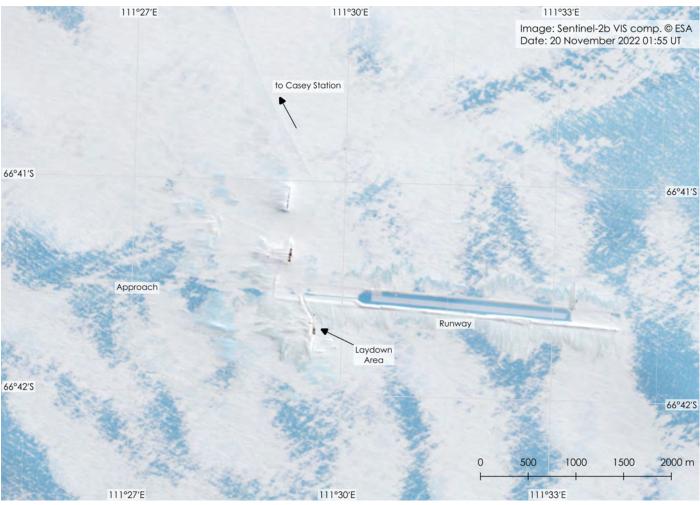
Figure 1: Sentinel-2b visible composite data acquired 20 November 2022 at 01:55 UT and provided by ESA.

Figure 1 shows high-resolution (10 m horizontal) visible data of Wilkins Aerodrome.

The ice runway is partly covered by fresh snow. North and south of the runway, snow dunes are left from previous clearing the runway.

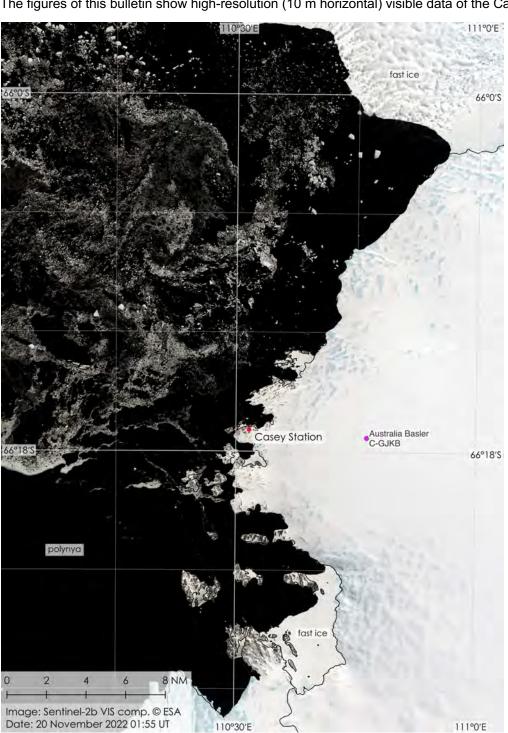
Figure 1: Sentinel-2b visible composite data acquired 20 November 2022 at 01:55 UT and provided by ESA.

The figures of this bulletin show high-resolution (10 m horizontal) visible data of the Casey Station region.

North and south of the station, fast ice continues to break up and pieces of ex-fast ice are floating in the polynya westward.

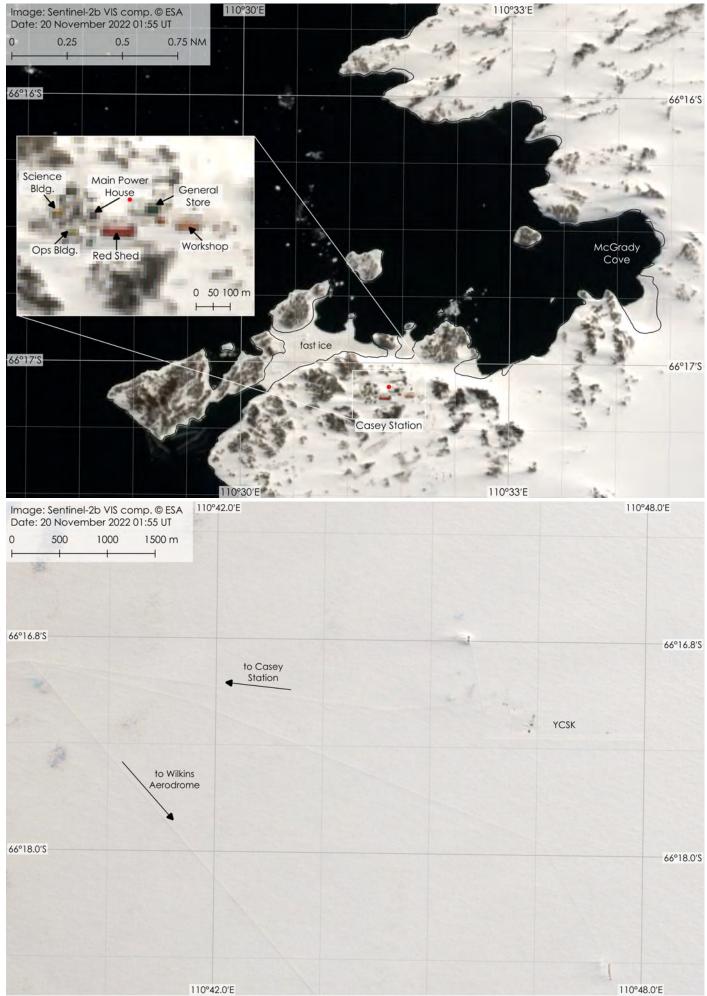
Figure 2: Sentinel-2b visible composite data acquired 20 November 2022 at 01:55 UT and provided by ESA

Figure 2 shows larger details around the station vicinity (upper panel) and the Casey Skiway (YCSK) (lower panel).

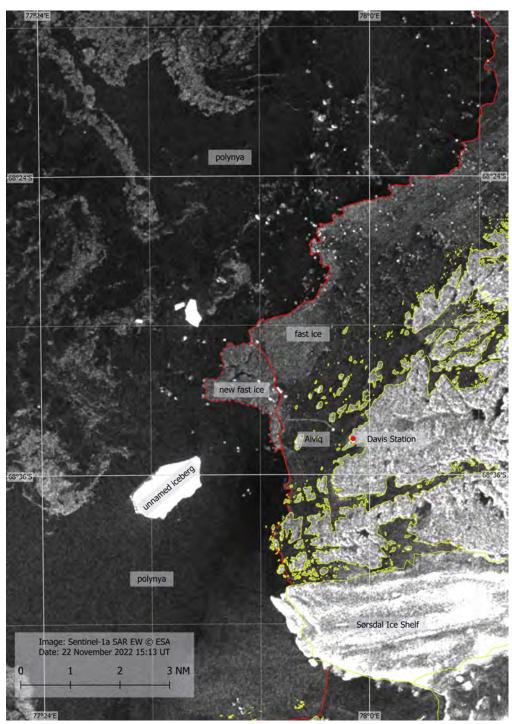
Figure 1: Sentinel-1a SAR EW data acquired 22 November 2022 at 15:13 UT and provided by Polar View.

Off the Vestfold Hills, most icebergs remain frozen in while off the fast-ice edge, some icebergs have shifted during dynamic periods.

Closer to Davis Station, the Aiviq's track through the fast ice can be clearly seen, with the ship appearing as a bright feature in position south of Anchorage Island.

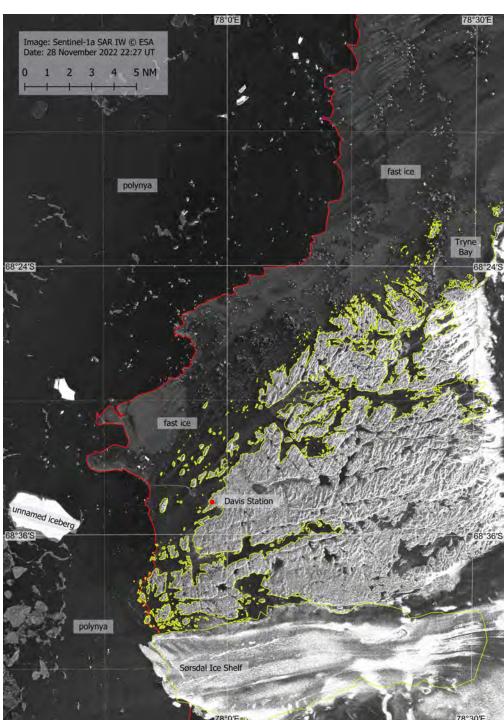
Figure 1: Sentinel-1a SAR IW data acquired 30 November 2022 at 22:27 UT and provided by Polar View.

Off Davis station, the fast-ice edge remains relatively stable at roughly 2.5 to 3 nautical miles offshore. Over the last week, the new ice which consolidated northwest of Davis Station has fractured and refrozen near the fast-ice edge.

Off the Vestfold Hills, most icebergs remain frozen in while off the fast-ice edge, some icebergs have shifted during dynamic periods.

Closer to Davis Station, the Aiviq's track of departure through the fast ice can be clearly seen.

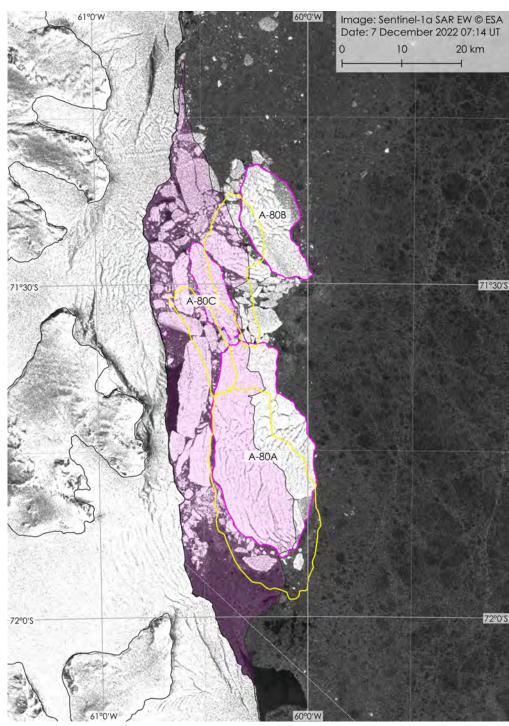
Figure 1: Sentinel-1a SAR EW data acquired 7 December 2022 at 07:14 UT and provided by PolarView.

The entire mass broke into many icebergs during the calving and initially three large tabular icebergs were identified as A-80A, A-80B and A-80C (marked by yellow shapes).

The latest data set shows that iceberg A-80B has already lost roughly 17 km² and iceberg A-80C has crumbled to below tracked size (only approximated by the dashed pink shape). Iceberg A-80A is currently stable at roughly 450 km².

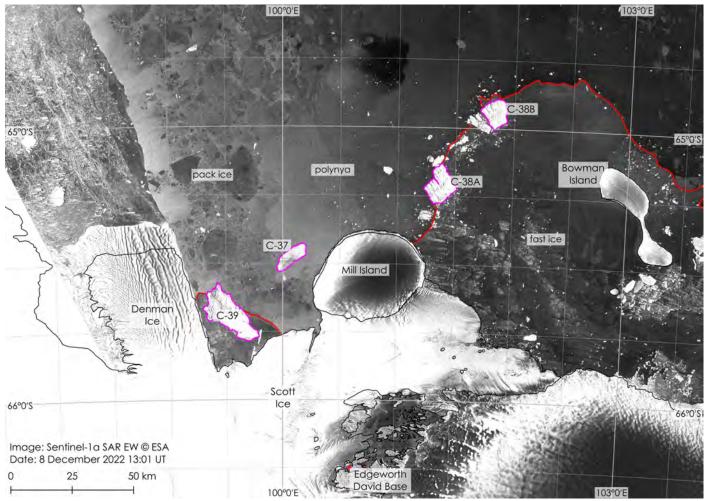
Figure 1: Sentinel-1a SAR EW data acquired 8 December 2022 at 13:01 UT and provided by PolarView.

Figure 1 shows SAR data off Mill Island west of Casey Station.

Iceberg C-37 continues drifting freely west of Mill Island close to iceberg C-39, which is locked in by fast ice, as are icebergs C-38A and C-38B.

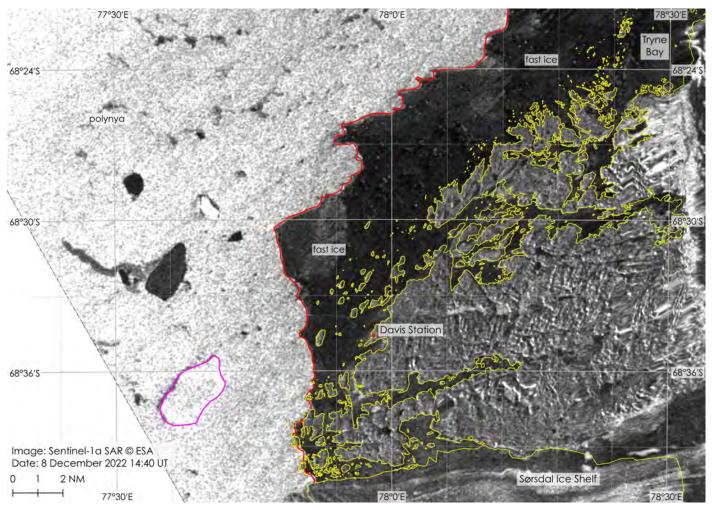
Figure 1: Sentinel-1a SAR EW data acquired 8 December 2022 at 14:40 UT and provided by PolarView.

Figure 1 shows SAR data off Davis Station.

The fast-ice edge has remained largely stable since 20 November 2022 and is roughly 3 nautical miles offshore. A large iceberg is still west of the station (marked by a pink outline).

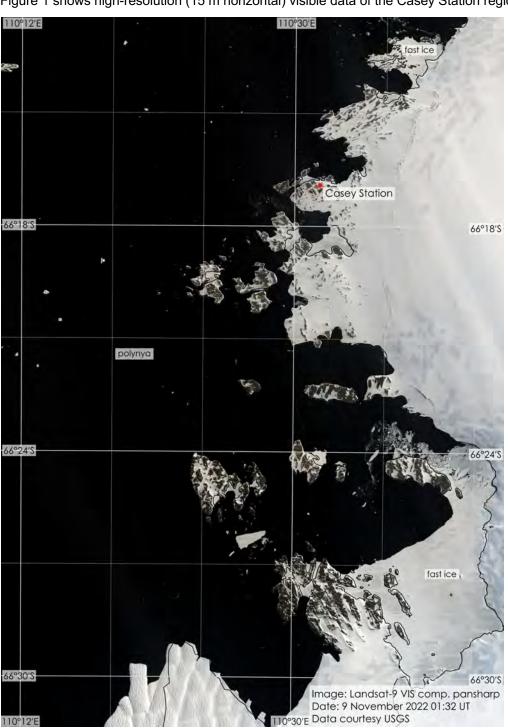
Figure 1: Landsat-9 visible composite pansharpened data acquired 9 December 2022 at 01:32 UT and provided by USGS.

Figure 1 shows high-resolution (15 m horizontal) visible data of the Casey Station region.

North and south of the station, fast ice continues to break up and pieces of ex-fast ice and isolated icebergs are floating in the polynya.

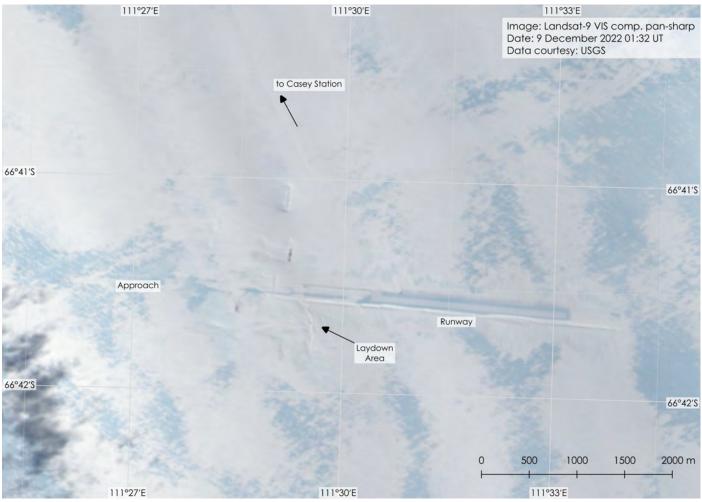
Figure 1: Landsat-9 visible composite pansharpened data acquired 9 December 2022 at 01:32 UT and provided by USGS.

Figure 1 shows high-resolution (15 m horizontal) visible data of Wilkins Aerodrome. Some cloud shadows are visible in the lower left corner.

The ice runway is partly covered by snow. North and south of the runway, snow dunes are left from previous clearing the runway.

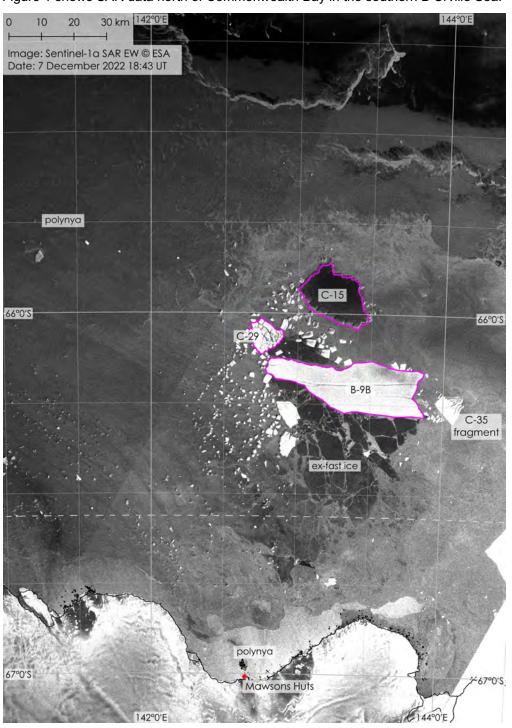
Figure 1 shows SAR data north of Commonwealth Bay in the southern D'Urville Sea.

In early-December 2022, the fast ice connecting Commonwealth Bay/Mawsons Huts with the grounded icebergs further north has shatterd and the bay off the huts is now a polynya.

East of iceberg B-9B, a fragment of iceberg C-35, which calved off the Ninnis Ice Shelf in July 2018, has drifted across from the Ninnis Ice Shelf.

East of the icebergs and the ex-fast ice, some pack ice remains local and is decaying. West of the icebergs, only very little sea ice is off Dumont D'Urville Station (outside of the frame of Figure 1) and only strips and patches of decaying sea ice are drifting freely further north.

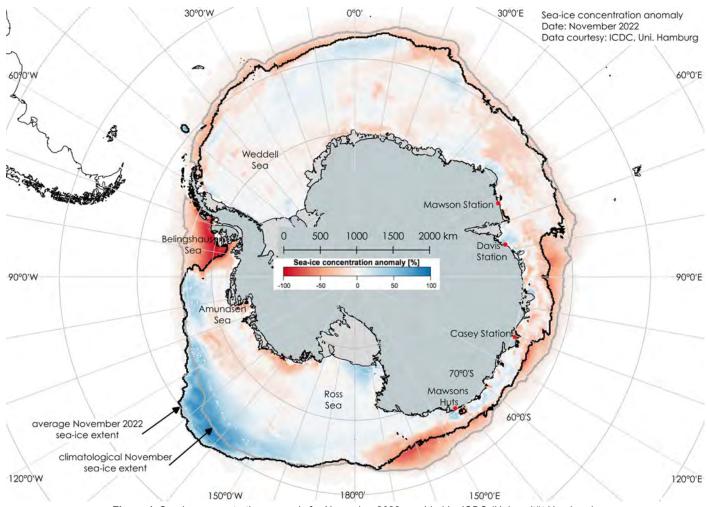
Figure 1: Sea-ice concentration anomaly for November 2022 provided by ICDC (Universität Hamburg).

Figure 1 shows the pan-Antarctic sea-ice concentration anomaly based on passive microwave remote sensing data.

Pan-Antarctic sea-ice conditions continue to be overall low but not record-breaking (5th lowest) during November.

Northeast of the northern tip of the Antarctic Peninsula, an isolated apparent positive anomaly is caused by the drift of large iceberg A-76A, which is north (outside) of the sea-ice zone and drifting further northward into the southern South Atlantic.

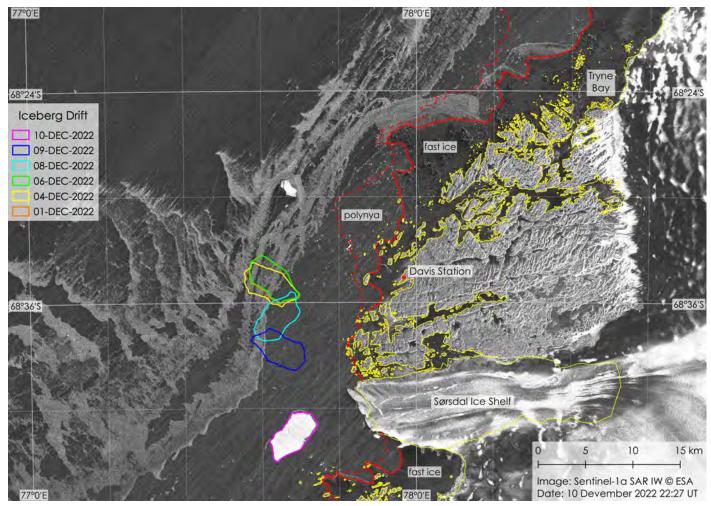
Figure 1: Sentinel-1a SAR IW data acquired 10 December 2022 at 22:27 UT and provided by PolarView.

Figure 1 shows SAR data off Davis Station. The fast-ice edge is marked by a red line (dashed red for 8 December 2022).

During the weekend, fast ice broke away and off station the fast-ice edge is now roughly 1.5 nautical miles offshore.

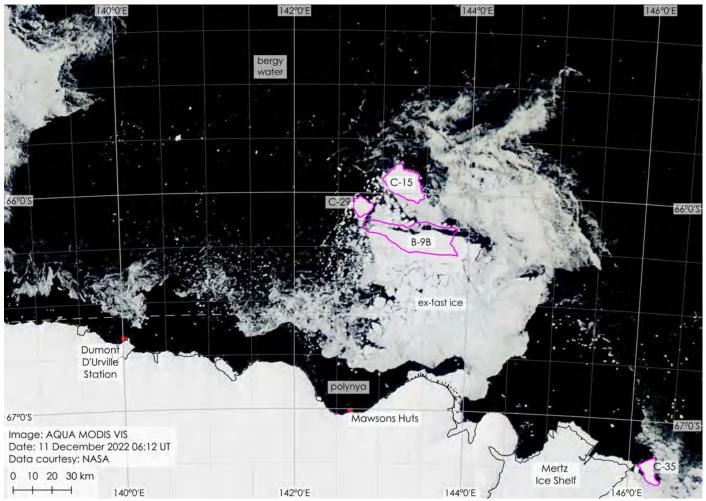
Figure 1: AQUA MODIS VIS data acquired 11 December 2022 at 06:12 UT and provided by NASA.

Figure 1 shows visible data north of the southern D'Urville Sea.

During the weekend, iceberg B-9B moved south-eastward (pink shapes indicate positions prior to the weekend), which indicates that the berg is not grounded but trapped between smaller icebergs and fast ice up until recently.

East of the icebergs and the ex-fast ice, some pack ice remains local and is decaying. West of the icebergs troika north of Mawsons Huts, only very little sea ice is off Dumont D'Urville Station and only strips and patches of decaying sea ice are drifting freely further north.

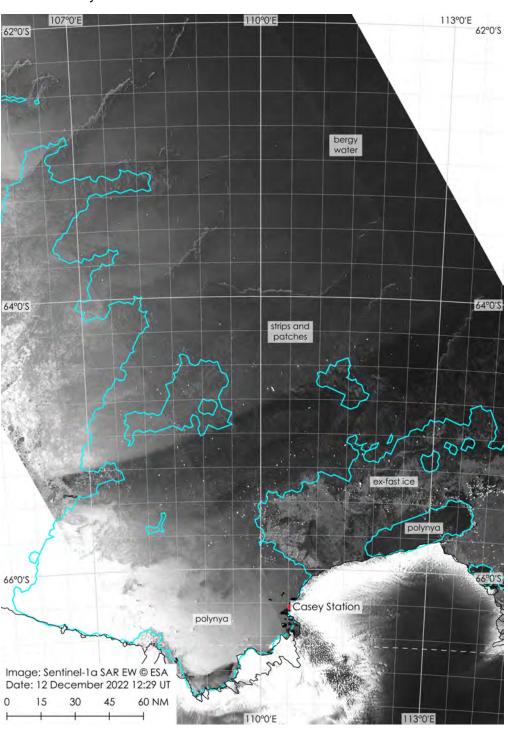
Figure 1 shows SAR data of the Casey Station region. The sea-ice edge based on passive microwave data is included as a cyan line.

North of Casey Station, some fast ice remains attached to the western flank of Law Dome but it is breaking up and releasing ex-fast ice floes northward.

West of 110°0'E, only very little sea ice remains but many small to medium-sized icebergs are present.

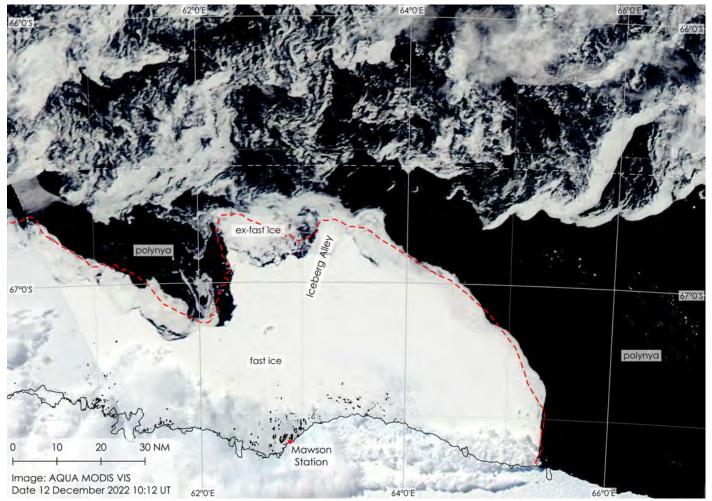
Figure 1: AQUA MODIS visible composite data acquired 12 December 2022 at 10:12 UT and provided by NASA.

Figure 1 shows visible data off Mawson Station.

North of the station, the fast-ice edge is starting to break up and the is moving southward. North of the fast ice, first-year sea ice and ex-fast ice are drifting freely. Some icebergs are also present.

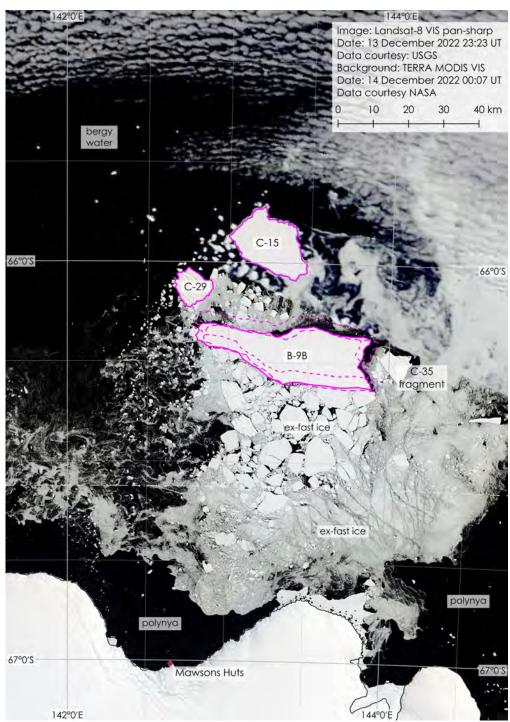
Figure 1: Landsat-8 visible composite pan-sharpened data acquired 13 December 2022 at 23:23 UT and provided by USGS; background TERRA MODIS VIS data acquired 13 December 2022 at 00:07 UT and provided by NASA.

East of iceberg B-9B, a fragment of iceberg C-35 remains close to iceberg B-9B.

East and south of the troika of icebergs north of Mawsons Huts, ex-fast ice and some pack ice remains local and is decaying. West of the icebergs, only very little sea ice is off Dumont D'Urville Station (not included in the figure) and only strips and patches of decaying sea ice are drifting freely further north.

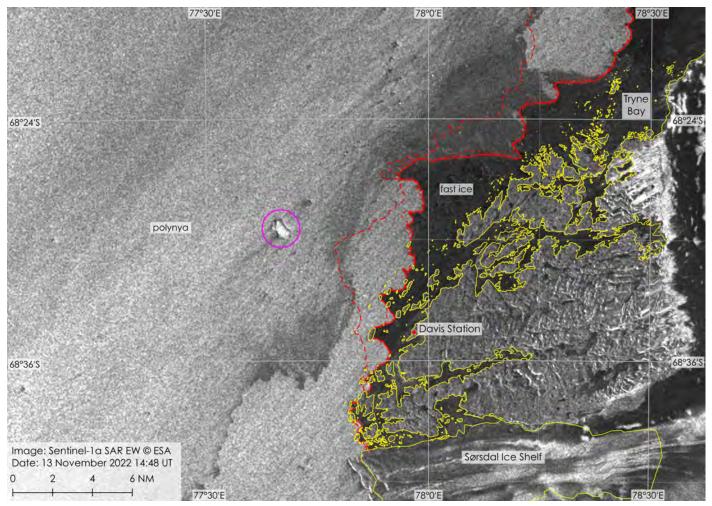
Figure 1 shows SAR data off Davis Station. The fast-ice edge is marked by a red line (dashed and dotted red for 8 December 2022 and 10 December 2022, respectively).

Figure 1: Sentinel-1a SAR IW data acquired 10 December 2022 at 22:27 UT and provided by PolarView.

Fast ice continues to brake away off station and the fast-ice edge is now only a little more than 1 nautical mile offshore.

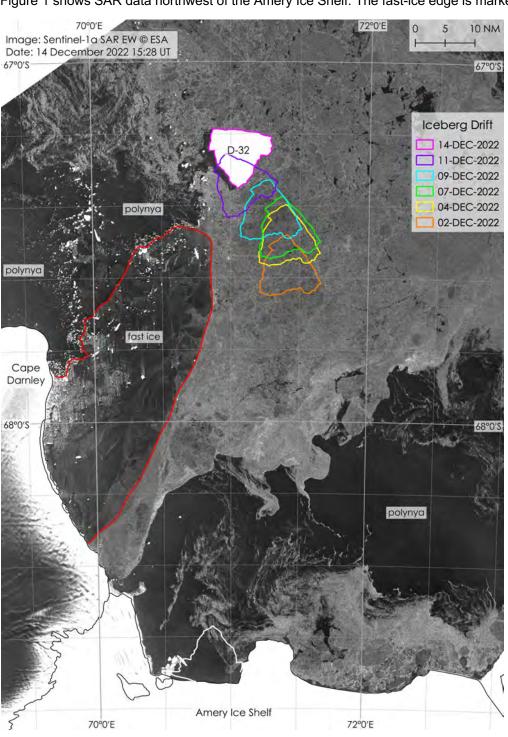
Figure 1 shows SAR data northwest of the Amery Ice Shelf. The fast-ice edge is marked by a red line.

East of Cape Darnley, fast ice continues to shrink. Large iceberg D-32 calved off the Amery Ice Shelf in early-October (its initial position is marked by the white line off the western shelf-ice edge) and the iceberg's drift during December (so far) is indicated by colour-coded shapes. The iceberg is about the clear the northernmost grounded icebergs northeast of Cape Darnley and expected to turn west then and drift along the continental shelf break.

Further north, the sea-ice edge is within a couple of nautical miles of the median sea-ice extent for December.

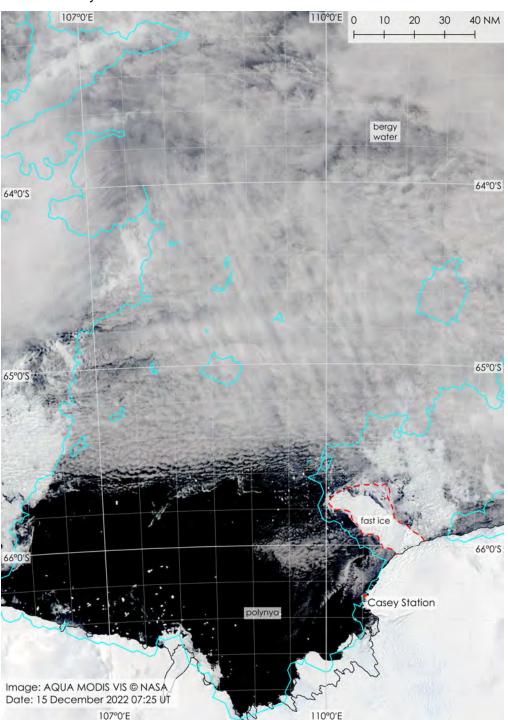
Figure 1 shows visible data of the Casey Station region. The sea-ice edge based on passive microwave data is included as a cyan line.

North of Casey Station, some fast ice remains attached to the western flank of Law Dome but it is breaking up and releasing ex-fast ice floes northward. The fast-ice edge on 14 December 2022 is indicated by a dashed red line.

Between 107°0'E and 110°0'E, only very little sea ice remains in strips and patches but many small to medium-sized icebergs are present.

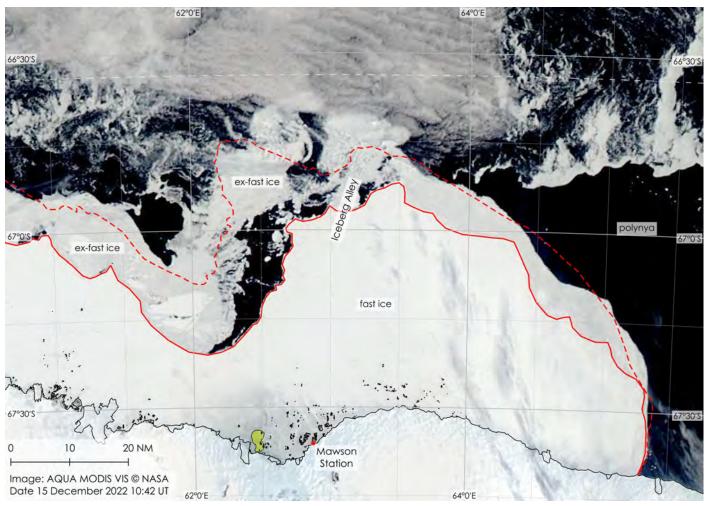
Figure 1 shows visible data off Mawson Station. The fast-ice edge is marked by a red line (dashed red for 4 December 2022).

Figure 1: AQUA MODIS visible composite data acquired 15 December 2022 at 10:42 UT and provided by NASA.

North of the station, the fast-ice edge continues moving southward. North of the fast ice, first-year sea ice and ex-fast ice are drifting freely. Some icebergs are also present.

West of Mawson Station, fast ice is deteriorating nearshore and open-water holes start to appear nearshore (marked by a green-shaded shape).

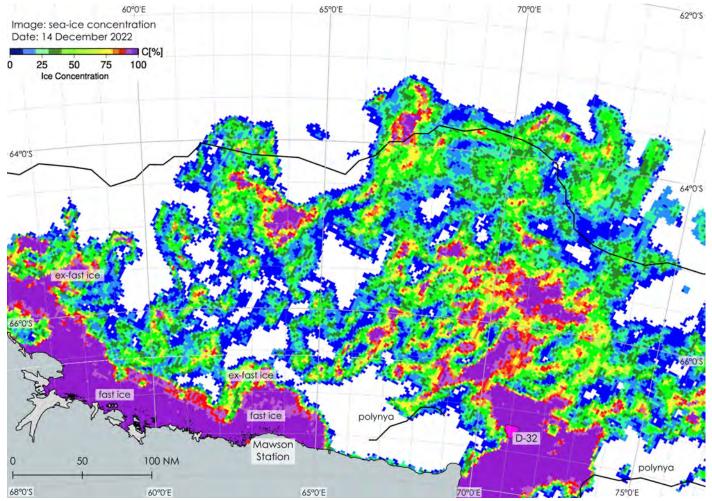
Further north, the northern sea-ice edge (see Figure 2) is currently within a couple of nautical miles of the median sea-ice extent for December (marked by a black line) but the sea-ice concentration within the extent is below average conditions.

Figure 2: Sea-ice concentration data acquired 14 December 2022 and provided by ICDC.

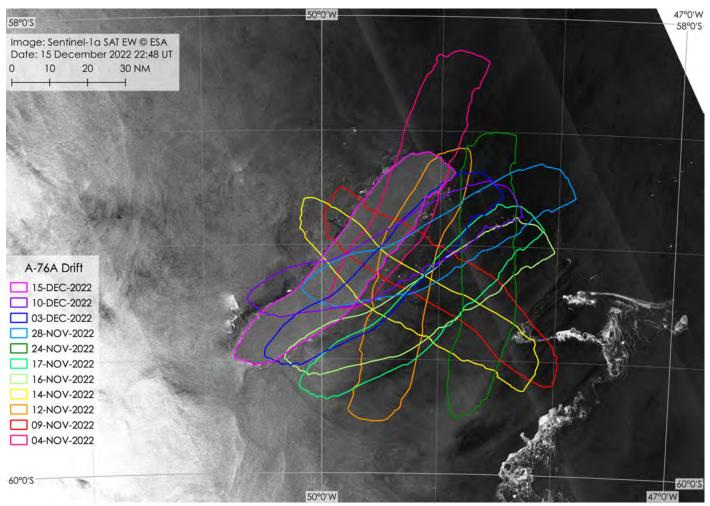
Figure 1 shows SAR data northeast of the Antarctic Peninsula in the north-western Weddell Sea. The drift of iceberg A-76A since November 2022 is indicated by colour-coded shapes.

Figure 1: Sentinel-1a SAR EW data acquired 15 December 2022 at 22:48 UT and provided by PolarView.

The iceberg is 250 nautical miles north of the sea-ice edge based on passive microwave data (not shown in the figure) and drifting in the Scotia Sea into the southern South Atlantic Ocean however, there are some strips and patches of sea ice north of the sea-ice edge that are below the detection limit of the passive microwave instrument and algorithm. Some of those patches can be seen as bright filaments southeast of the iceberg.

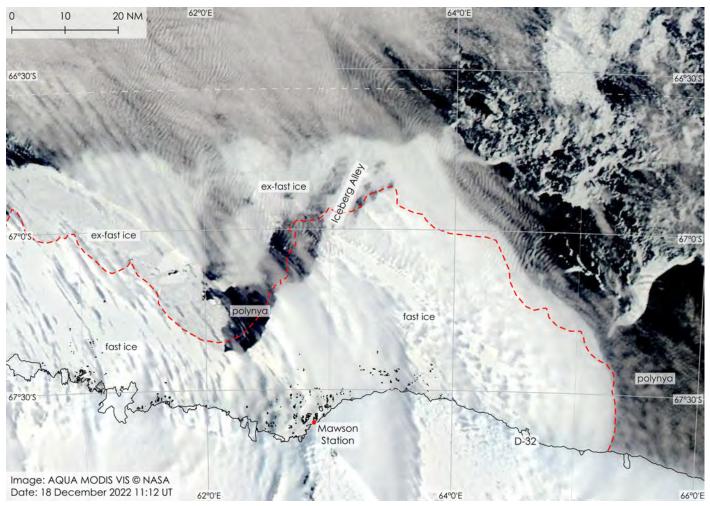
Figure 1 shows visible data off Mawson Station. The fast-ice edge on 15 December 2022 is marked by a dashed red line.

Figure 1: AQUA MODIS visible composite data acquired 18 December 2022 at 11:12 UT and provided by NASA.

North of the station, the fast-ice edge continues moving southward during the weekend. North of the fast ice, first-year sea ice and ex-fast ice are drifting freely. Some icebergs are also present.

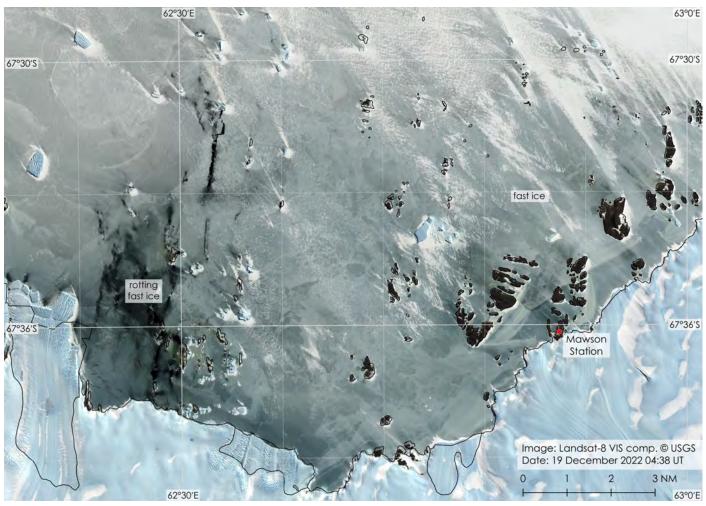
Figure 1 shows high-resolution (15 m horizontal) visible data off Mawson Station. The fast-ice edge is marked by a red line.

Figure 1: Landsat-8 visible composite pan-sharpened data acquired 19 December 2022 at 04:38 UT and provided by USGS.

West of Mawson Station, fast ice has started to deteriorate nearshore. North of the station, only the southern part of Iceberg Alley (marked by green outlines) remains covered by fast ice (see Figure 2).

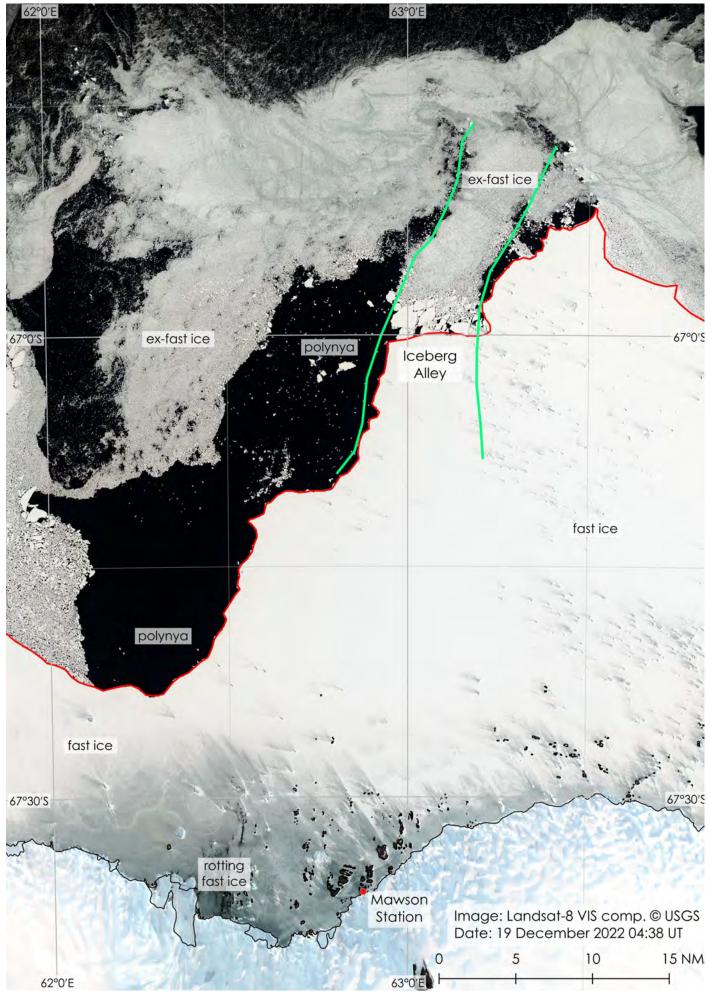
Figure 2: Landsat-8 visible composite pan-sharpened data acquired 19 December 2022 at 04:38 UT and provided by USGS.

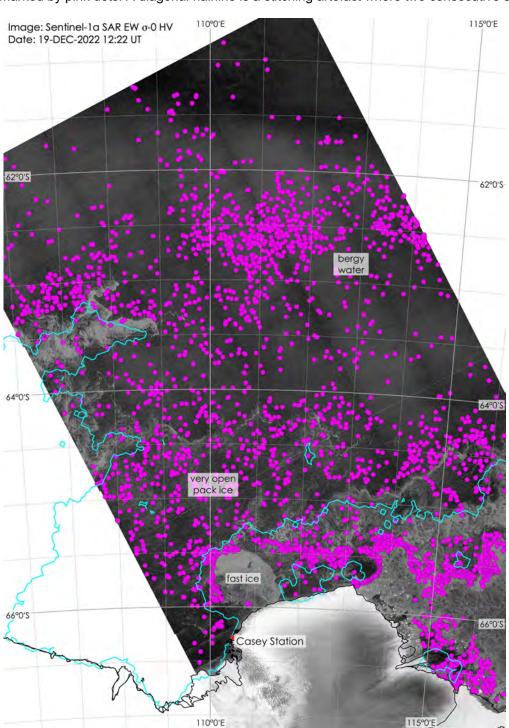
Figure 1 shows SAR data of the Casey Station region. The sea-ice edge based on passive microwave data is included as a cyan line. The data has been analysed for iceberg presence and more than 1500 features have been marked by pink dots. A diagonal hairline is a stitching artefact where two consecutive scenes join.

North of Casey Station, some fast ice remains attached to the western flank of Law Dome but it is breaking up and releasing ex-fast ice floes northward.

Between 108°0'E and 110°0'E, only very little sea ice remains in strips and patches but many small to medium-sized icebergs are present.

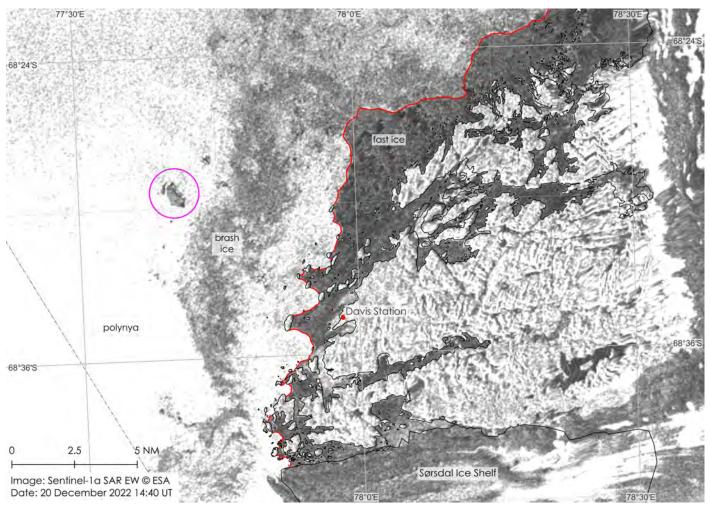
Figure 1 shows SAR data off Davis Station.

Figure 1: Sentinel-1a SAR EW data acquired 20 December 2022 at 14:40 UT and provided by PolarView.

Fast-ice edge is currently stable and only a little more than 1 nautical mile offshore. Some melting ex-fast ice is drifting as brash ice southward offshore.

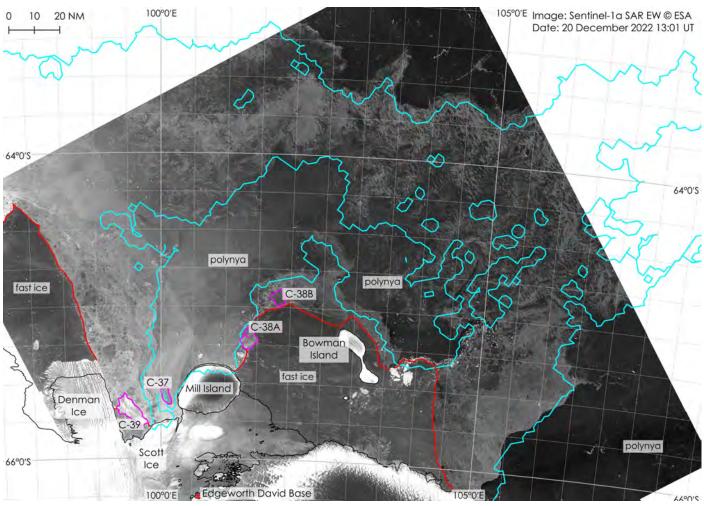
Figure 1 shows SAR data off Mill Island west of Casey Station. Fast-ice areas are outlined in red and the sea-ice edge based on passive microwave data is shown in light-blue.

Figure 1: Sentinel-1a SAR EW data acquired 20 December 2022 at 13:01 UT and provided by PolarView.

A polynya is present north and west of the island and a bit further northeast.

Iceberg C-37 continues drifting freely in this polynya close to iceberg C-39, which is still locked in by fast ice as well as iceberg C-38A. However, iceberg C-38B is not enclosed by fast ice anymore and moving slightly north-eastward. Further north, the northern sea-ice edge is roughly 30 nautical miles below (south of) the median sea-ice extent for December (not shown in the figure) and the sea-ice concentration within this extent is below average conditions.

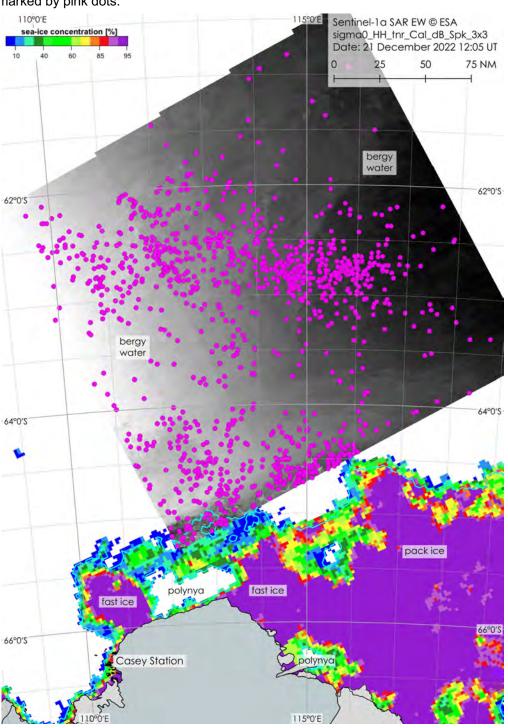
Figure 1 shows a composite of data north of the Casey Station region. The sea-ice edge based on passive microwave data is included as a cyan line. The SAR data has been analysed for iceberg presence and 1200 features have been marked by pink dots.

North of Casey Station, some fast ice remains attached to the western flank of Law Dome but it is breaking up and releasing ex-fast ice floes northward.

Between 108°0'E and 110°0'E, only very little sea ice remains in strips and patches but many small to medium-sized icebergs are present.

Figure 1: Sentinel-1a SAR EW data acquired 21 December 2022 at 12:05 UT and provided by ESA; sea-ice concentration data acquired 20 December 2022 and provided by ICDC.

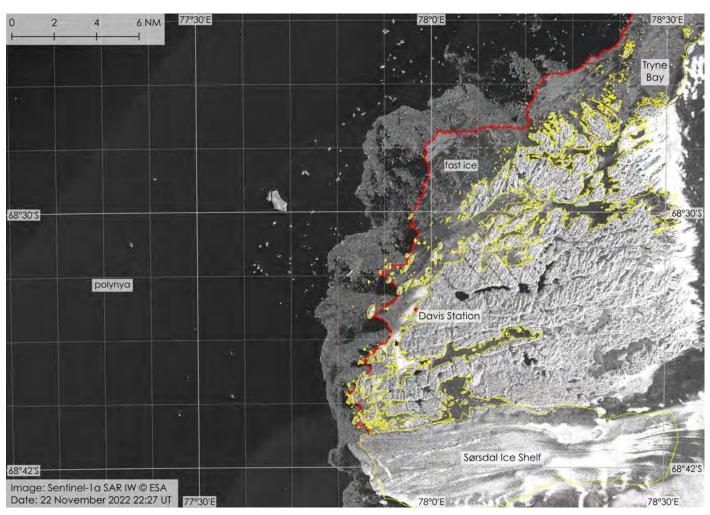
Figure 1 shows high-resolution (15 m horizontal) SAR data off Davis Station.

Figure 1: Sentinel-1a SAR IW data acquired 22 December 2022 at 22:27 UT and provided by PolarView.

Fast-ice edge remains currently largely stable and only a little more than 1 nautical mile offshore. Some melting exfast ice is drifting as brash ice southward offshore.

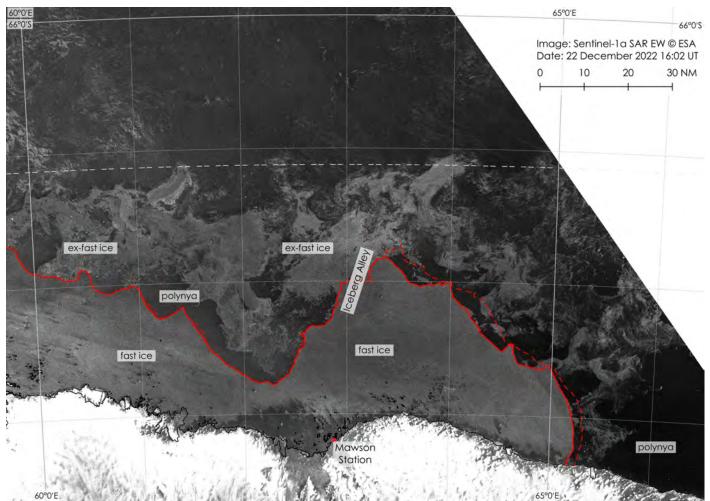
Figure 1 shows SAR data off Mawson Station. The fast-ice edge is marked by a red line (dashed red for 19 December 2022).

Figure 1: Sentinel-1a SAR EW data acquired 22 December 2022 at 16:02 UT and provided by PolarView.

North of the station, only the southern part of Iceberg Alley remains covered by fast ice.
