Ice Bulletins for the Antarctic Shipping Season 2022 – 2023

Prepared by Dr Jan L Lieser

Antarctic Meteorology Section — Bureau of Meteorology

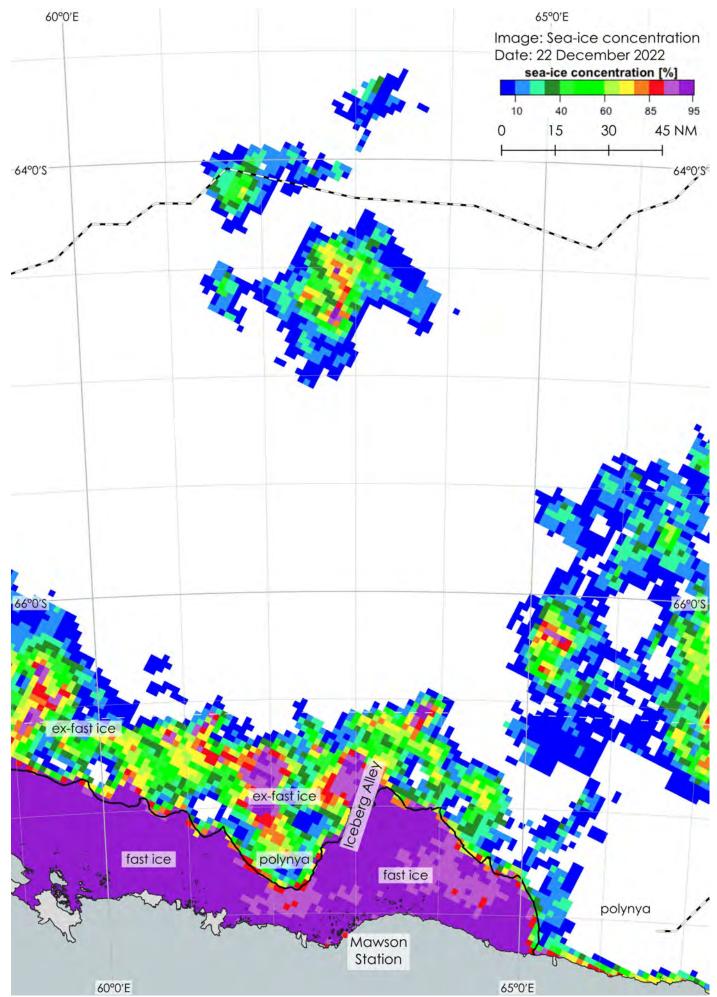
The northern sea-ice edge (see Figure 2) has now largely collapsed and is generally 140 nautical miles below (south of) the median sea-ice extent for December, which is marked by a dashed black-white line in Figure 2. However, isolated patches of deteriorating sea ice remain within the climatological December median extent.

Figure 2: Sea-ice concentration data acquired 22 December 2022 and provided by ICDC.

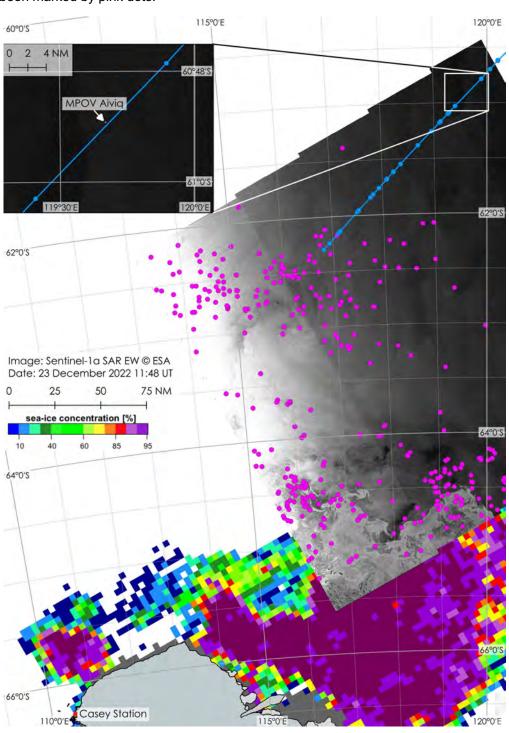
Figure 1 shows a composite of data northeast of the Casey Station region. The cruise track of MPOV *Aiviq* is included as a blue line (up until 23 December 2022 23:33 UT). The inset shows the vessel at the time of the SAR data acquisition as a bright spot. The SAR data has been analysed for iceberg presence and more than 350 features have been marked by pink dots.

North of Casey Station, some fast ice remains attached to the western flank of Law Dome but it is breaking up and releasing ex-fast ice floes northward.

Between 108°0'E and 110°0'E, only very little sea ice remains in strips and patches but many small to medium-sized icebergs are present.

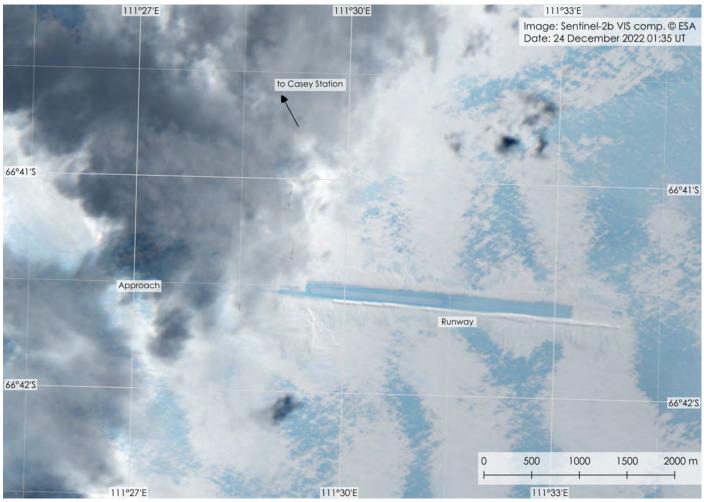
Figure 1 shows high-resolution (10 m horizontal) visible data of Wilkins Aerodrome. The scene is obscured by cloud in the western part.

Figure 1: Sentinel-2b visible composite data acquired 24 December 2022 at 01:35 UT and provided by ESA.

The ice runway is partly covered by snow. North and south of the runway, snow dunes are left from previous clearing the runway.

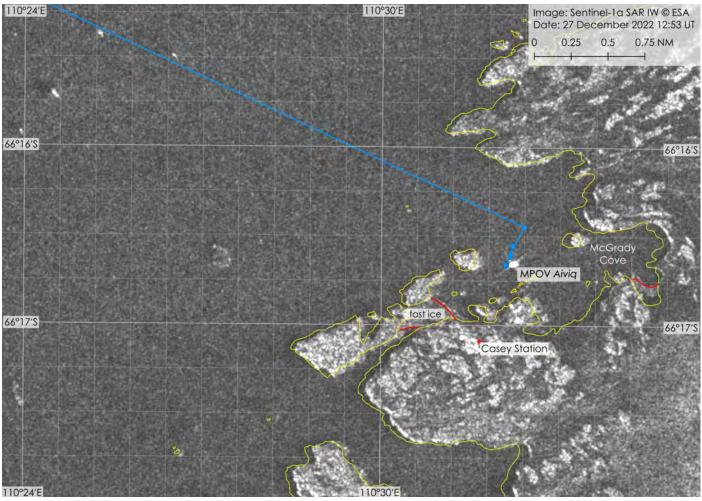
Figure 1 shows SAR data off the Casey Station region. The cruise track of MPOV *Aiviq* is included as a blue line (up until 27 December 2022 22:41 UT). At the time of the SAR data acquisition, the vessel can be seen as a bright spot off station.

Figure 1: Sentinel-1a SAR IW data acquired 27 December 2022 at 12:53 UT and provided by ESA.

Off station, little fast ice remains nearshore and some icebergs are drifting in the polynya offshore.

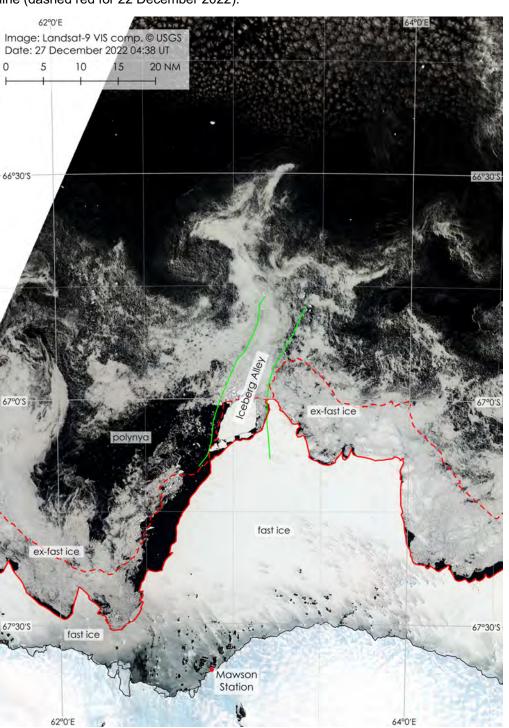
Figure 1 shows high-resolution (30 m horizontal) visible data off Mawson Station. The fast-ice edge is marked by a red line (dashed red for 22 December 2022).

North of the station, fast ice is now also breaking in the southern part of Iceberg Alley (marked by green outlines).

West of the station, rotting fast ice nearshore is expanding northward and starting to connect with the polynya northwest of the station.

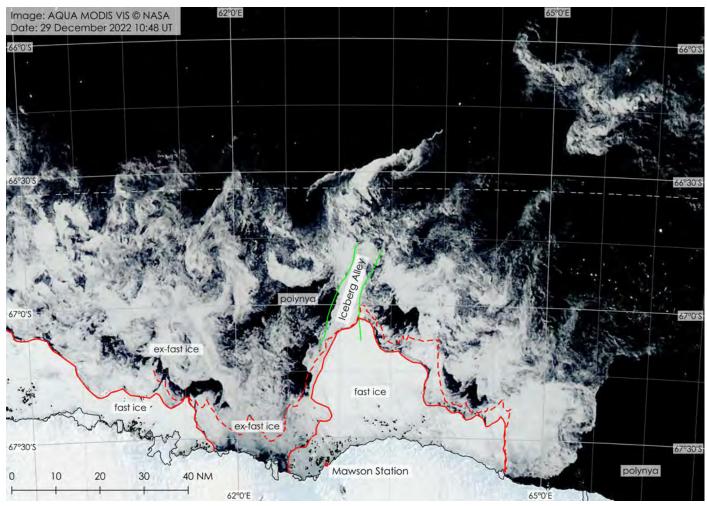
Figure 1 shows visible data off Mawson Station. The fast-ice edge is marked by a red line (dashed red for 27 December 2022).

Figure 1: AQUA MODIS VIS composite data acquired 29 December 2022 at 10:48 UT and provided by NASA.

West of the station, fast ice has now broken off along roughly 20 nautical miles nearshore, and the polynya northwest of the station has expanded southward.

North of the station, Iceberg Alley (marked by green outlines) is almost clear of fastened sea ice but remains filled with decaying ex-fast ice.

Further east, the fast-ice edge moved further southward since 27 December 2022. North of the fast ice, deteriorating first-year sea ice and ex-fast ice is drifting freely. Some icebergs are also present.

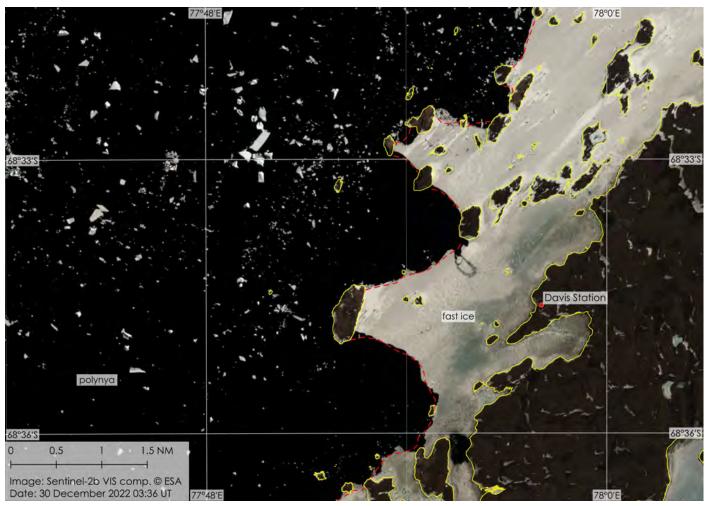
Figure 1 shows high-resolution (10 m horizontal) visible data off Davis Station. The fast-ice edge on 20 December 2022 is included as a dashed red line.

Figure 1: Sentinel-2b visible composite data acquired 30 December 2022 at 03:36 UT and provided by ESA.

Fast-ice edge remains currently largely stable and only a little more than 1 nautical mile offshore. Off station, the teardrop created in the fast ice by MPOV *Aiviq* leaving earlier is still visible.

Most icebergs offshore are grounded but some are drifting with decaying ex-fast ice floes generally south-westward.

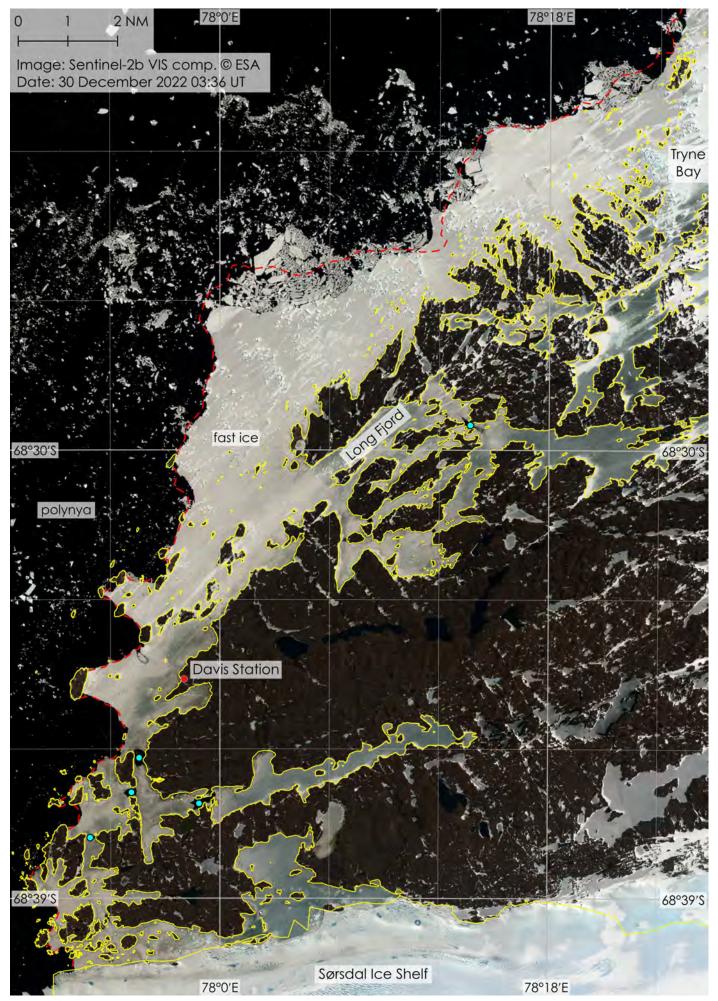
South of the station, areas where nearshore fast ice is melting through are marked by light blue dots. Some melting is also observed in Long Fjord.

Figure 2: Sentinel-2b visible composite data acquired 30 December 2022 at 03:36 UT and provided by ESA.

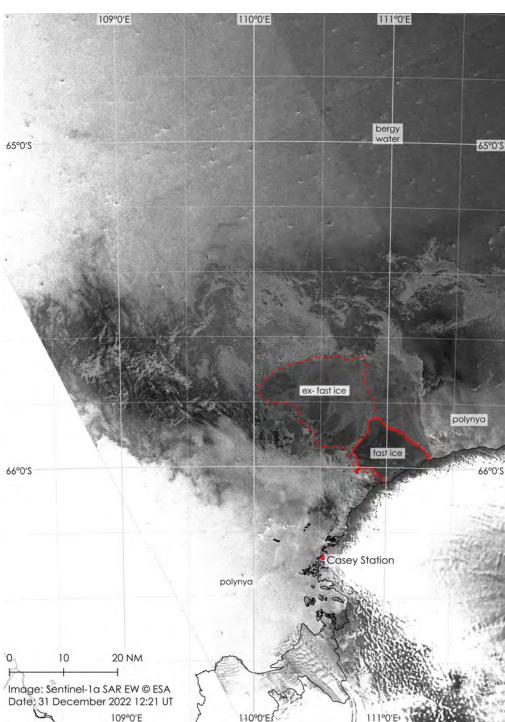
Further north and west, pack ice consisting of decaying first-year sea ice and breaking up ex-fast ice is drifting between 108°0'E and 110°0'E.

Between 109°0'E and 110°0'E, the pack-ice zone is obscured by clouds but some of the open pack ice can be identified.

Figure 1: Sentinel-1a SAR EW data acquired 31 December 2022 at 12:21 UT and provided by PolarView.

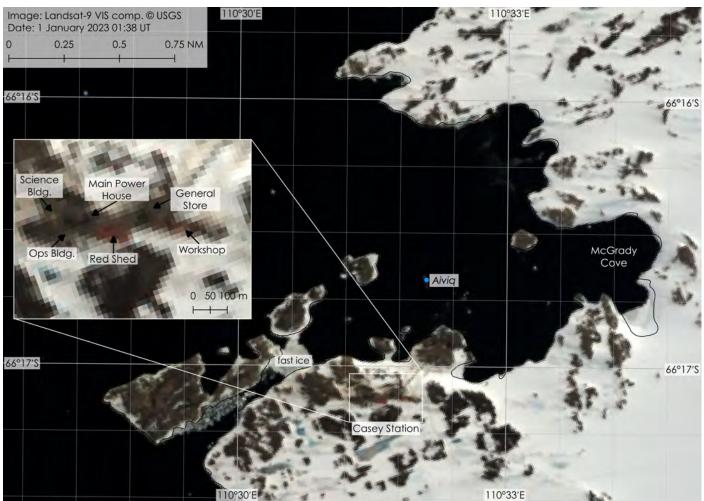
Figure 1 shows high-resolution (15 m horizontal) visible of Casey Station. The positon of MPOV *Aiviq* on 1 January 2023 at 03:04 UT is marked by a blue dot.

Figure 1: Landsat-9 visible composite pan-sharpened data acquired 1 January 2023 at 01:38 UT and provided by USGS.

Only very little fast ice remains in sheltered bays around the station.

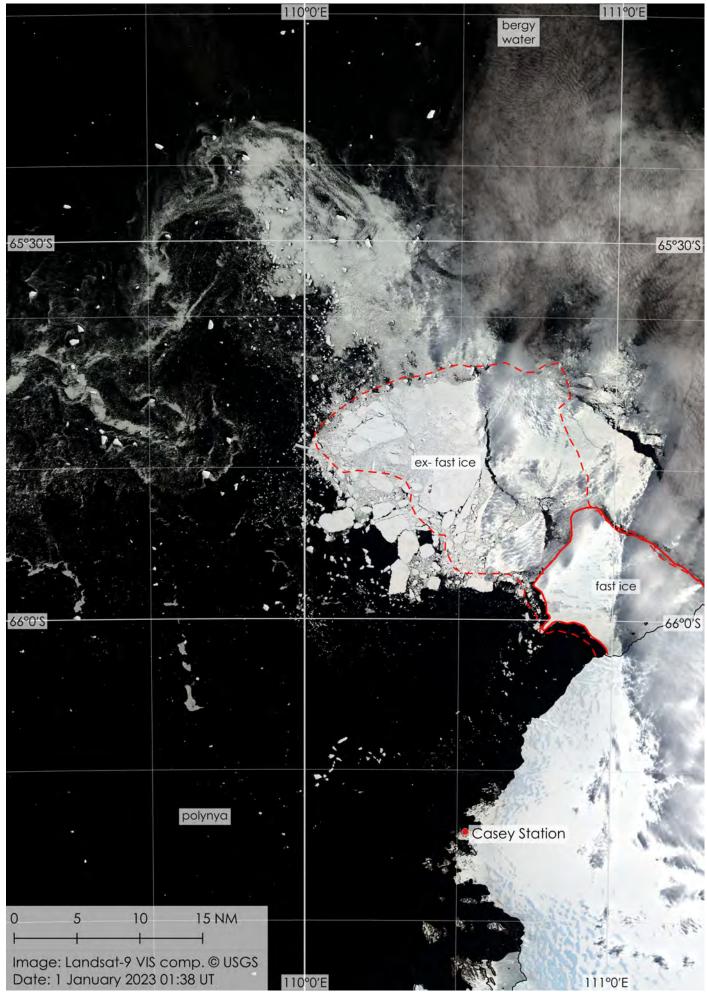
Pack ice consisting of decaying first-year sea ice and breaking up ex-fast ice is drifting between 108°0'E and 110°0'E. Many small to medium-sized icebergs are also present.

Figure 2: Landsat-9 visible composite data acquired 1 January 2023 at 01:38 UT and provided by USGS.

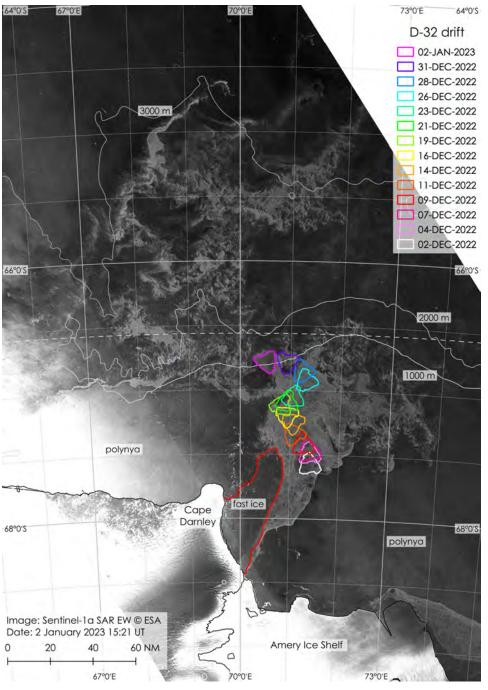
Figure 1 shows SAR data off Cape Darnley. The fast-ice edge is marked as a red outline. The drift of iceberg D-32 during December 2022 is indicated by colour-coded shapes. Seafloor bathymetry is included as grey lines.

The iceberg has drifted beyond (north of) the continental shelf and has turned westward. It is expected it will continue its drift roughly along the shelf break.

Off Cape Darnley, fast ice continues to break up. Sea ice is present as far north as 64°30'S but it is generally decaying and roughly 50 nautical miles below (south of) the median sea-ice extent for December along 70°0'E and up to 150 nautical miles below (south of) the median further west (including north of Mawson Station, which is outside of the figure).

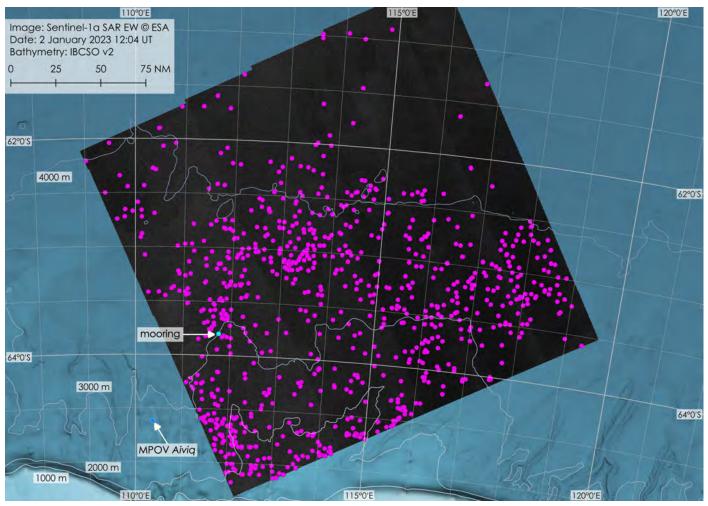
Figure 1 shows SAR data northeast if the Casey Station region. Seafloor bathymetry corresponding to the background has been included as grey lines. The position of MPOV *Aiviq* on 3 January 2023 at 02:01 UT is marked by a blue dot.

Figure 1: Sentinel-1a SAR EW data acquired 2 January 2023 at 12:04 UT and provided by ESA.

The SAR data have been analysed for iceberg presence and more than 840 features have been marked by pink dots. Drifting icebergs are present as far north as 61°0'S and in the vicinity of an oceanographic mooring (marked by a light blue dot).

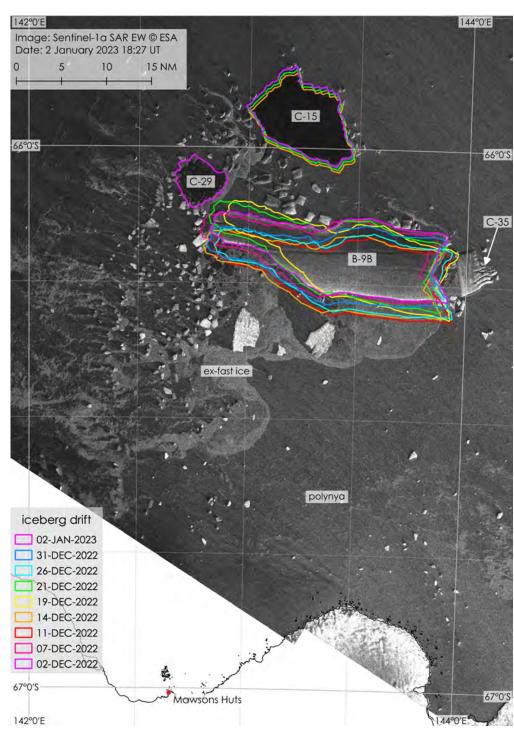
Ex-fast ice is deteriorating around the iceberg and generally drifting westward through small to mediumsized grounded icebergs.

East of iceberg B-9B, a fragment of iceberg C-35 remains close to iceberg B-9B.

Off Mawson's Huts, Cape Denison is ice free.

Figure 1: Sentinel-1a SAR EW data acquired 2 January 2023 at 18:27 UT and provided by PolarView.

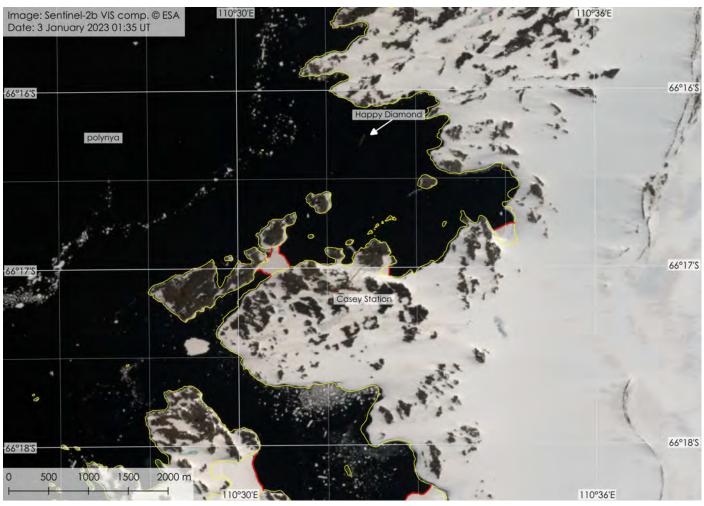
Figure 1 shows high-resolution (10 m horizontal) visible data of the Casey Station region. The fast-ice edge is included as a red line.

Figure 1: Sentinel-2b visible composite data acquired 3 January 2023 at 01:35 UT and provided by ESA.

Around Casey Station, very little fast ice remains in sheltered bays and it is breaking up and releasing ex-fast ice floes.

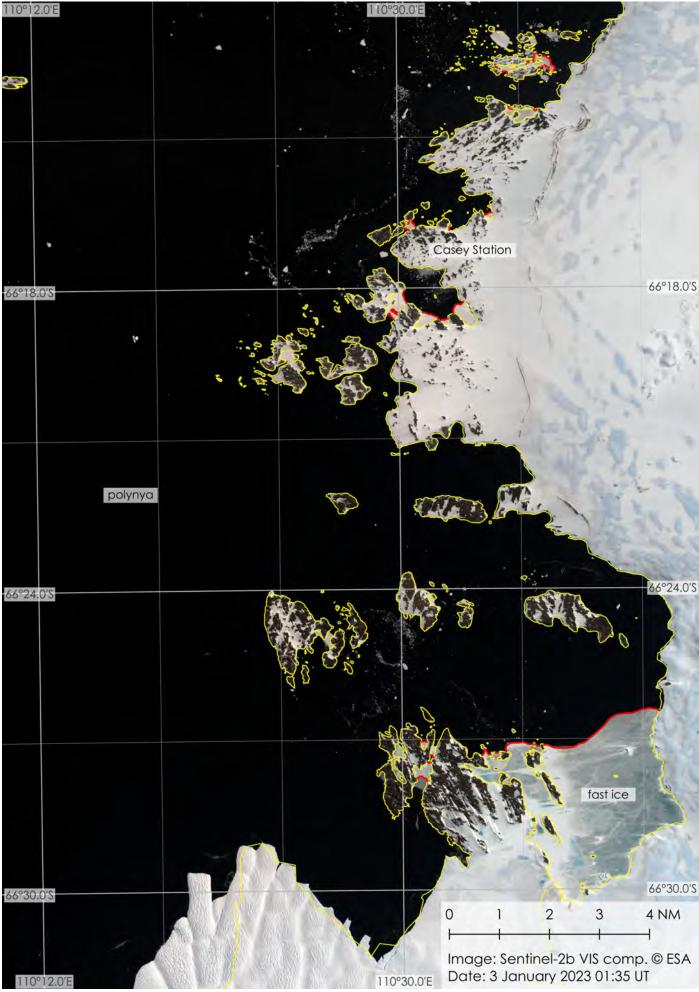
Only isolated sea-ice floes and icebergs are present in the polynya offshore.

Figure 2: Sentinel-2b visible composite data acquired 3 January 2023 at 01:35 UT and provided by ESA.

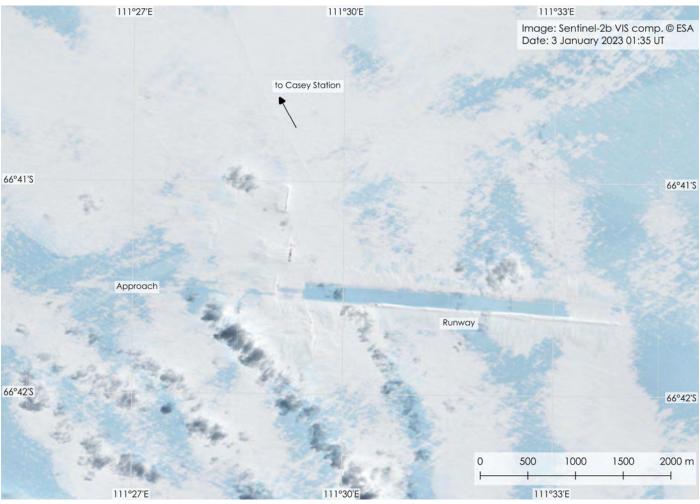
Figure 1 shows high-resolution (10 m horizontal) visible data of Wilkins Aerodrome. Some cloud shadows are visible in the lower left corner.

Figure 1: Sentinel-2b visible composite data acquired 3 January 2023 at 01:35 UT and provided by ESA.

The ice runway is partly covered by snow. North and south of the runway, snow dunes are left from previous clearing the runway.

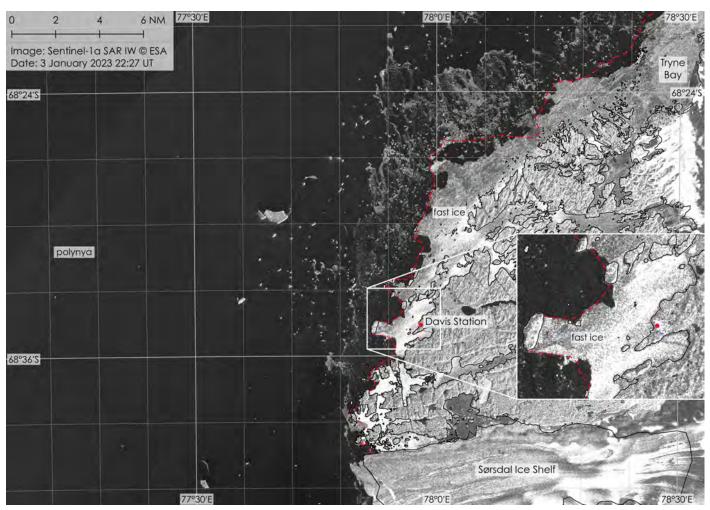
Figure 1 shows high-resolution SAR data off Davis Station. The fast-ice edge on 22 December 2022 is included as a dashed red line.

Figure 1: Sentinel-1a SAR IW data acquired 3 January 2023 at 22:27 UT and provided by PolarView.

Fast-ice edge remains currently largely stable and roughly 1 nautical mile offshore. Off station, the teardrop created in the fast ice by MPOV *Aiviq* leaving earlier has now broken out.

Most icebergs offshore are grounded but some are drifting with decaying ex-fast ice floes.

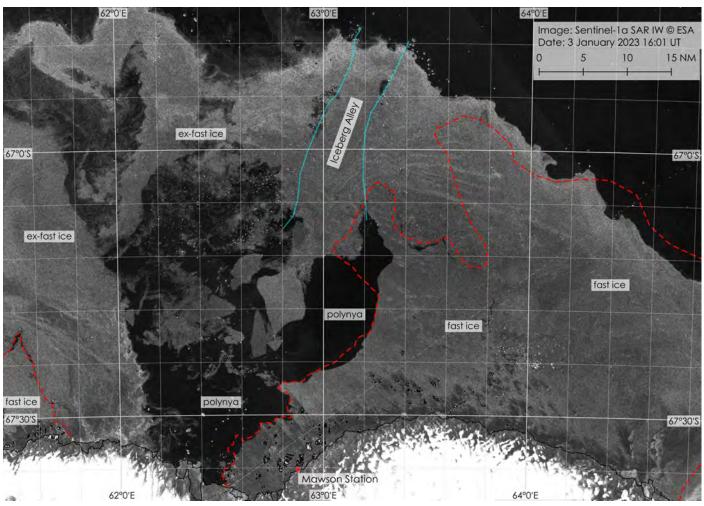
Figure 1 shows SAR data off Mawson Station. The fast-ice edge on 31 December 2022 is marked by a dashed red line.

Figure 1: Sentinel-1a SAR EW data acquired 3 January 2023 at 16:01 UT and provided by PolarView.

West of the station, fast ice has broken off along roughly 20 nautical miles nearshore, and the polynya northwest of the station has expanded southward.

North of the station, Iceberg Alley (marked by blue outlines) is clear of fastened sea ice but remains filled with decaying ex-fast ice.

Further east, the fast-ice edge moved further southward since 31 December 2022. North of the fast ice, deteriorating first-year sea ice and ex-fast ice is close to the fast-ice edge. Some icebergs are also present.

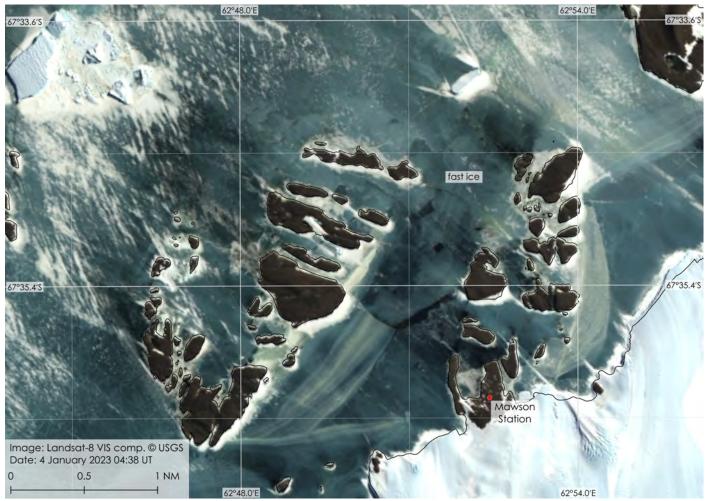
Figure 1 shows high-resolution (15 m horizontal) visible data off Mawson Station.

Figure 1: Landsat-8 visible composite pan-sharpened data acquired 4 January 2023 at 04:38 UT and provided by USGS.

Off station, the surface of the fast ice reveals different freezing stage when the ice was formed last autumn. Some patches offshore start to show signs of thawing through now.

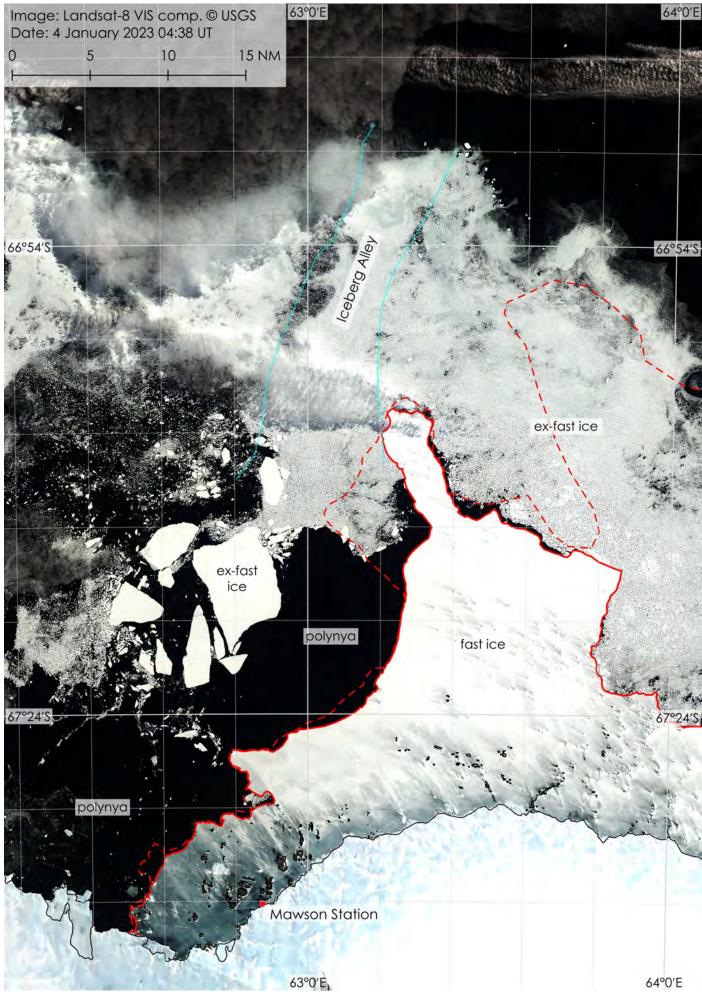
Figure 2 shows a larger-scale overview north of the station. The general ice conditions have not changed significantly since our last Mawson Station Ice Bulletin.

West of the station, fast ice has broken off along roughly 20 nautical miles nearshore, and the polynya northwest of the station has expanded towards the shoreline.

North of the station, Iceberg Alley (marked by blue outlines) is clear of fastened sea ice but remains filled with decaying ex-fast ice.

Further east, the fast-ice edge moved further southward since 31 December 2022. North of the fast ice, deteriorating first-year sea ice and ex-fast ice is drifting close to the fast-ice edge. Some icebergs are also present.

Figure 2: Landsat-8 visible composite pan-sharpened data acquired 4 January 2023 at 04:38 UT and provided by USGS.

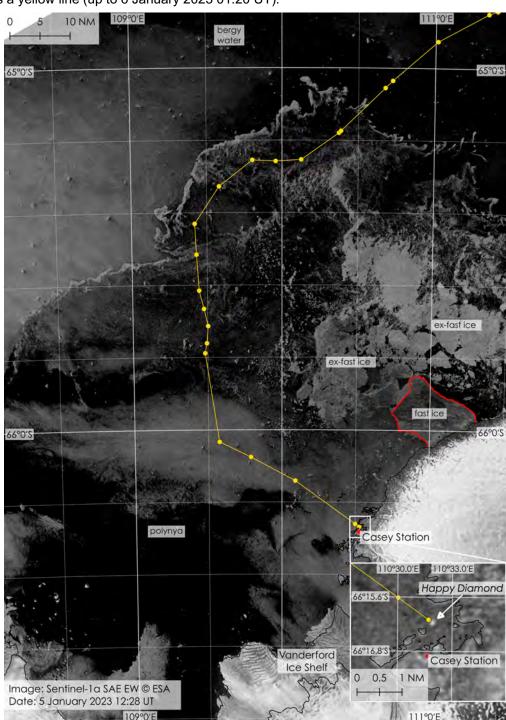
Figure 1 shows SAR data of the Casey Station region. The fast-ice edge is included as a red line. The cruise track of MV *Happy Diamond* is shown as a yellow line (up to 6 January 2023 01:20 UT).

In the vicinity of Casey Station, only minimal fast ice remains in sheltered bays. Further north, some fast ice remains off the western flank of Law Dome. It is breaking up and releasing ex-fast ice floes north- and westward.

Figure 1: Sentinel-1a SAR EW data acquired 5 January 2023 at 12:28 UT and provided by ESA.

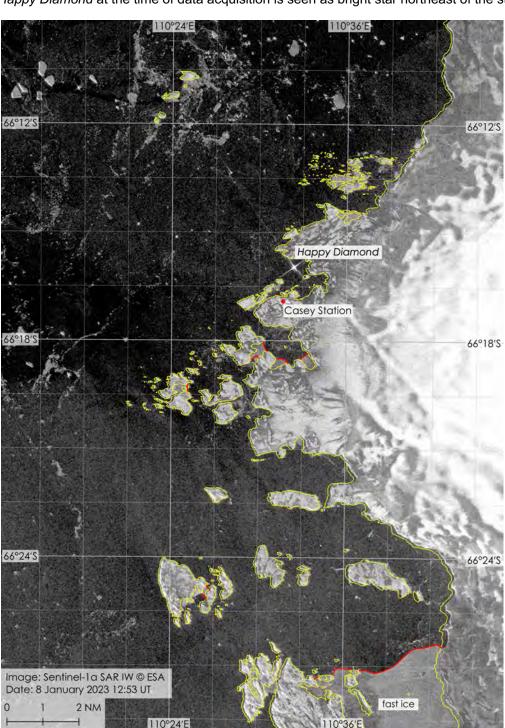
Figure 1 shows SAR data of the Casey Station region. The fast-ice edge is included as a red line. The position of MV *Happy Diamond* at the time of data acquisition is seen as bright star northeast of the station.

In the vicinity of Casey Station, minimal fast ice remains in sheltered bays.

Further north (outside of Figure 1), some fast ice remains off the western flank of Law Dome. It is breaking up and releasing ex-fast ice floes north- and westward.

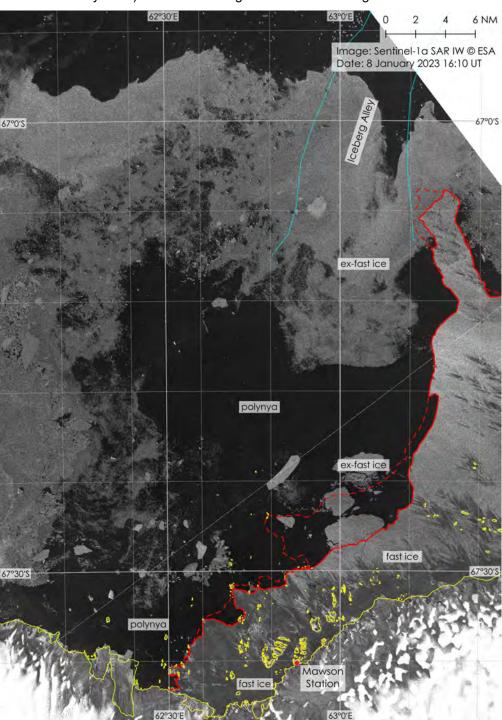
Figure 1 shows high-resolution SAR data off Mawson Station. The fast-ice edge is marked with a red line (dashed red line for 4 January 2023). A thin white diagonal line is a stitching artefact where two consecutive scenes join.

North of the station, Iceberg Alley (marked by blue outlines) is clear of fastened sea ice but remains filled with decaying ex-fast ice.

Between the alley and the station, fast ice continues to break up.

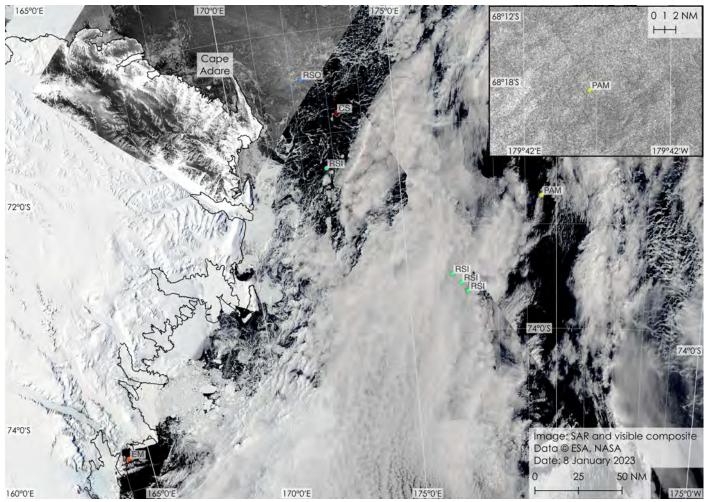
Figure 1 shows a composite of visible and SAR data of the north-western Ross Sea. RV *Tangaroa* cruise TAN2302 mooring locations are marked by coloured dots.

Figure 1: AQUA MODIS VIS data acquired 8 January 2023 at 04:44 UT and provided by NASA; north-western overlay: Sentinel-1a SAR IW data acquired 8 January 2023 at 16:01 UT and provided by PolarView. upper right inset: Sentinel-1a SAR EW data acquired 8 January 2023 at 07:56 UT and provided by PolarView.

The inset shows that the 'PAM' mooring at 68°20'S is covered by drifting sea ice, but this pack ice is melting, drifting freely and dispersing. Similar conditions are present at all other mooring locations except for the southernmost ('EM' in Terra Nova Bay), which is free of sea ice. While the bay is free of sea ice, it is still surrounded high concentration of first-year pack ice (see Figure 2).

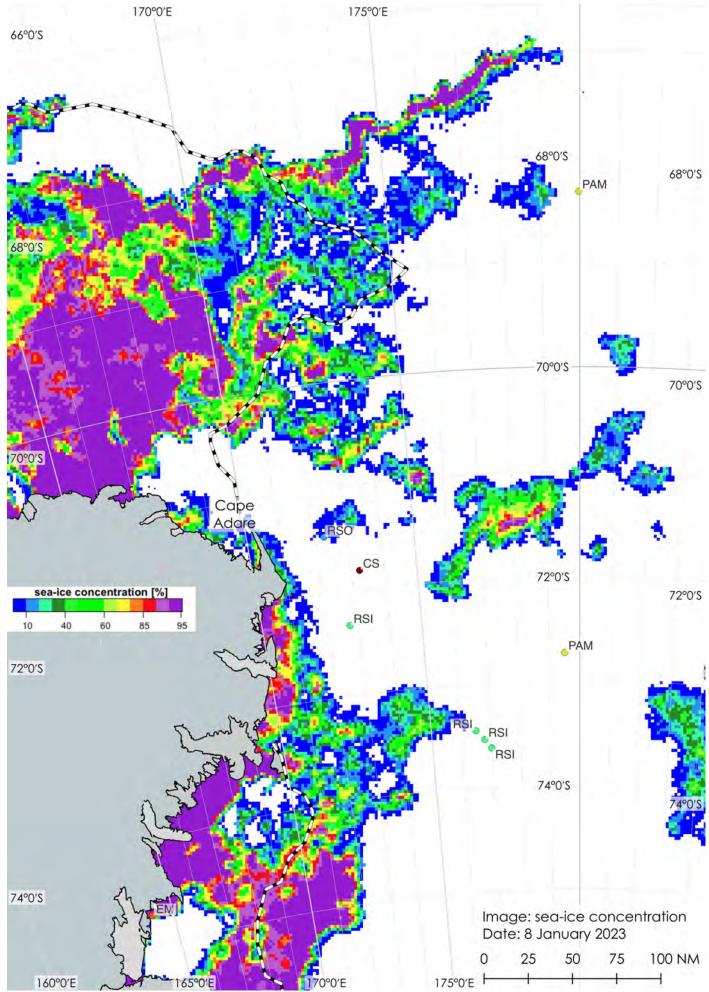
While all but one ('RSO' off Cape Adare) mooring locations appear to be 'ice free', the low concentration of sea ice that is obvious in the SAR data is below the detection limit of the passive microwave instrument (and processing algorithm) that is the source of the concentration chart.

Figure 2: Sea-ice concentration data acquired 8 January 2023 and provided by ICDC, Uni. Hamburg.

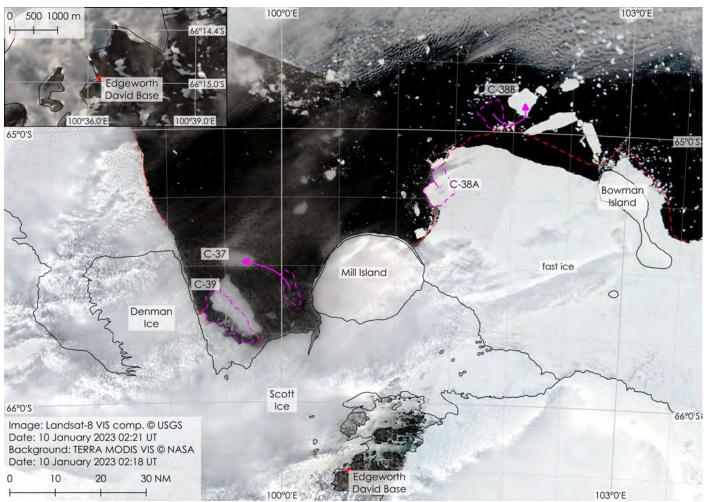
Figure 1 shows a composite of visible data around Mill Island west of Casey Station. Fast-ice edge and large iceberg positions are marked by a dashed red line and dashed pink shapes, respectively, for 20 December 2022.

Figure 1: TERRA MODIS VIS data acquired 10 January 2023 at 02:18 UT and provided by NASA; overlay of Landsat-8 visible composite pan-sharpened data acquired 10 January 2023 at 02:21 UT and provided by USGS.

A polynya remains present north and west of the island and a bit further northeast.

Further north, sea ice is melting the sea-ice concentration is below January average conditions.

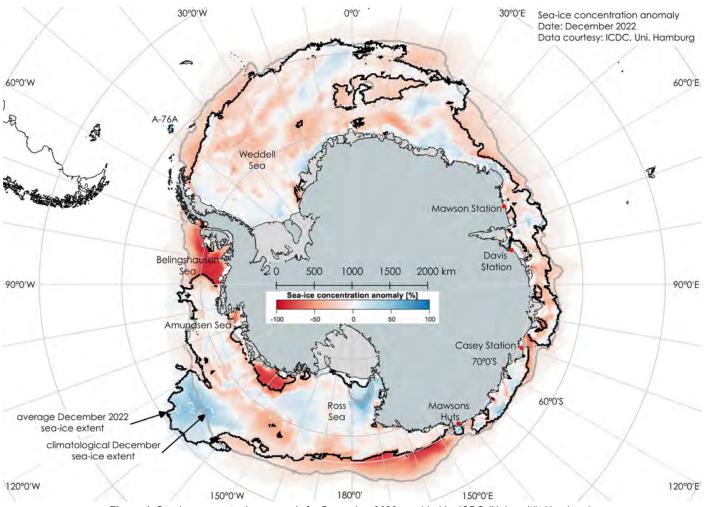
Figure 1 shows the pan-Antarctic sea-ice concentration anomaly based on passive microwave remote sensing data.

Figure 1: Sea-ice concentration anomaly for December 2022 provided by ICDC (Universität Hamburg).

Pan-Antarctic sea-ice conditions continue to be overall low with trends from November 2022 accelerated.

Northeast of the northern tip of the Antarctic Peninsula, an isolated apparent positive anomaly is caused by the drift of large iceberg A-76A, which is north (outside) of the sea-ice zone and drifting further northward into the southern South Atlantic.

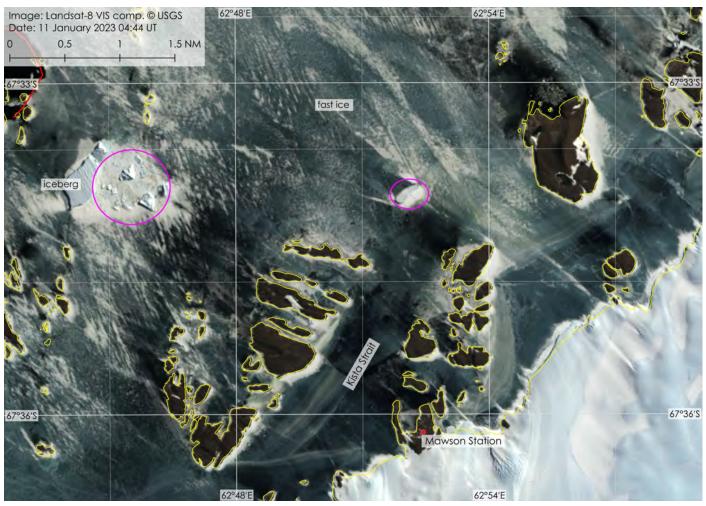
Figure 1 shows high-resolution visible data off Mawson Station. The fast-ice edge is marked with a red line (dashed red line for 8 January 2023).

Figure 1: Landsat-8 visible composite pan-sharpened data acquired 11 January 2023 at 04:44 UT and provided by USGS.

Off station, the fast ice is thinning. Northwest of the station, a large tabular iceberg has been crumbling during winter and a field of glacial debris is marked with a pink circle. North of the station, a singular iceberg is enclosed by fast ice north of Kista Strait (also marked by a pink circle).

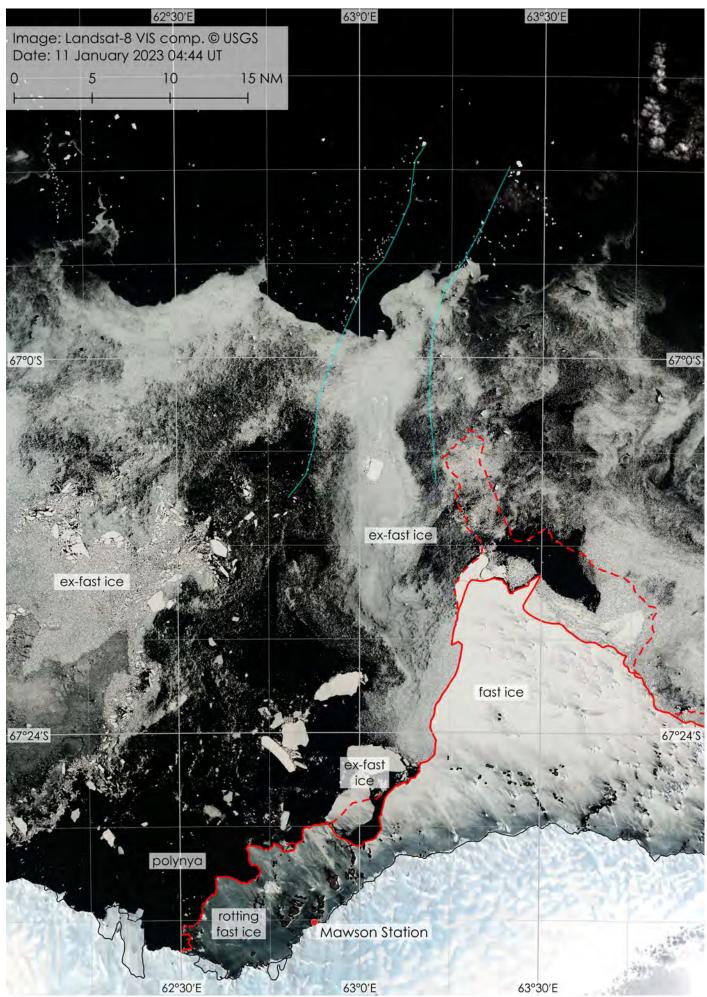
North of the station, Iceberg Alley (marked by blue outlines) is clear of fastened sea ice and the northern part of the alley is now clear of ex-fast ice too, but the southern part of the alley remains filled with decaying ex-fast ice.

The northern sea-ice edge remains generally a couple of nautical miles below (south of) the median sea-ice extent for January (not shown in the figure).

Figure 2: Landsat-8 visible composite pan-sharpened data acquired 11 January 2023 at 04:44 UT and provided by USGS.

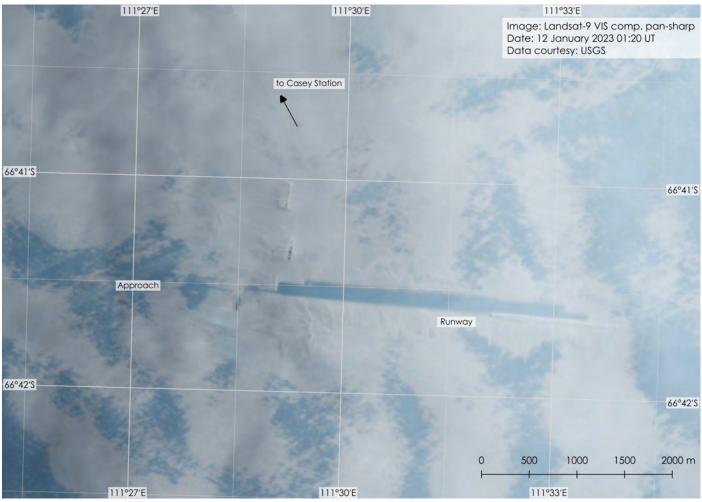
Figure 1 shows high-resolution (15 m horizontal) visible data of Wilkins Aerodrome. Some cloud shadows are visible in the left part of the figure.

Figure 1: Landsat-9 visible composite pan-sharpened data acquired 12 January 2023 at 01:20 UT and provided by USGS.

The ice runway is partly covered by snow. North and south of the runway, snow dunes are left from previous clearing the runway.

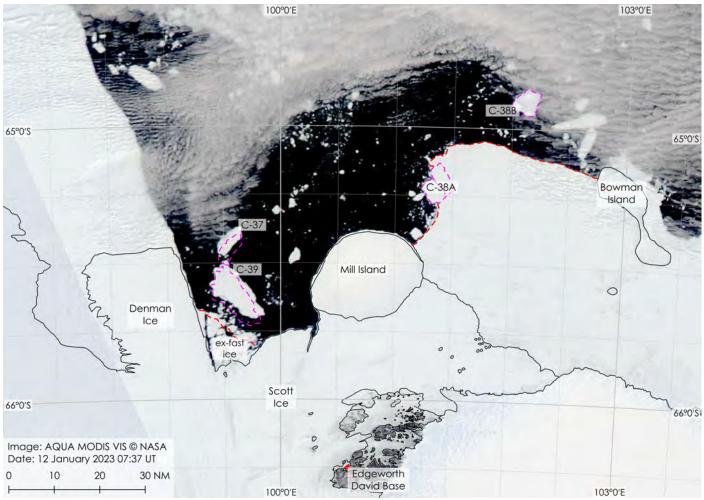
Figure 1 shows visible data around Mill Island west of Casey Station. Fast-ice edge and large iceberg positions are marked by a dashed red line and dashed pink shapes, respectively, for 11 January 2023.

Figure 1: AQUA MODIS VIS data acquired 12 January 2023 at 07:37 UT and provided by NASA.

A polynya remains present north and west of the island and a bit further northeast.

Further north, sea ice is melting the sea-ice concentration remains below January average conditions.

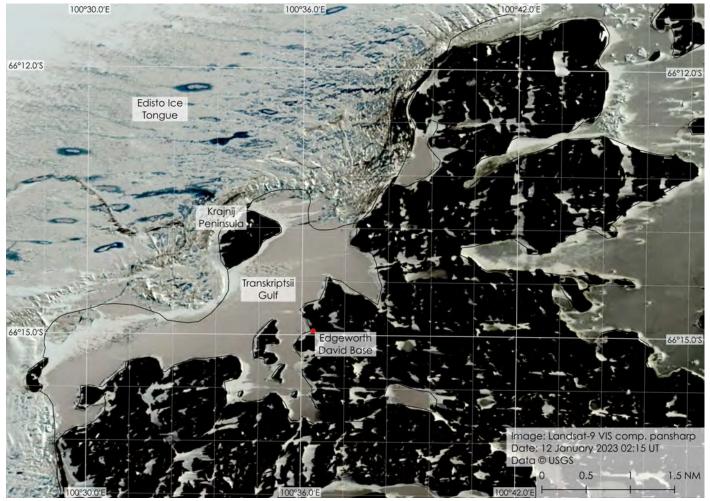
Figure 2: Landsat-9 visible composite pan-sharpened data acquired 12 January 2023 at 02:15 UT and provided by USGS.

Figure 2 shows high-resolution (15 m horizontal) visible data around Edgeworth-David Base in the south-western part of the Bunger Hills.

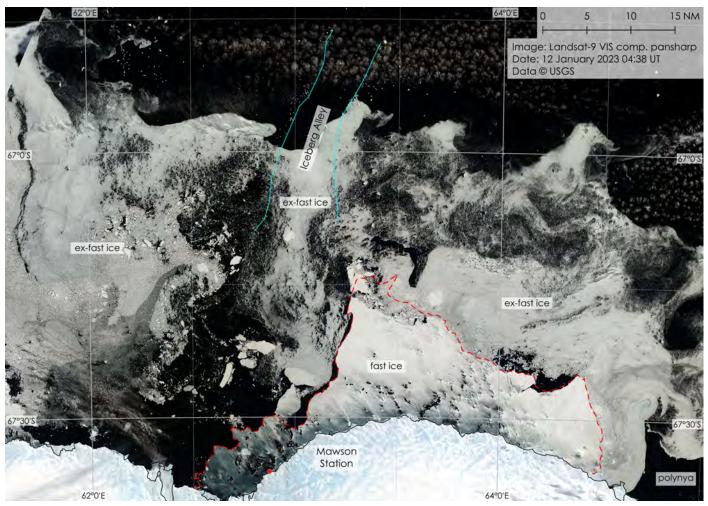
Figure 1: Landsat-9 visible composite pan-sharpened data acquired 12 January 2023 at 04:38 UT and provided by USGS.

Figure 1 shows high-resolution (15 m horizontal) visible data off Mawson Station. The fast-ice edge is marked with a dashed red line for 11 January 2023.

North of the station, Iceberg Alley (marked by blue outlines) is clear of fastened sea ice and the northern part of the alley is now largely clear of ex-fast ice too, but the southern part of the alley remains filled with decaying ex-fast ice.

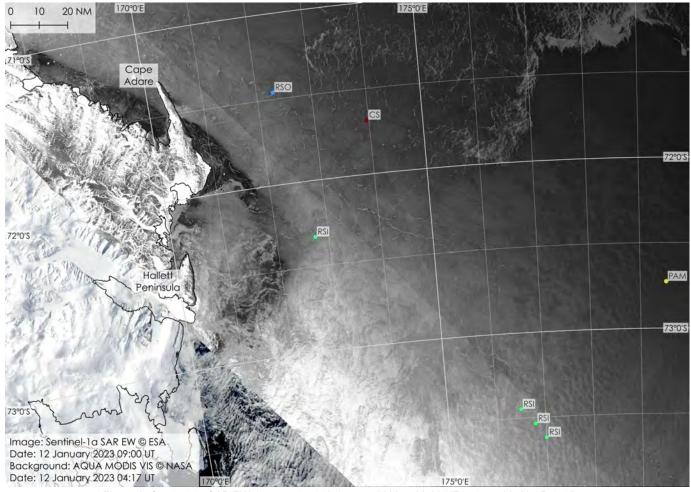
Figure 2: Sentinel-1a SAR EW data acquired 12 January 2023 at 09:00 UT and provided by PolarView; background: AQUA MODIS VIS data acquired 12 January 2023 at 04:17 UT and provided by NASA.

Figure 2 shows a composite of visible and SAR data of the north-western Ross Sea. All mooring locations are affected by minimal sea ice that is drifting freely, melting and dispersing. Nearshore, higher concentration of sea ice remains present, but it is decaying as well and drifting in strips and patches.

While Terra Nova Bay is largely free of drifting sea ice it is however, surrounded by a ring of first-year pack ice from the tip of the Drygalksi Ice Tongue northward. This pack ice is also decaying but consists still of partly large floes.

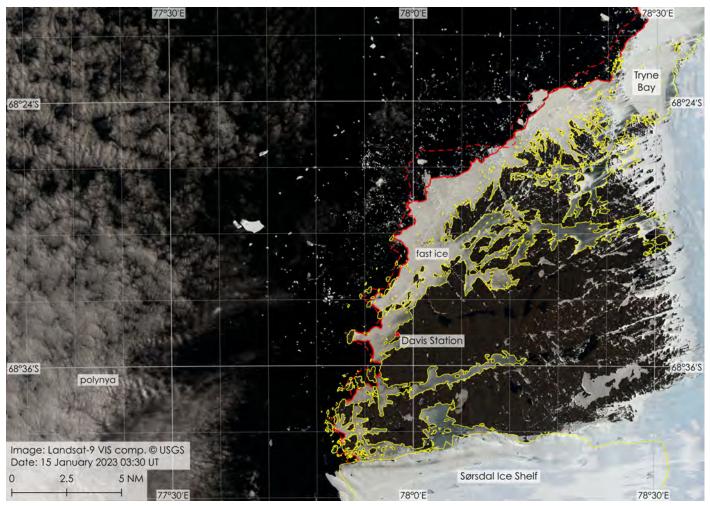
Figure 1: Landsat-9 visible composite pan-sharpened data acquired 15 January 2023 at 03:30 UT and provided by USGS.

Figure 1 shows high-resolution (15 m horizontal) visible data off Davis Station. The fast-ice edge is marked by a red line (dashed red line for on 22 December 2022).

Off station, fast ice remains currently largely stable and roughly 1 nautical mile offshore. Further along the off the hills, fast ice continues to retreat towards the shore.

Most icebergs offshore are grounded but some are drifting with decaying ex-fast ice floes.

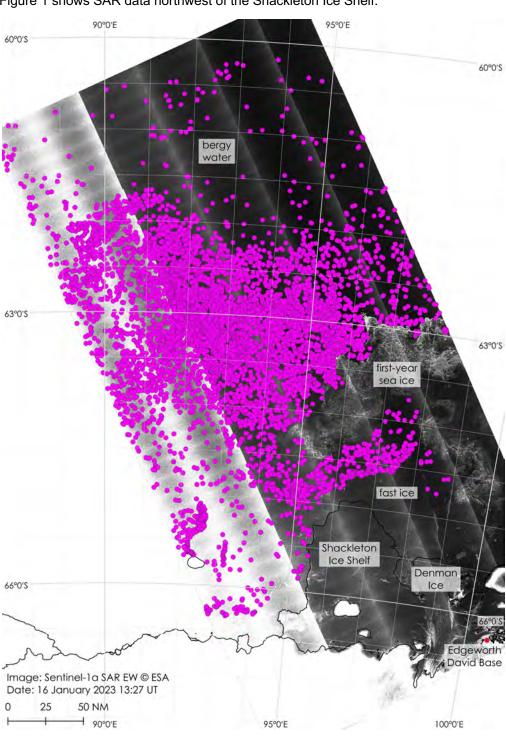
The scene has been analysed for iceberg presence and more than 5500 features have been marked by pink dots outside of the sea-ice zone of the region.

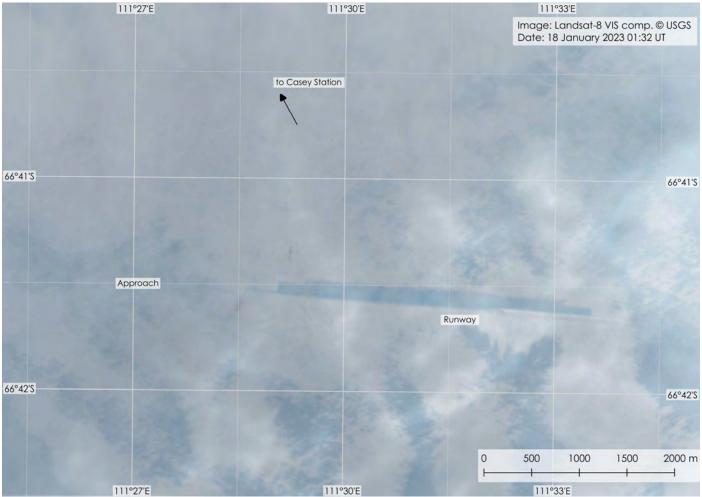
Figure 1: Landsat-8 visible composite pan-sharpened data acquired 18 January 2023 at 01:32 UT and provided by USGS.

Figure 1 shows high-resolution (15 m horizontal) visible data of Wilkins Aerodrome. The scene is slightly obscured by clouds.

The ice runway is partly covered by snow. North and south of the runway, snow dunes are left from previous clearing the runway.

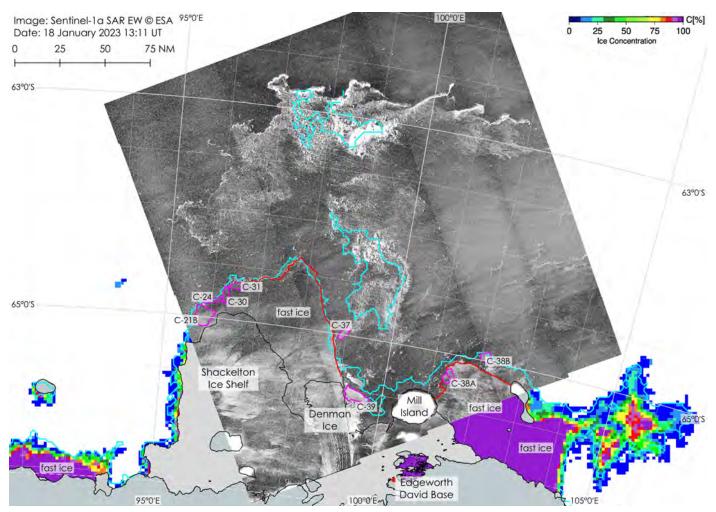
Figure 1: Sentinel-1a SAR EW data (cross-polarised Intensity) acquired 18 January 2023 at 13:11 UT and provided by ESA; background of sea-ice concentration data acquired 18 January 2023 and provided by ICDC, University Hamburg.

Figure 1 shows SAR data north of the Shackleton Ice Shelf. The fast-ice edge is included as a red line. The sea-ice edge based on passive microwave data is shown by the light-blue line.

The passive microwave sea-ice edge (and concentration) is underestimating the extent of sea ice in the region. Most of the sea ice is decaying first-year sea ice but some ex-fast ice is present as well.

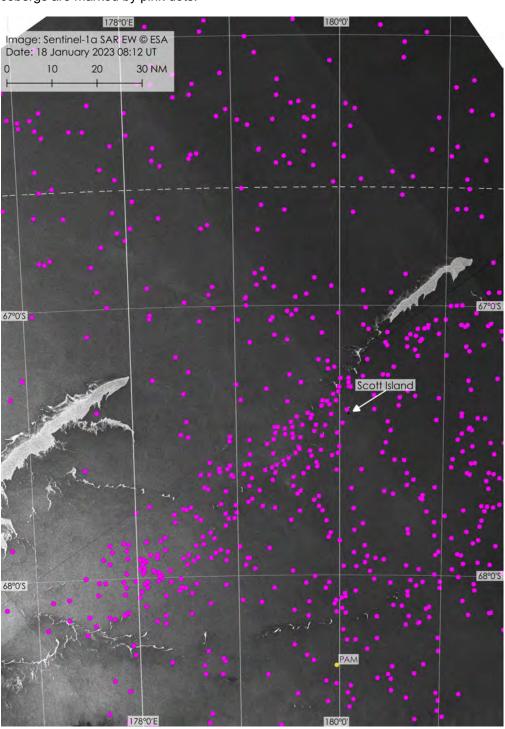
Figure 1: Sentinel-1a SAR EW data acquired 18 January 2023 at 08:12 UT and provided by PolarView.

Figure 1 shows SAR data of the north-western Ross Sea. The SAR data haven been analysed for iceberg presence, icebergs are marked by pink dots.

The 'PAM' mooring south of Scott Island (67°22'S and 179°54'W) is currently not affected by sea ice however, a spit-like pack ice feature originating from first-year sea ice further west is stretching eastward and reaching across 180° north of that mooring location.
