Ice Bulletins for the Antarctic Shipping Season 2022 – 2023

Prepared by Dr Jan L Lieser

Antarctic Meteorology Section — Bureau of Meteorology

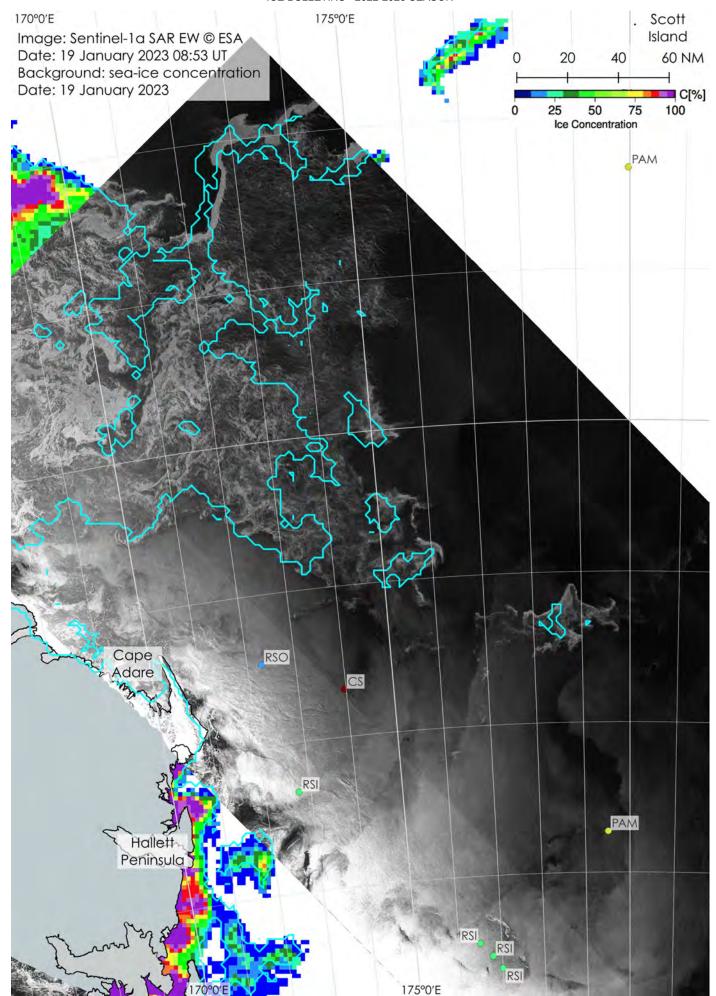
Figure 2: Sentinel-1a SAR EW data acquired 19 January 2023 at 08:53 UT and provided by PolarView; background of sea-ice concentration data acquired 19 January 2023 and provided by ICDC, University Hamburg.

Figure 2 shows a composite of sea-ice concentration and SAR data of the north-western Ross Sea. Additionally, the sea-ice edge based on passive microwave data is included as a light-blue line.

All marked mooring locations are affected only by minimal sea ice that is drifting freely, melting and dispersing. However, higher concentration of sea ice remains present nearshore, but it is decaying as well and drifting in strips and patches.

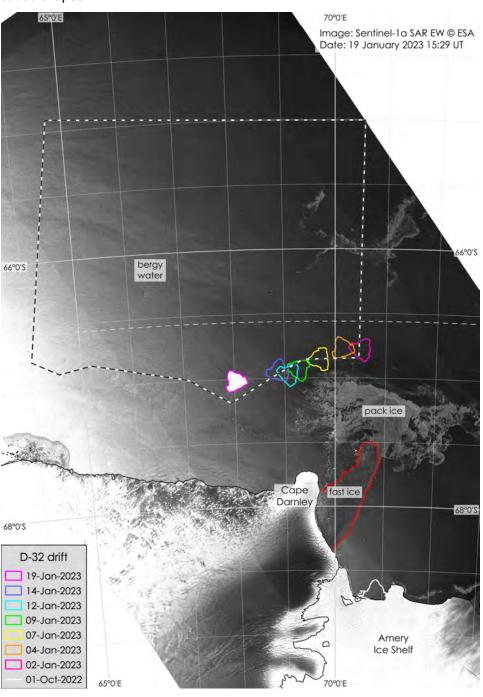
Figure 1 shows SAR data off Cape Darnley. The black/white outline marks the proposed survey area of RV *Investigator* voyage IN2023-V01.

The fast-ice edge is marked by a red outline. The drift of iceberg D-32 during January 2023 is indicated by colour-coded shapes.

Since calving off the Amery Ice Shelf in October 2022 (the white outline at the western edge of the shelf front), the iceberg has drifted northward and off the continental shelf. Since late-December 2022, it has turned westward and is expected to continue its drift westward roughly along the shelf break.

Off Cape Darnley, fast ice continues to break up. Pack ice is present as far north as 65°30'S but it is generally decaying.

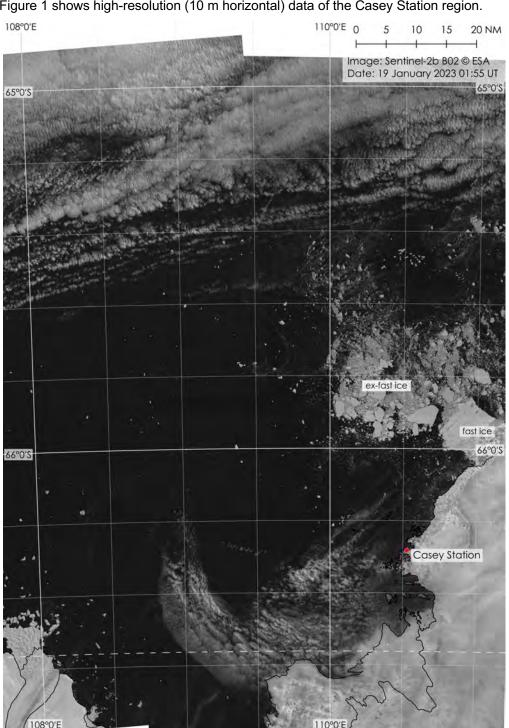
Figure 1 shows high-resolution (10 m horizontal) data of the Casey Station region.

In the vicinity of Casey Station, minimal fast ice remains in sheltered bays.

Further north, some fast ice remains off the western flank of Law Dome. It is breaking up and releasing ex-fast ice floes north- and westward.

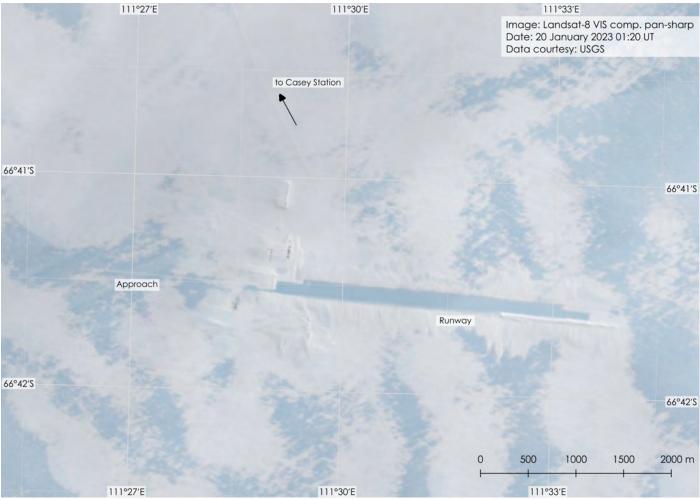
Figure 1: Landsat-8 visible composite pan-sharpened data acquired 20 January 2023 at 01:20 UT and provided by USGS.

Figure 1 shows high-resolution (15 m horizontal) visible data of Wilkins Aerodrome.

The ice runway is partly covered by snow. North and south of the runway, snow dunes are left from previous clearing the runway.

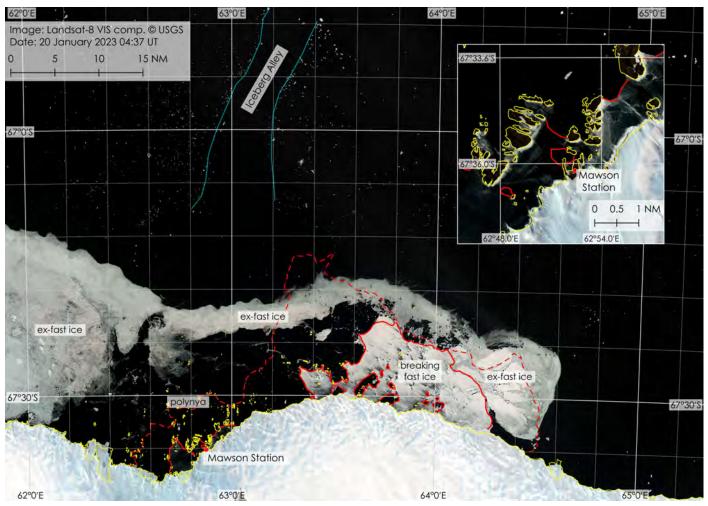
Figure 1: Landsat-8 visible composite pan-sharpened data acquired 20 January 2023 at 04:37 UT and provided by USGS.

Figure 1 shows high-resolution (15 m horizontal) visible data off Mawson Station. The fast-ice edge is marked with a red line (dashed red line for 11 January 2023).

North of the station, Iceberg Alley (marked by blue outlines) is now clear of any sea ice.

Off station, fast ice continues to break up, east of the station partly in vast sheets. A band of decaying ex-fast ice is separating the polynya off station with the open ocean to the north. This band originates from the rapidly breaking up fast ice east of Mawson Station.

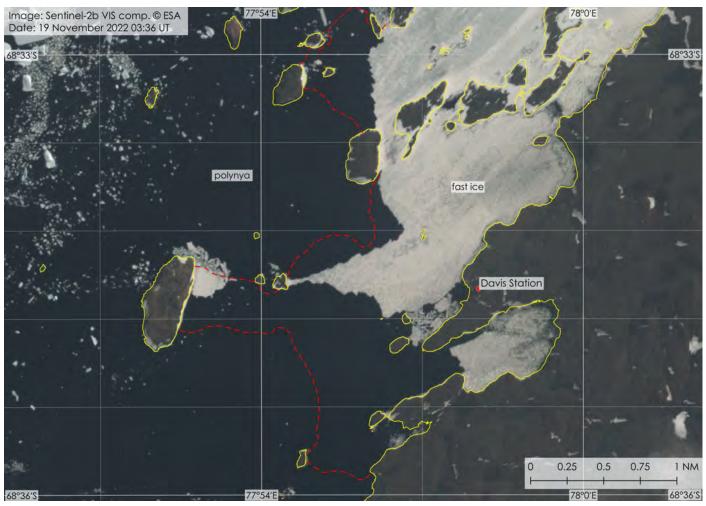
Figure 1: Sentinel-2b visible composite data acquired 19 January 2023 at 03:36 UT and provided by ESA.

Figure 1 shows high-resolution (10 m horizontal) visible data off Davis Station. The fast-ice edge is marked by a dashed red line for on 15 January 2023.

Off station, fast ice is breaking up but some fast ice remains between pin-points (islands offshore). Further along the off the hills, fast ice continues to retreat towards the shore (see Figure 2).

Most icebergs offshore are grounded but some are drifting with decaying ex-fast ice floes.

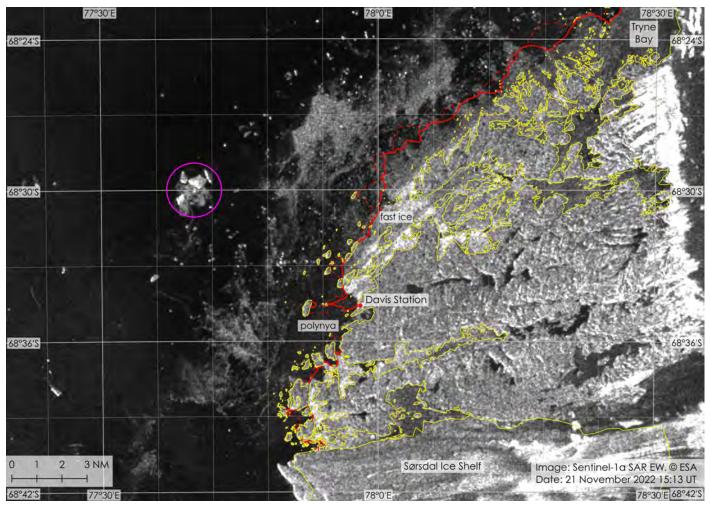
Figure 1: Sentinel-1a SAR EW data acquired 21 January 2023 at 15:13 UT and provided by PolarView.

Figure 1 shows SAR data off Davis Station. The fast-ice edge is marked by a dashed red line for on 15 January 2023 and with a solid red line for 19 January 2023.

Off station, fast ice continues breaking up, but some fast ice remains between pinpoints (islands offshore). Further along off the hills, fast ice continues to retreat towards the shore and ex-fast ice is generally drifting south-westward.

Most icebergs offshore are grounded but some are drifting with decaying ex-fast ice floes. An area of glacial debris is marked by a pink circle where a group of grounded icebergs is breaking up.

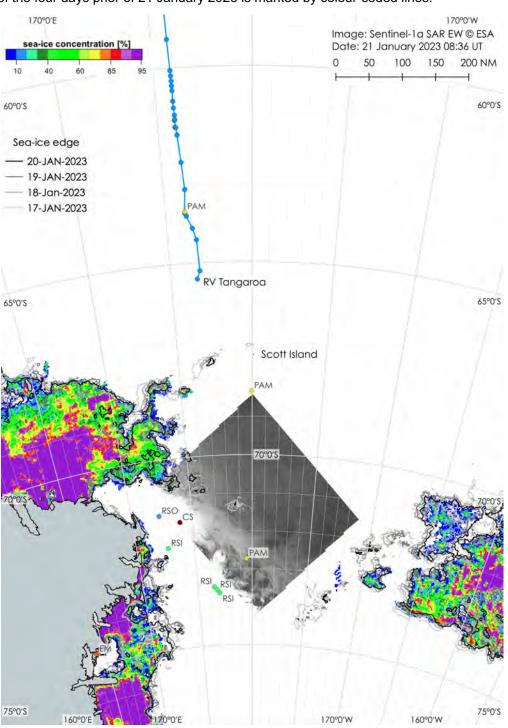
Mooring locations of RV *Tangaroa* cruise TAN2302 are marked by coloured dots in the figure of this Bulletin. The cruise track of the vessel up until 22 January 2023 00:00 UT is marked by a blue line.

Figure 1 shows a composite of SAR and sea-ice concentration data of the north-western Ross Sea. The sea-ice edge of the four days prior of 21 January 2023 is marked by colour-coded lines.

The 'PAM' mooring south of Scott Island is currently not affected by sea ice however, a spit-like pack ice feature originating from first-year sea ice further west is stretching eastward and was reaching across 180° north of that mooring location. The sea ice of this feature is decaying and dispersing.

Nearshore, higher concentration of sea ice remains present, but it is decaying as well and drifting in strips and patches.

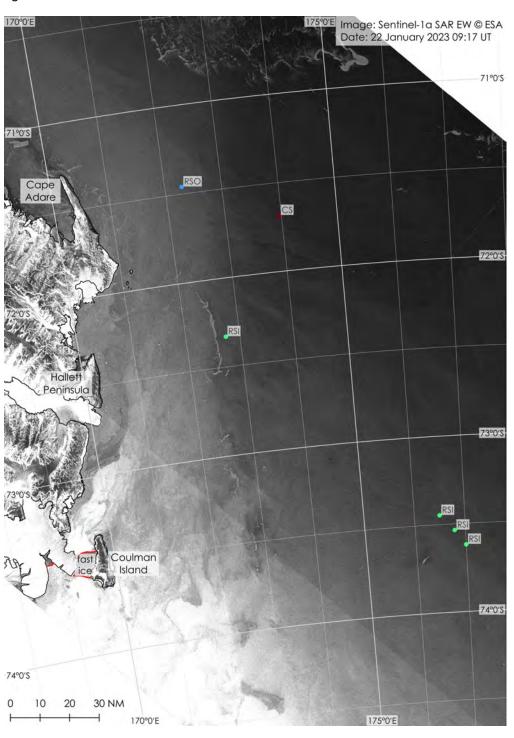
Mooring locations of RV *Tangaroa* cruise TAN2302 are marked by coloured dots in the figure of this Bulletin. Figure 1 shows SAR data of the north-western Ross Sea.

Nearshore between Cape Adare and Coulman Island, sea ice appears to be flushed out and is decaying in strips and patches further offshore.

North and northeast of Cape Adare, decaying pack ice remains present between roughly 68°0'S and 71°0'S.

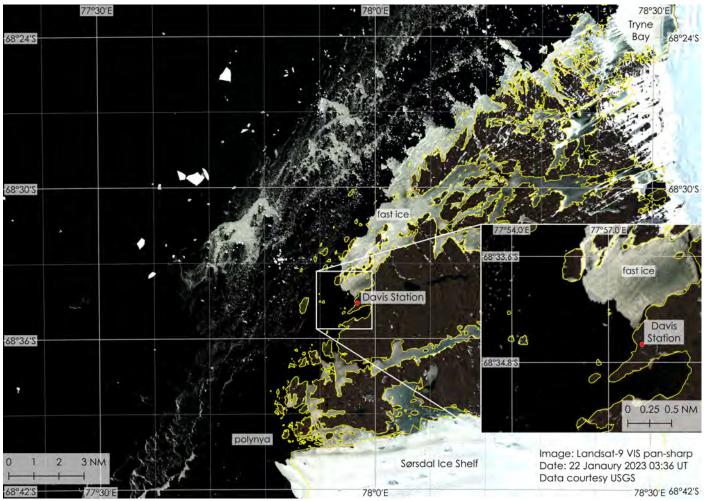
Figure 1: Landsat-9 visible composite pan-sharpened data acquired 22 January 2023 at 03:36 UT and provided by USGS.

Figure 1 shows high-resolution (15 m horizontal) visible data off Davis Station.

Off station, fast ice continues breaking up, but some fast ice remains between pinpoints (islands offshore). Further along off the hills, fast ice continues to retreat towards the shore and ex-fast ice is generally drifting south-westward.

Most icebergs offshore are grounded but some are drifting with decaying ex-fast ice floes.

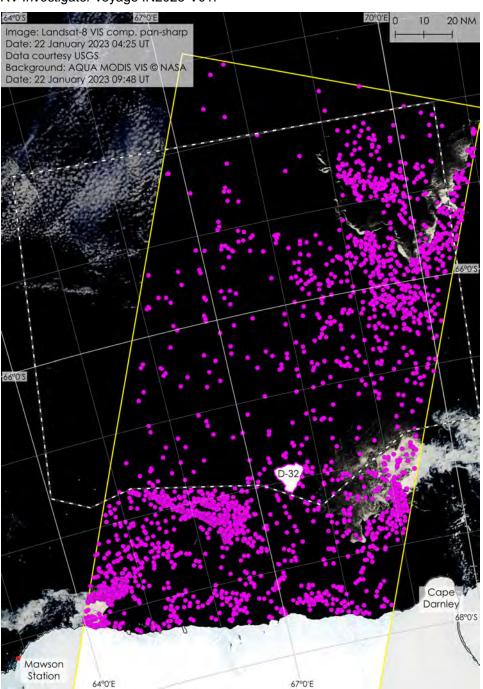
Figure 1 shows visible composite data off Cape Darnley. The black/white outline marks the proposed survey area of RV *Investigator* voyage IN2023-V01.

The high-resolution Landsat-8 data (within the yellow frame) have been analysed for iceberg presence and more than 2300 features have been marked by pink dots.

Large iceberg D-32 continues its westward drift parallel to the continental shelf break.

Pack ice is present in the northeastern and southern part of the proposed survey area, but it is generally decaying and dispersing.

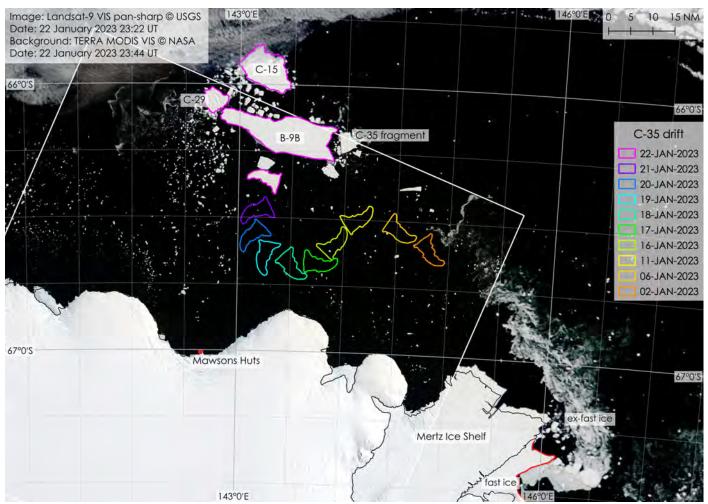
Figure 1: Landsat-9 visible composite pan-sharpened data (marked by a white line) acquired 22 January 2023 at 23:22 UT and provided by USGS; background of TERRA MODIS VIS data acquired 22 January 2023 at 23:44 UT and provided by NASA.

Figure 1 shows visible data north of Mawson's Huts in the southern D'Urville Sea. The drift of iceberg C-35 is marked by colour-coded shapes.

Since iceberg C-35 crossed in front of the Mertz Ice Shelf late last year, it drifted westward and appears to have been caught in an eddy current since 11 January 2023. The iceberg originally calved further southeast off the Ninnis Ice Shelf (outside Figure 1) in late-August 2018.

East of the Mertz Ice Shelf, fast ice is breaking up and deteriorating and generally drifting north-westward towards the group grounded and ungrounded icebergs north of Mawson's Huts/Commonwealth Bay.

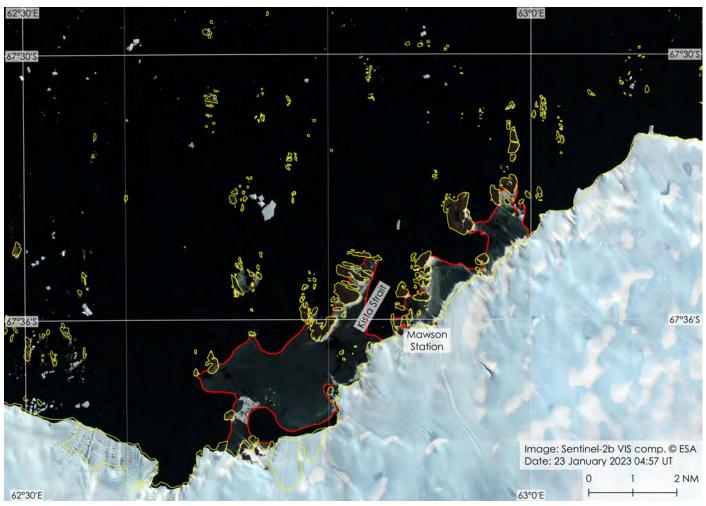
Figure 1: Sentinel-2b visible composite data acquired 23 January 2023 at 04:57 UT and provided by ESA.

Figure 1 shows high-resolution (10 m horizontal) visible data off Mawson Station. The fast-ice edge is marked with a red line.

Off station, fast ice continues to break up. The northern part of Kista Strait is free of fast ice and the remaining fast ice appears unstable.

North of the station, Iceberg Alley (marked by blue outlines) is now clear of any sea ice. A band of decaying ex-fast ice is separating the polynya off station with the open ocean to the north. This band originates from the rapidly disintegrating fast ice east of Mawson Station.

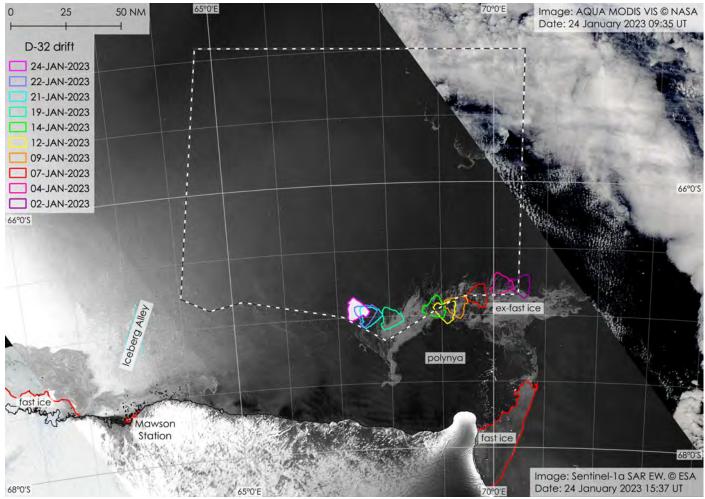
Figure 1 shows SAR data off Cape Darnley. The drift of large iceberg D-32 has been marked by colour-coded shapes. The black/white outline marks the proposed survey area of RV *Investigator* voyage IN2023-V01.

Figure 1: Sentinel-1a SAR EW data acquired 24 January 2023 at 15:37 UT and provided by PolarView; background: AQUA MODIS VIS data acquired 24 January 2023 at 09:35 and provided by NASA.

Large iceberg D-32 continues its westward drift parallel to the continental shelf break.

Pack ice remains present in the north-eastern and southern part of the proposed survey area, but it is generally decaying and dispersing.

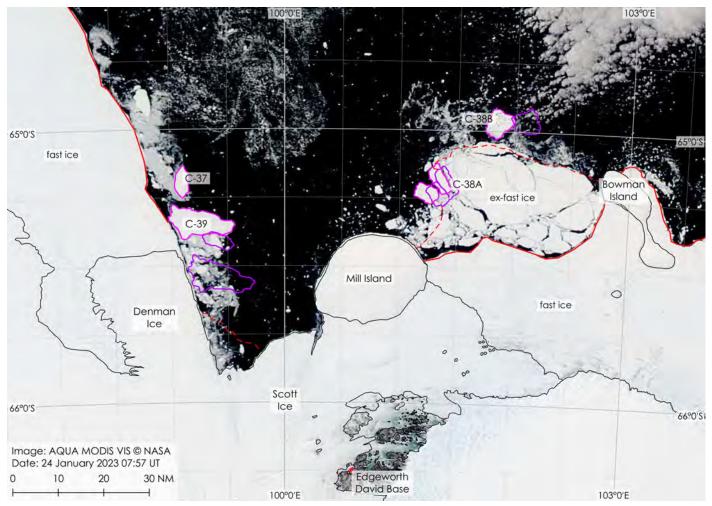
Figure 1 shows visible data around Mill Island. Large icebergs are outlined by pink shapes (purple shapes for the respective icebergs on 18 January 2023).

Figure 1: AQUA MODIS VIS data acquired 24 January 2023 at 07:57 and provided by NASA.

On 20 January 2023, roughly 2400 km² of fast ice have broken up northeast of Mill Island and released large iceberg C-38A, which has subsequently split in two icebergs that are not satisfying the criteria for large icebergs that are tracked specifically anymore.

All large icebergs are now drifting freely in the region. Pack ice and ex-fast ice is deteriorating and breaking up.

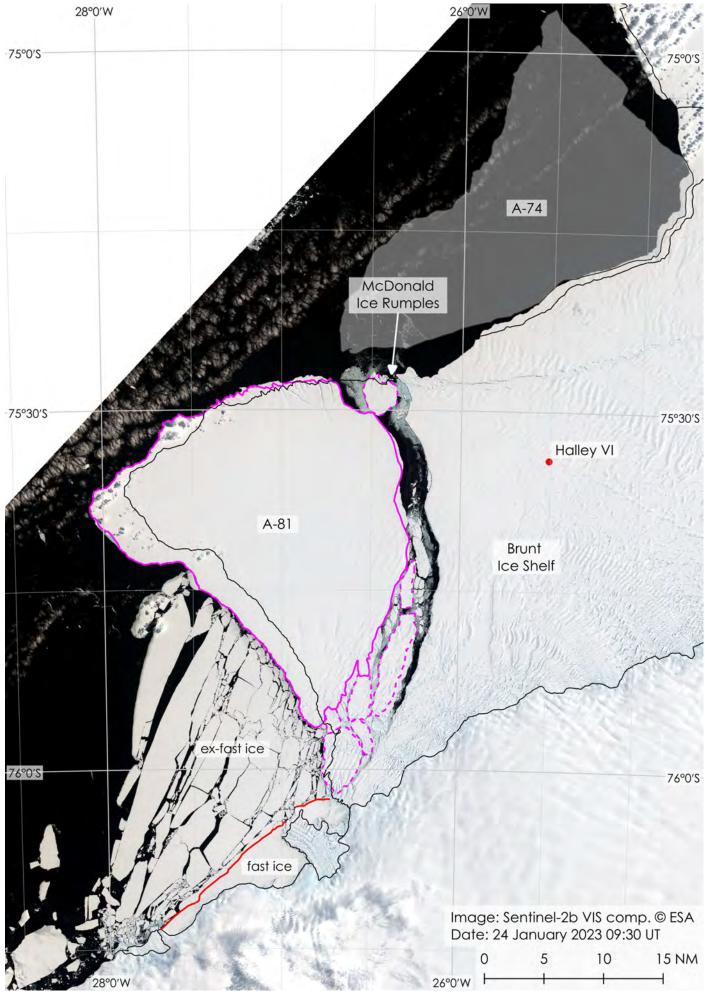
Figure 1: Sentinel-2b visible composite data acquired 24 January 2023 at 09:30 UT and provided by ESA.

On 22 January 2023 during a spring tide, new iceberg A-81 with an area 1550 km² (almost the size of Greater Hobart) has broken off the 150 m thick Brunt Ice Shelf. The iceberg calved off the ice shelf when a fissure known as Chasm-1, which had been developing from the south northward towards the MacDonald Rumples, connected to smaller cracks that developed around the rumples southward.

Also, during the calving, the fast ice that was still present at the southern edge of the ice shelf shattered.

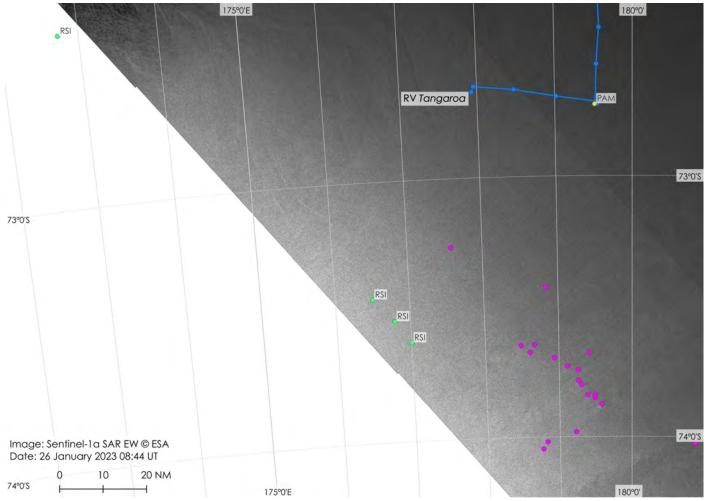
Figure 1 shows SAR data of the north-western Ross Sea. The cruise track of the vessel is indicated by the blue line (up until 26 January 2023 23:00 UT). Freely drifting icebergs are marked by pink dots.

Figure 1: Sentinel-1a SAR EW data acquired 26 January 2023 at 08:44 UT and provided by ESA.

There is minimal drifting sea ice in the north-western part of the scene.

Between Coulman Island and the Borchgrevink Glacier Tongue, fast ice has broken up between the shelf front and the island. Only south from there, some fast ice remains at the coast.

And band of higher concentration pack ice still connects Ross Island (outside of Figure 1) and the coast south of Coulman Island. This band is effectively cutting off Terra Nova Bay, which is otherwise largely free of drifting pack ice. Freely drifting icebergs can be present throughout the entire region shown in the figures.

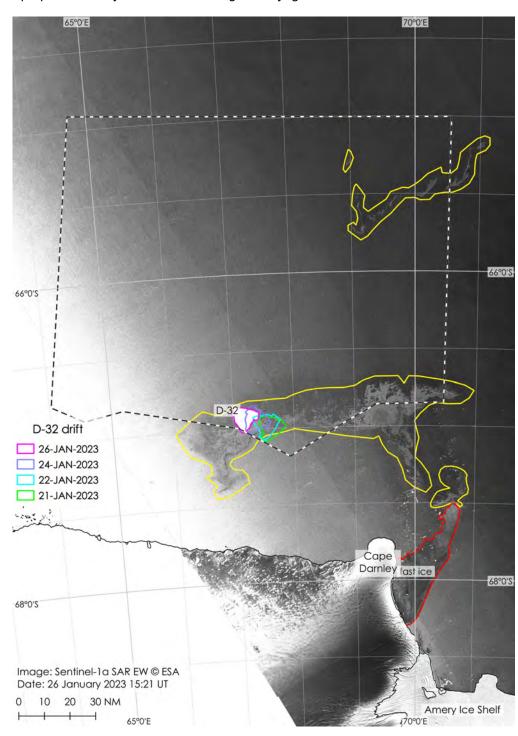
Figure 1: Sentinel-1a SAR EW data acquired 26 January 2023 at 15:21 UT and provided by PolarView.

Pack ice remains present in the north-eastern and southern part of the proposed survey area (outlined by yellow shapes), but it is generally decaying and dispersing.

East off Cape Darnley, fast ice continues to break up and is releasing ex-fast ice floes northward, which are then carried by the predominant current westward.

The largest part of the proposed survey area is free of drifting pack ice but icebergs are present throughout the region.

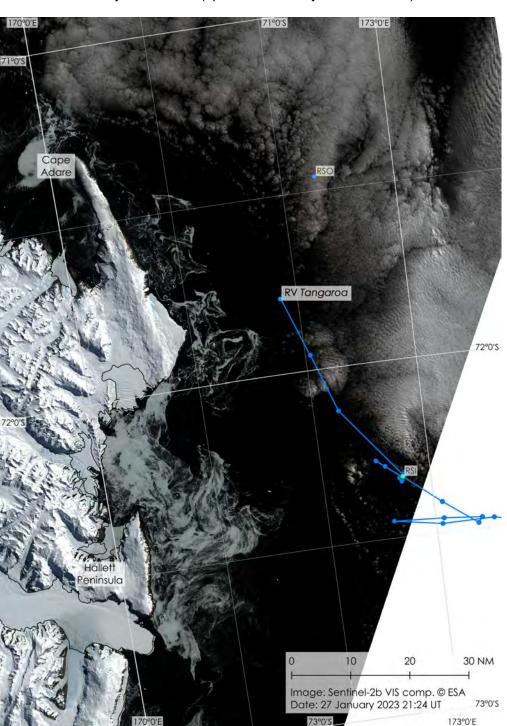
Figure 1 shows high-resolution (10 m horizontal) visible data of the north-western Ross Sea. The cruise track of the vessel is indicated by the blue line (up until 28 January 2023 06:00 UT).

Nearshore between Cape Adare and Hallet Peninsula, sea ice is decaying in strips and patches offshore and drifting generally eastward towards the open sea. Freely drifting icebergs can be present throughout the entire

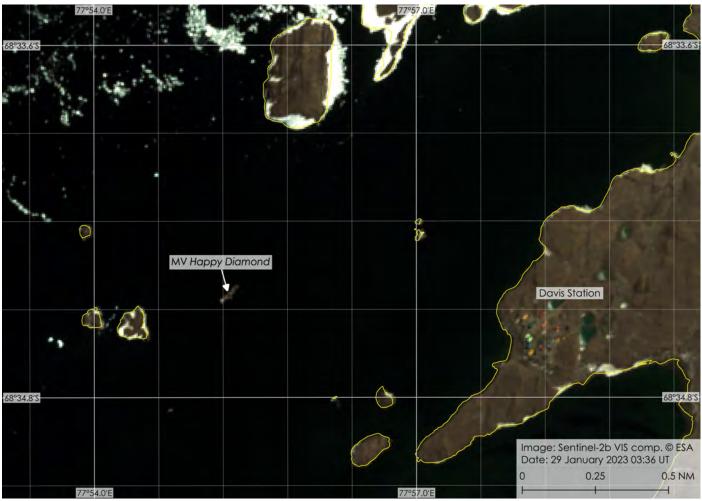
Figure 1 shows high-resolution (10 m horizontal) visible data off Davis Station.

Figure 1: Sentinel-2b visible composite data acquired 29 January 2023 at 03:36 UT and provided by ESA.

Off station, fast ice continues breaking up.

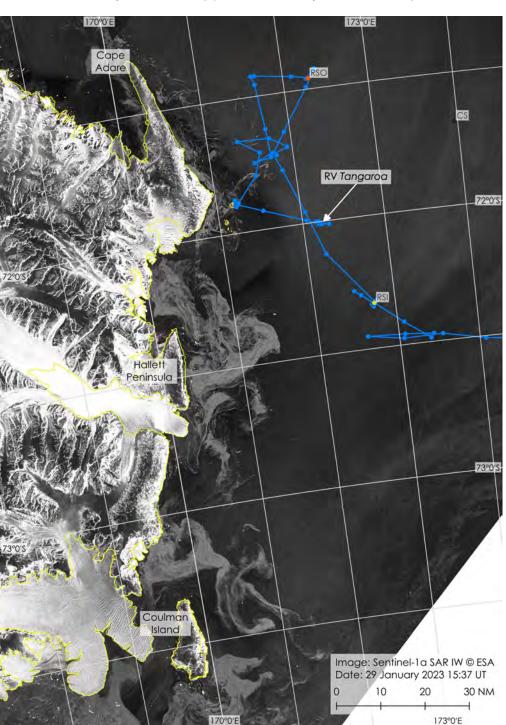
Figure 1 shows high-resolution (15 m horizontal) SAR data of the north-western Ross Sea. The cruise track of the vessel is indicated by the blue line (up until 30 January 2023 01:00 UT).

Nearshore between Cape Adare and Coulman Island, sea ice is decaying in strips and patches offshore and drifting generally eastward towards the open sea.

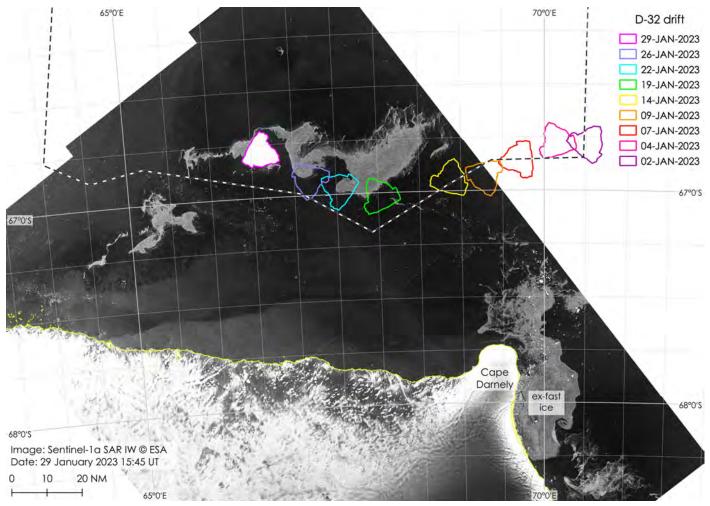
Figure 1 shows high-resolution SAR data off Cape Darnley. The drift of large iceberg D-32 has been marked by colour-coded shapes. The black/white outline marks the proposed survey area of RV *Investigator* voyage IN2023-V01.

Figure 1: Sentinel-1a SAR IW data acquired 29 January 2023 at 15:45 UT and provided by PolarView.

Large iceberg D-32 continues its westward drift parallel to the continental shelf break.

Pack ice remains present in the southern part of the proposed survey area, but it is generally decaying and dispersing.

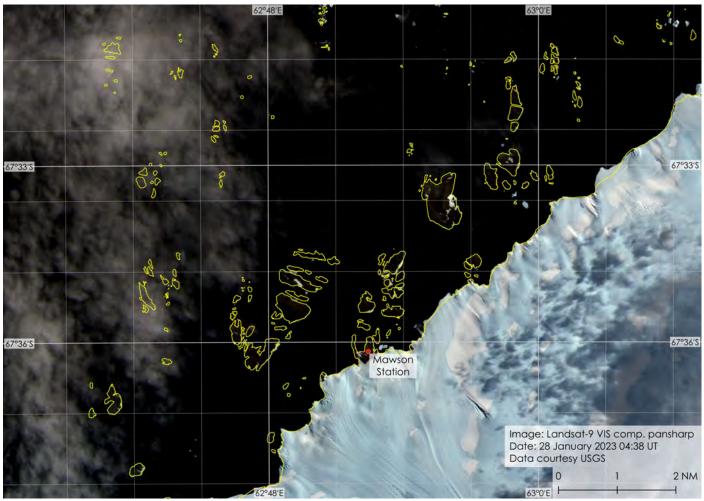
Figure 1 shows high-resolution (15 m horizontal) visible data off Mawson Station.

Figure 1: Landsat-9 visible composite pan-sharpened data acquired 28 January 2023 at 04:38 UT and provided by USGS.

Off station, the last remaining fast ice has broken out. Kista Strait is now free of fast ice.

North of the station, Iceberg Alley is clear of any sea ice. Only remnants of a band of decaying ex-fast ice that was separating the former polynya off station with the open ocean to the north remain west 62°30'E. These remnants continue to rapidly disintegrate. East of Mawson Station, no more fast ice is along Mawson Coast.

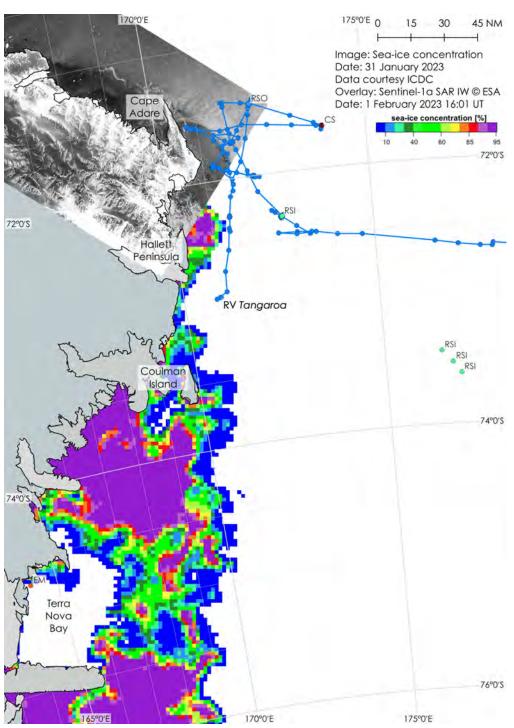
Figure 1 shows sea-ice concentration data of the north-western Ross Sea. The cruise track of the vessel is indicated by the blue line (up until 1 February 2023 22:00 UT).

Nearshore between Cape Adare and Coulman Island, sea ice continues decaying in strips and patches offshore and drifting generally towards the open sea.

Further south, Terra Nova Bay remains surrounded by a band of sea ice, which was recently drifting north-eastward into the Ross Sea.

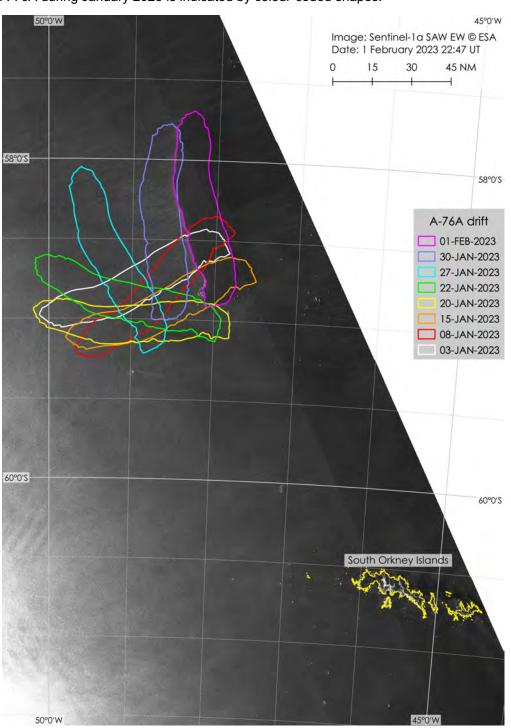
Figure 1 shows SAR data northeast of the Antarctic Peninsula in the north-western Weddell Sea. The drift of iceberg A-76A during January 2023 is indicated by colour-coded shapes.

The iceberg is 320 nautical miles north of the sea-ice edge based on passive microwave data (not shown in the figure) and drifting north of the South Orkney Islands in the Scotia Sea into the southern South Atlantic Ocean.

During January 2023, the iceberg drifted initially a few miles southward before turning 100 degrees clockwise and drifting eastward again.

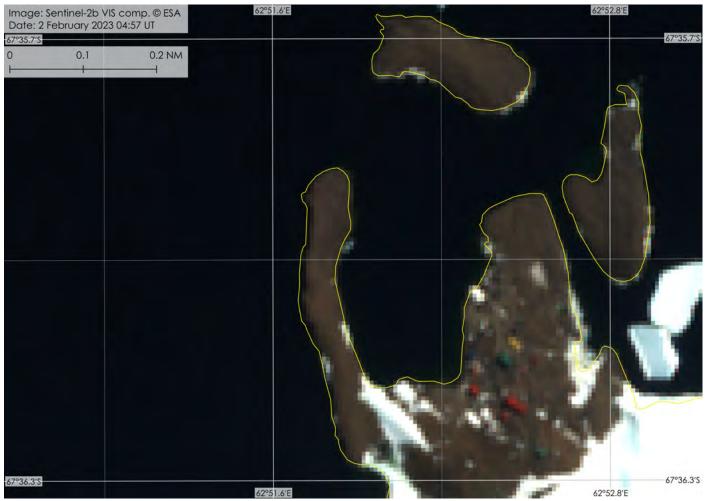
Figure 1 shows high-resolution (10 m horizontal) visible data of Mawson Station.

Figure 1: Sentinel-2b visible composite data acquired 2 February 2023 at 04:57 UT and provided by ESA.

Horseshoe Harbour off station is largely free of sea ice.

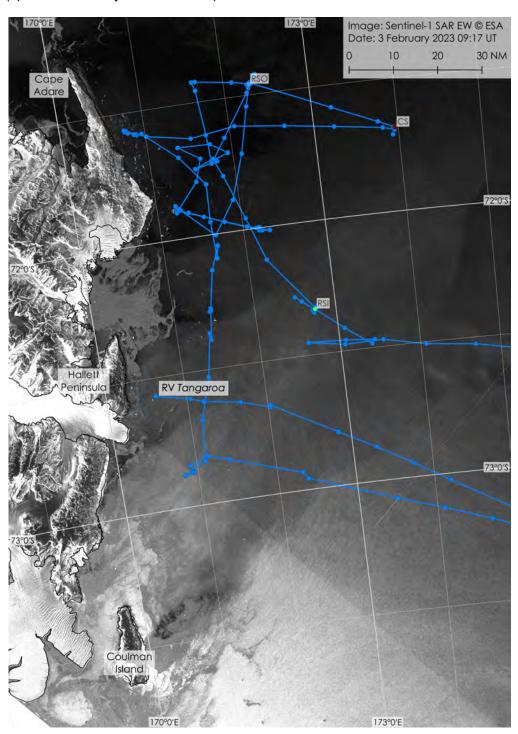
Figure 1 shows SAR data of the north-western Ross Sea. The cruise track of the vessel is indicated by the blue line (up until 3 February 2023 23:00 UT).

Nearshore between Cape Adare and Coulman Island, sea ice continues decaying in strips and patches offshore and is drifting generally northeastward towards the open sea.

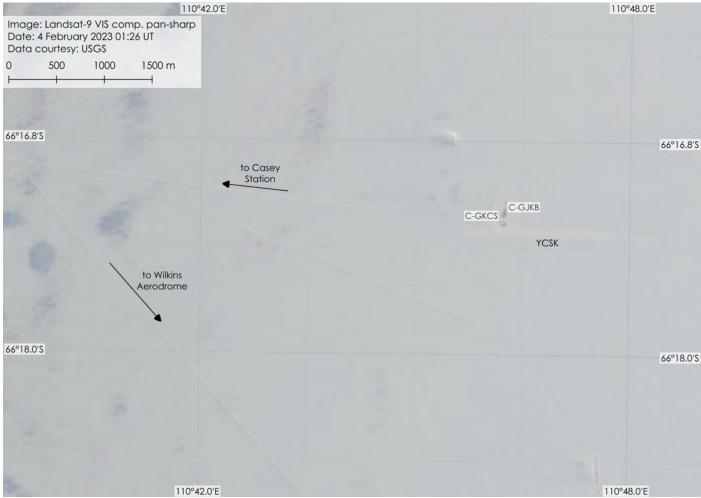
Figure 2 shows a close-up of Casey Skiway (YCSK) with two aircraft currently north of the ice runway.

Figure 2: Landsat-9 visible composite pan-sharpened data acquired 4 February 2023 at 01:26 UT and provided by USGS.

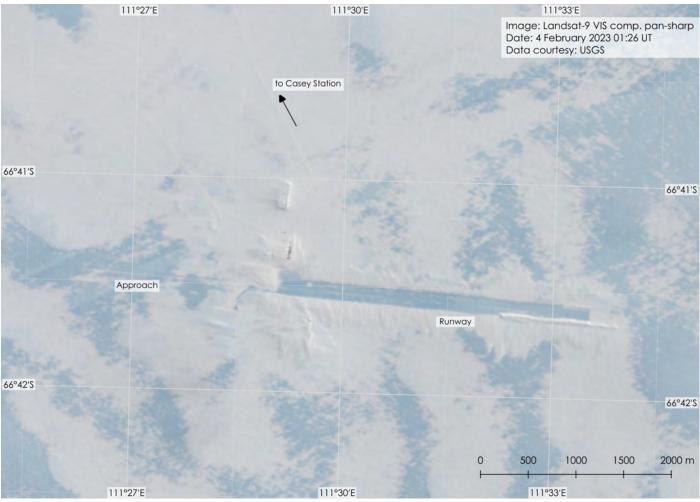
Figure 1 shows high-resolution (15 m horizontal) visible data of Wilkins Aerodrome.

Figure 1: Landsat-9 visible composite pan-sharpened data acquired 4 February 2023 at 01:26 UT and provided by USGS.

The ice runway is partly covered by snow. North and south of the runway, snow dunes are left from previous clearing the runway.

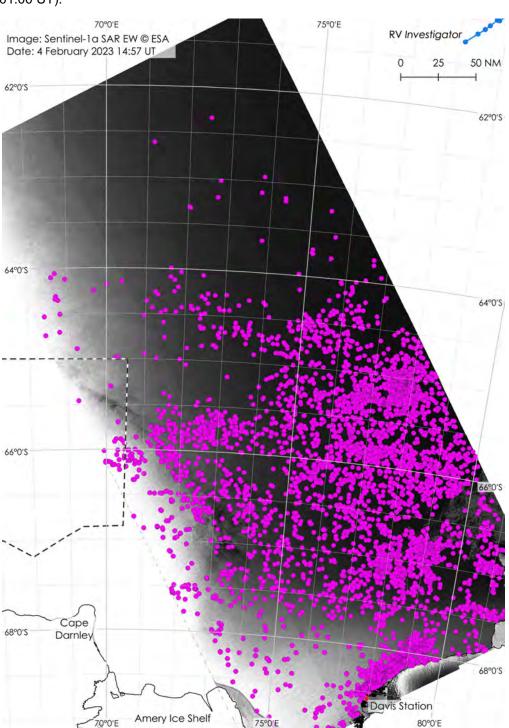
Figure 1 shows SAR data northeast of Cape Darnley. The black/white outline marks the proposed survey area of RV *Investigator* voyage IN2023-V01. The cruise track of the vessel is marked by a blue line (up until 5 February 2023 01:00 UT).

The SAR data has been analysed for iceberg presence and more than 5000 features have been marked by pink dots.

The largest part of the proposed survey area is free of drifting pack ice, but icebergs are present throughout the region.

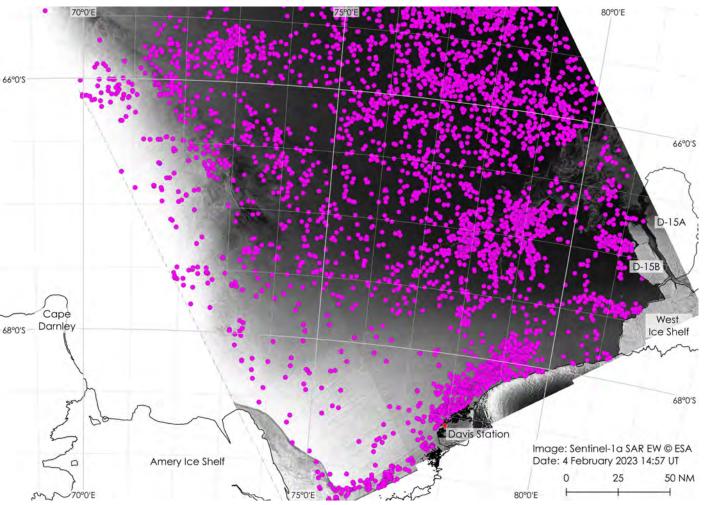
Figure 1 shows SAR data off the Amery Ice Shelf.

Figure 1: Sentinel-1a SAR EW data acquired 4 February 2023 at 14:57 UT and provided by ESA.

The SAR data has been analysed for iceberg presence and more than 4000 features have been marked by pink dots.

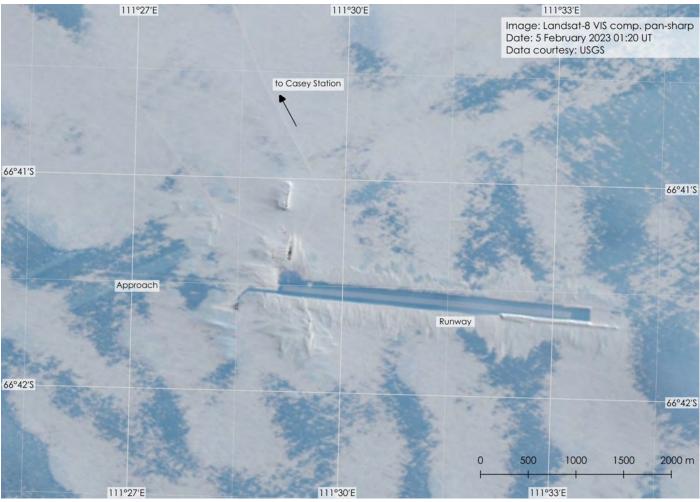
Figure 1 shows high-resolution (15 m horizontal) visible data of Wilkins Aerodrome.

Figure 1: Landsat-8 visible composite pan-sharpened data acquired 5 February 2023 at 01:20 UT and provided by USGS.

The ice runway is partly covered by snow. North and south of the runway, snow dunes are left from previous clearing the runway.

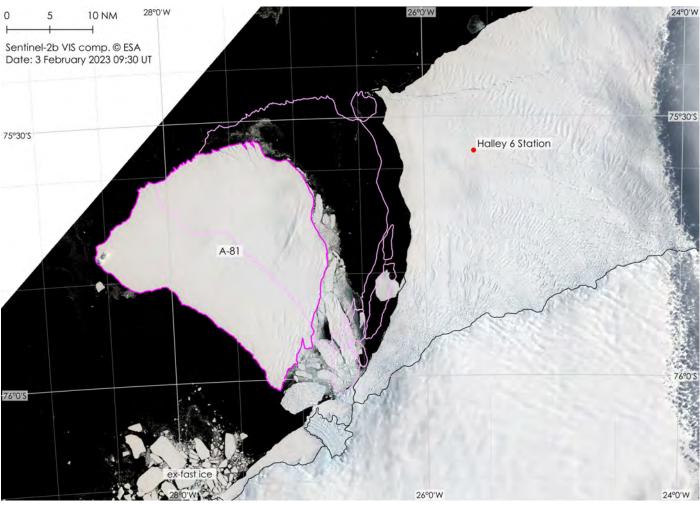
Figure 1 shows high-resolution (10 m horizontal) visible data of the Brunt Ice Shelf.

Figure 1: Sentinel-2b visible composite data acquired 3 February 2023 at 09:30 UT and provided by ESA.

Two weeks ago, iceberg A-81 calved off the Brunt Ice Shelf. The position on 24 January 2023 (two days after the break) is indicated by the light pink shape (including some of the surrounding new icebergs that were created at the same time).

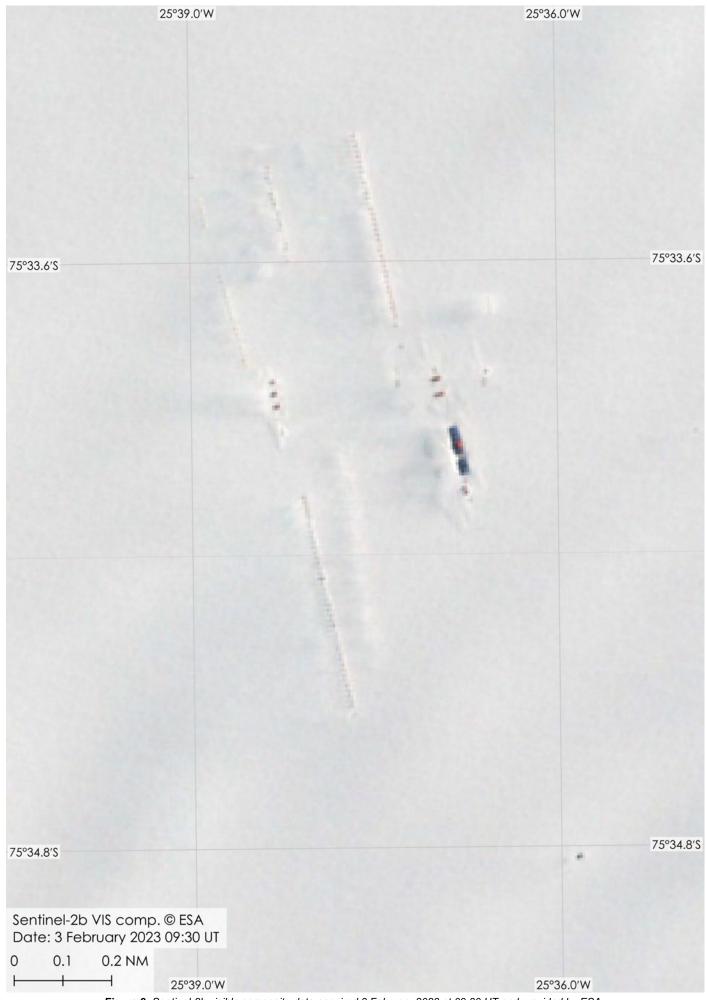
Figure 2: Sentinel-2b visible composite data acquired 3 February 2023 at 09:30 UT and provided by ESA.

Figure 2 shows a close-up view of the British Halley 6 Station. The blue modules of the station can be clearly seen with the largest, red module, the Robert Falcon Scott Living Module in the middle.

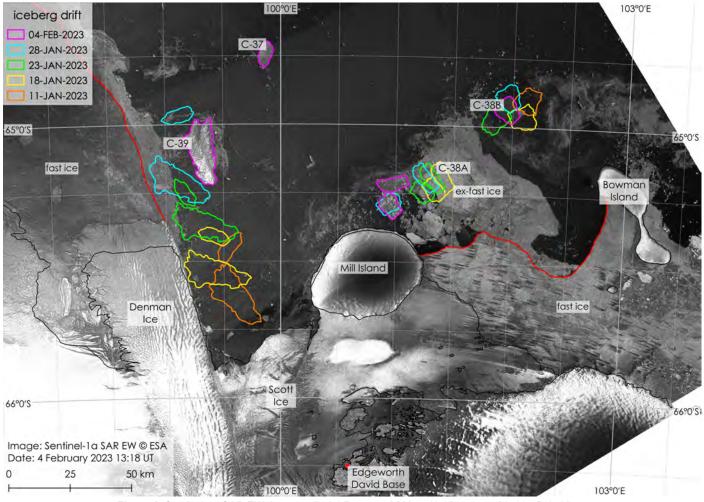
Figure 1: Sentinel-1a SAR EW data acquired 4 February 2023 at 13:18 and provided by PolarView.

Figure 1 shows SAR data around Mill Island. The drift of large icebergs is outlined by colour-coded shapes.

All large icebergs are drifting freely in the region. On 20 January, iceberg C-38A split into two icebergs that are not satisfying the criteria for large icebergs that are tracked specifically anymore however, they are still clearly discernible. Likewise, iceberg C-37 has also shrunk to a size below the tracked-iceberg criterion.

The melange of pack ice and ex-fast ice continues deteriorating and more fast ice is breaking up in the region.

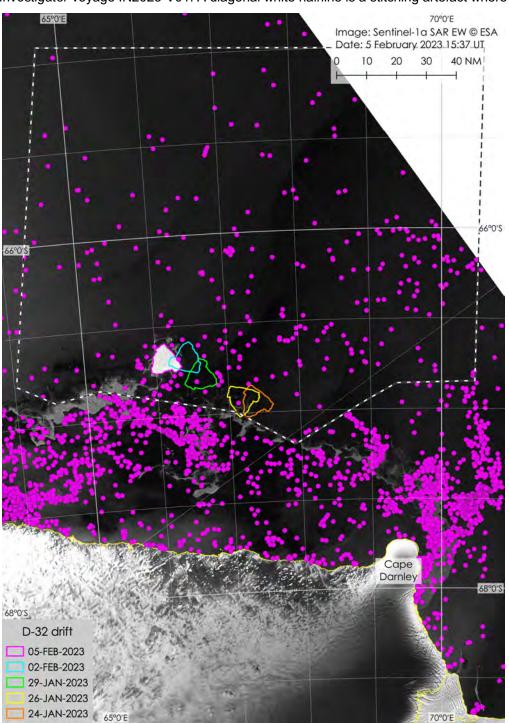
Figure 1 shows SAR data northeast of Cape Darnley. The black/white outline marks the proposed survey area of RV *Investigator* voyage IN2023-V01. A diagonal white hairline is a stitching artefact where two consecutive scenes join.

The SAR data has been analysed for iceberg presence and more than 2500 features have been marked by pink dots.

Iceberg D-32 continues its drift westward roughly along the continental shelf break.

The largest part of the proposed survey area is free of drifting pack ice, but icebergs are present throughout the region. The survey area is only affected by decaying ex-fast ice in the south-western part.

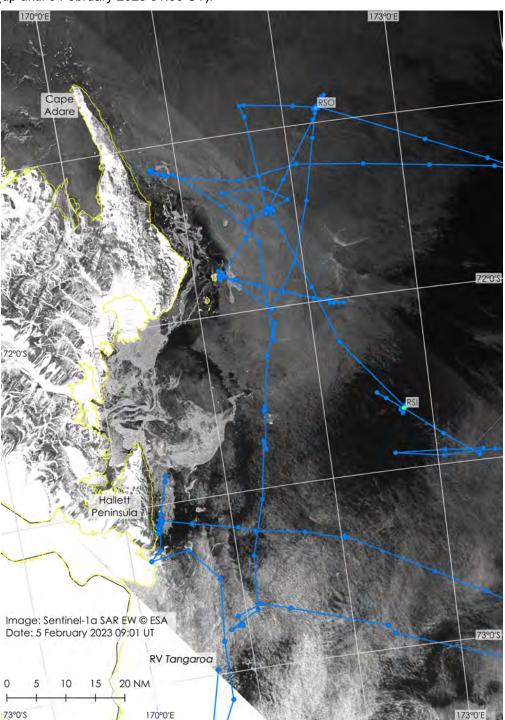
Figure 1: Sentinel-1 SAR EW data acquired 5 February 2023 at 09:01 UT and provided by PolarView.

Figure 1 shows SAR data of the north-western Ross Sea. The cruise track of the vessel is indicated by the blue line (up until 6 February 2023 01:00 UT).

Nearshore between Cape Adare and Hallett Peninsula, sea ice continues decaying in strips and patches offshore and is drifting generally eastward towards the open sea.

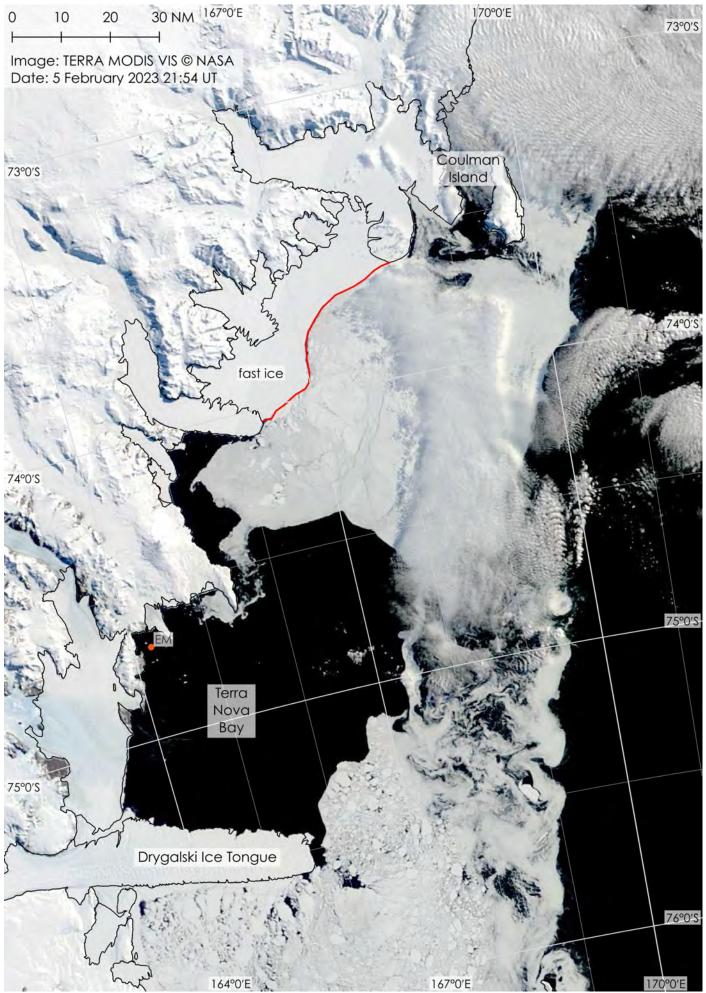
Figure 2: TERRA MODIS VIS data acquired 5 February 2023 at 21:54 UT and provided by NASA.

Further south, Terra Nova Bay (see Figure 2) remains surrounded by a band of higher concentration sea ice, which is thinning.

The thinning of the abovementioned band of pack ice, which is drifting northward around Drygalski Ice Tongue, is evident in the figure. The lowest ice concentration is found just north of 75°0'S.

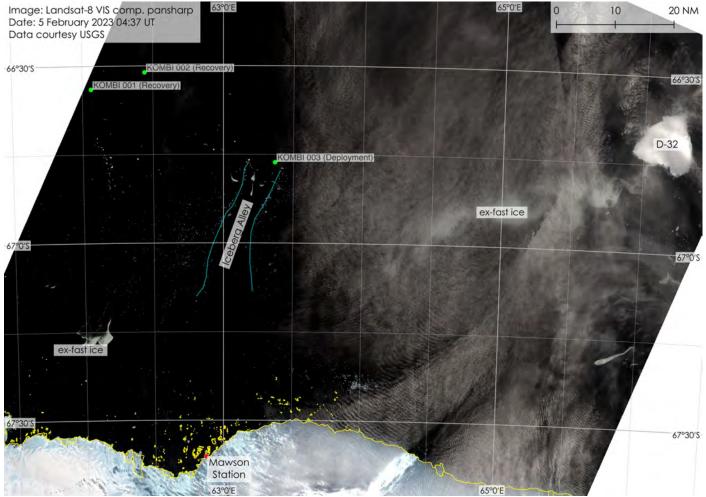
Figure 2: Landsat-8 visible composite pan-sharpened data acquired 5 February 2023 at 04:37 UT and provided by USGS.

North of the station, Iceberg Alley (marked by blue outlines in Figure 2) is mostly clear of any sea ice except for some strips and patches of decaying ex-fast ice in the northern part of the alley.

Iceberg D-32 and remnants of decaying ex-fast ice are further east along Mawson Coast, but the ex-fast ice continues to rapidly decay.

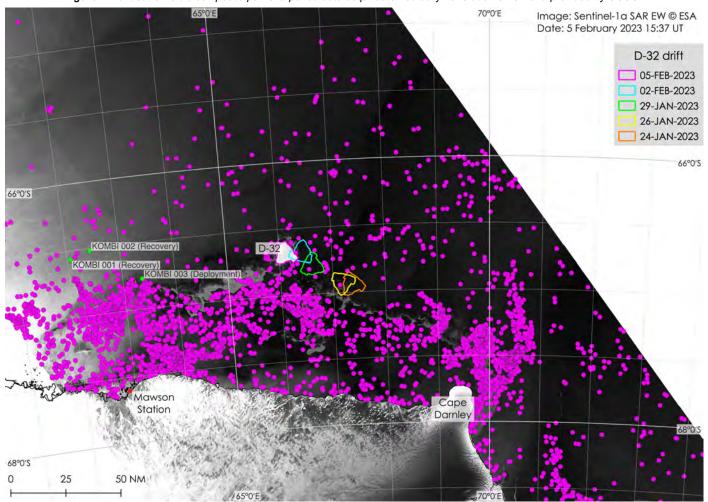
Figure 3: Sentinel-1a SAR EW data acquired 5 February 2023 at 15:37 UT and provided by PolarView.

Figure 3 shows SAR data northwest of Cape Darnley. The recent drift of large iceberg D-32 is indicated by colour-coded shapes. Additionally, the SAR data have been analysed for iceberg presence and more than 4000 features have been marked by pink dots.

Decaying ex-fast ice originates from fast ice that was attached off the eastern side of Cape Darnley. This patch of fast ice shattered recently, and the pack-ice floes are drifting now westward.

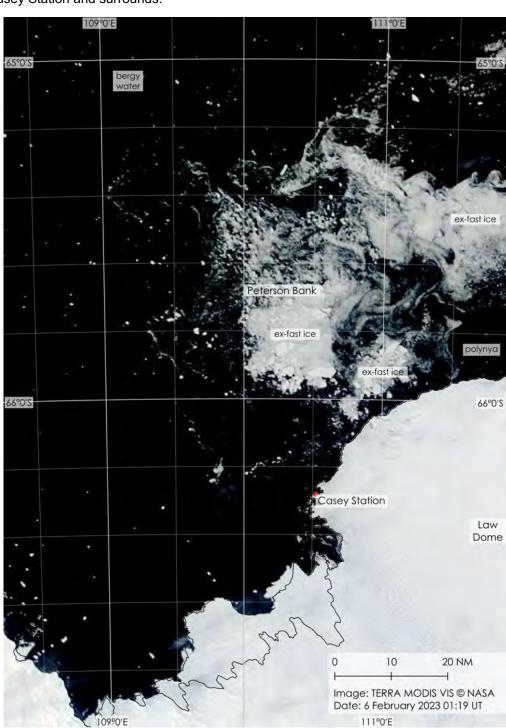
Figure 1: TERRA MODIS visible composite data acquired 6 February 2023 at 01:19 UT and provided by NASA.

On 3 February 2023, the last remaining fast ice that was attached to the north-western flank of Law Dome has shattered.

North of Law Dome, ex-fast ice continues now breaking up and melting. Some icebergs remain grounded on Peterson Bank and some a drifting freely.

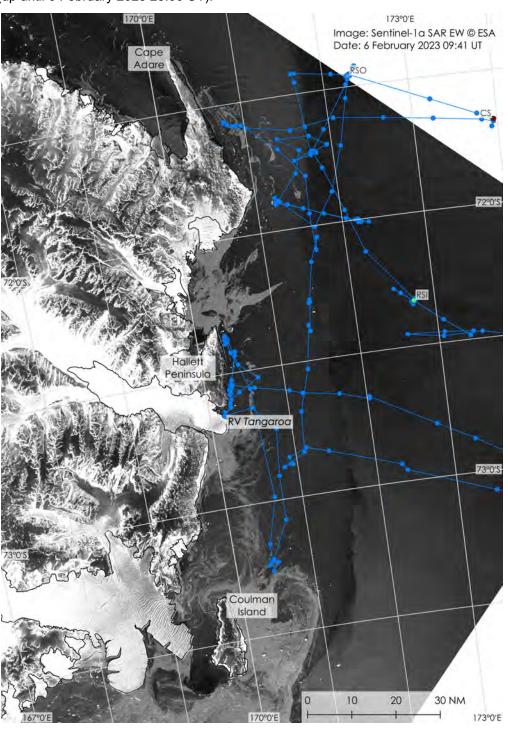
Figure 1: Sentinel-1 SAR EW data acquired 6 February 2023 at 09:41 UT and provided by PolarView.

Figure 1 shows SAR data of the north-western Ross Sea. The cruise track of the vessel is indicated by the blue line (up until 6 February 2023 23:00 UT).

Nearshore between Cape Adare and Hallet Peninsula, sea ice continues decaying in strips and patches offshore and is drifting generally eastward towards the open sea.
