Ice Bulletins for the Antarctic Shipping Season 2022 – 2023

Prepared by Dr Jan L Lieser

Antarctic Meteorology Section — Bureau of Meteorology

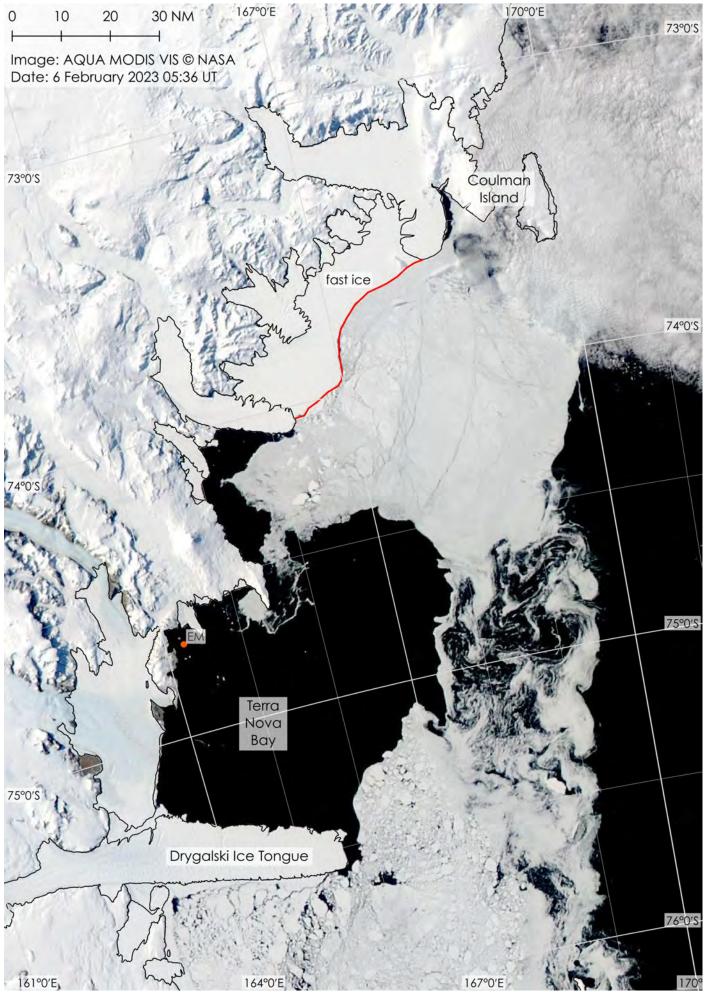
Figure 2: AQUS MODIS VIS data acquired 6 February 2023 at 05:36 UT and provided by NASA.

Further south, Terra Nova Bay (see Figure 2) remains surrounded by a band of higher concentration sea ice, which is thinning. This band of pack ice is fed by pack ice drifting northward around the Drygalski Ice Tongue. The lowest ice concentration is found just north of 75°0'S.

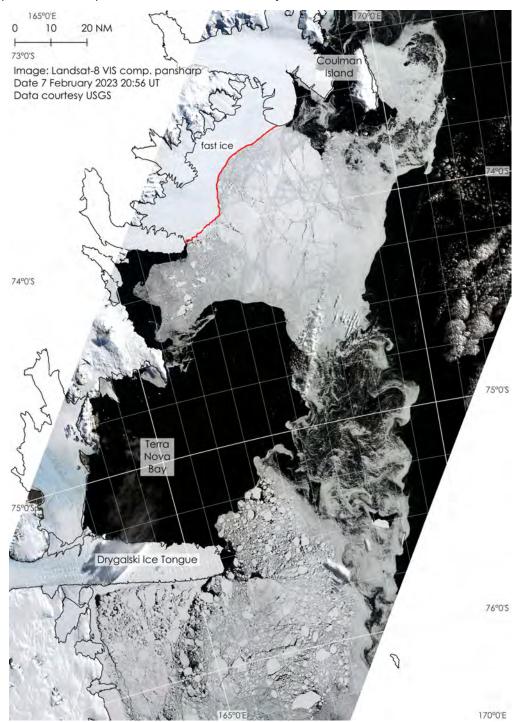
Figure 1: Landsat-8 visible composite pan-sharpened data acquired 7 February 2023 at 20:56 UT and provided by USGS.

Terra Nova Bay remains largely free of sea ice but is still surrounded by first-year pack ice. The lowest concentration of this pack ice is just north and around of 75°0'S. Some icebergs are drifting freely in the bay.

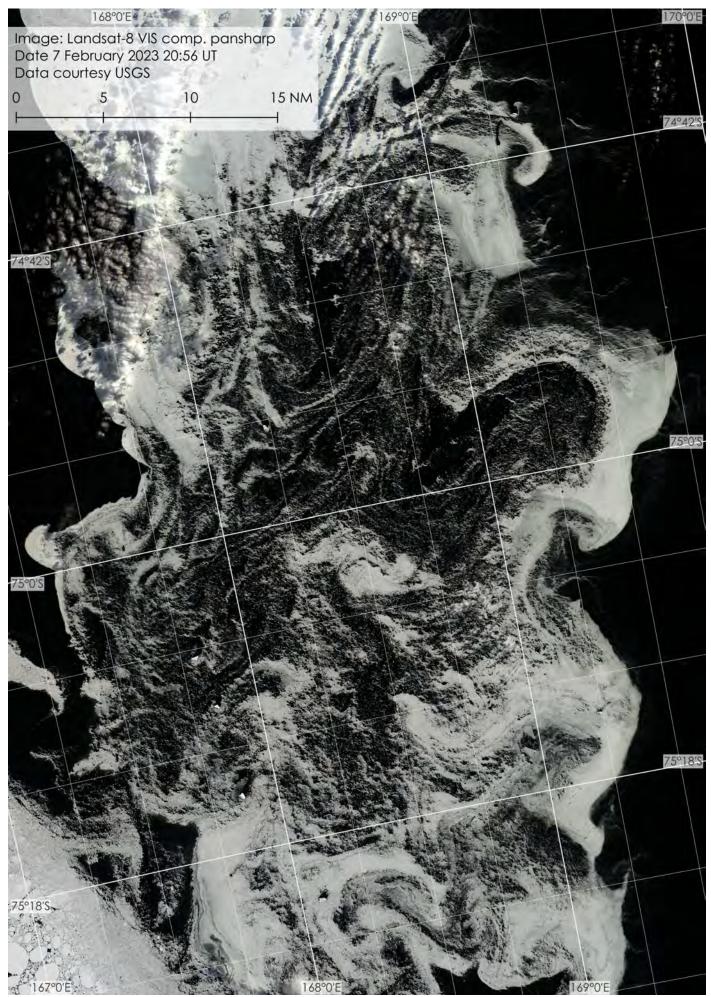
Figure 2: Landsat-8 visible composite pan-sharpened data acquired 7 February 2023 at 20:56 UT and provided by USGS.

Figure 2 shows close-up view of the part of lowest ice concentration off the bay.

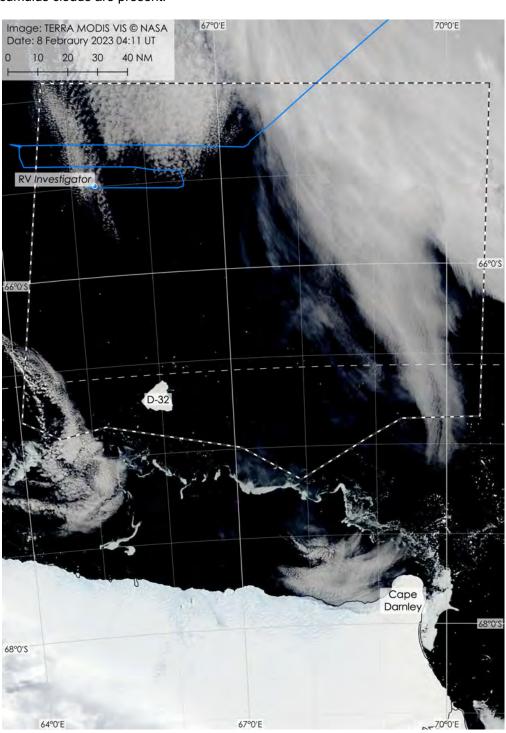
Figure 1 shows visible data northeast of Cape Darnley. The black/white outline marks the proposed survey area of RV *Investigator* voyage IN2023-V01. The cruise track of the vessel is given by the blue line (up until 8 February 2023 06:00 UT). The north-eastern part of the image is obscured by stratiform clouds and in the south-western corner some cumulus clouds are present.

Iceberg D-32 continues its drift westward roughly along the continental shelf break.

Almost the entire proposed survey area is free of drifting pack ice, but icebergs are present throughout the region. Only the southern part of the survey area may be affected by occasional decaying ex-fast ice floes.

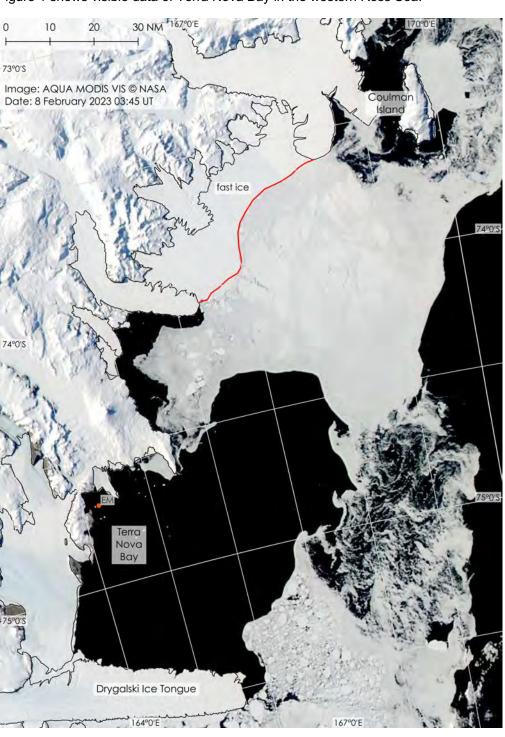
Figure 1: AQUA MODIS visible composite data acquired 8 February 2023 at 03:45 UT and provided by NASA.

Figure 1 shows visible data of Terra Nova Bay in the western Ross Sea.

Terra Nova Bay remains largely free of sea ice but is still surrounded by first-year pack ice. The lowest concentration of this pack ice is just north and around of 75°0'S. Some icebergs are drifting freely in the bay.

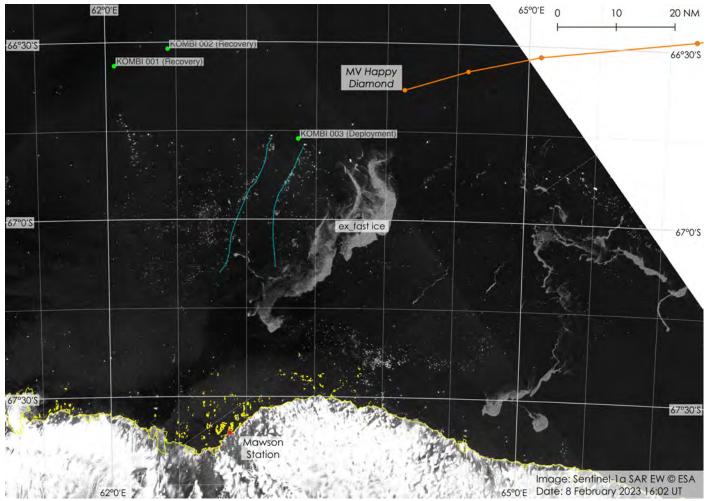
Figure 1: Sentinel-1a SAR data acquired 8 February 2023 at 16:02 UT and provided by PolarView.

Figure 1 shows SAR data off Mawson Station. A white diagonal hairline is a stitching artefact where two consecutive scenes join. The cruise track of MV *Happy Diamond* is indicated by the orange line (up until 8 February 2023 22:00 UT).

North of the station, Iceberg Alley (marked by blue outlines) is largely clear of sea ice. Only in the southern part of the alley, strips and patches of decaying ex-fast ice are present.

Remnants of decaying ex-fast ice remain east of the alley south of 66°45'S but continue to disintegrate.

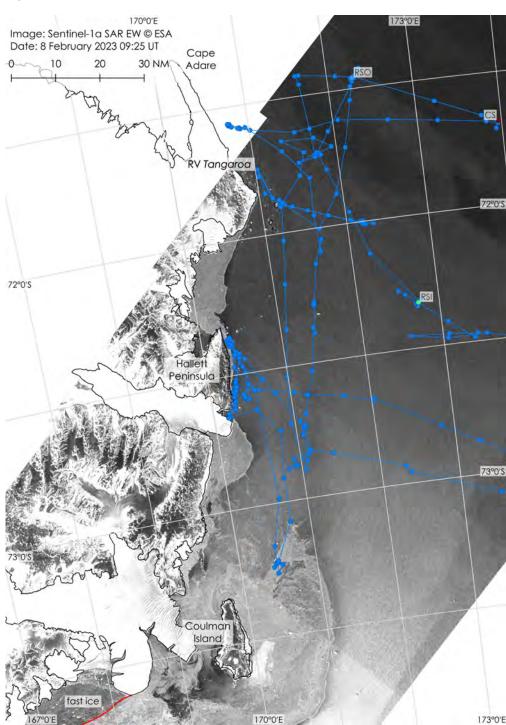
Figure 1: Sentinel-1a SAR EW data acquired 8 February 2023 at 09:25 UT and provided by PolarView.

Nearshore between Cape Adare and Hallett Peninsula, sea ice continues decaying and has been recently pushed back against the shore.

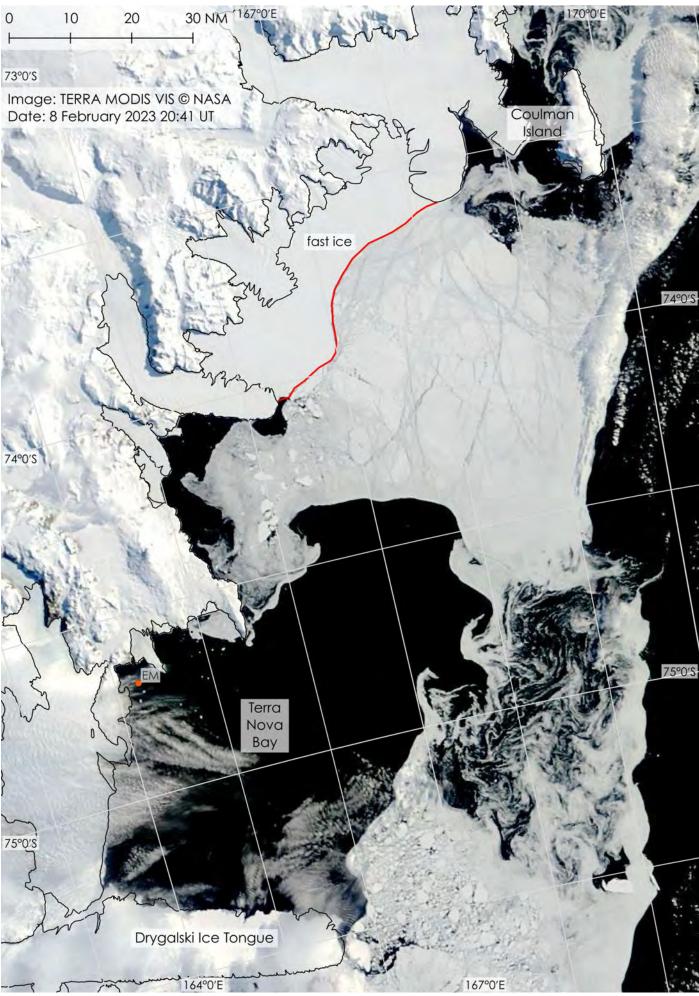
Figure 2: TERRA MODIS visible composite data acquired 8 February 2023 at 20:41 UT and provided by NASA.

Figure 2 shows visible data of Terra Nova Bay and offshore and Figure 3 shows high-resolution (15 m horizontal) visible data of the band of pack ice off Terra Nova Bay.

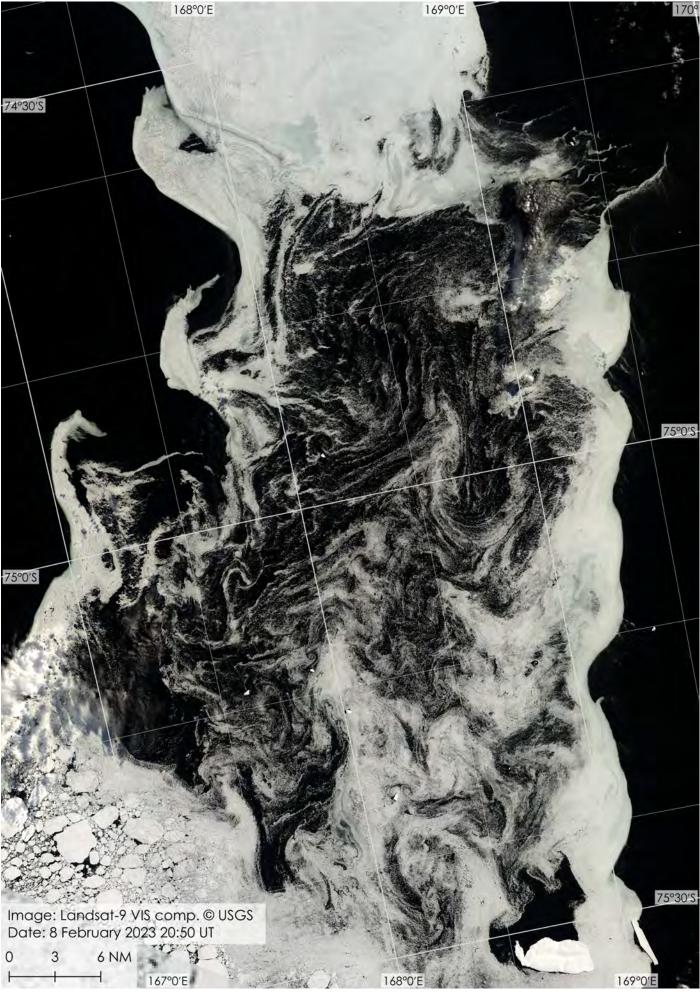
Figure 3: Landsat-9 visible composite pan-sharpened data acquired 8 February 2023 at 20:50 UT and provided by USGS.

The band of pack ice that is closing off the bay remains as the outer parts of the band (the western and eastern edges of the pack ice north of the Drygalksi Ice Tongue) appear to thicken slightly.

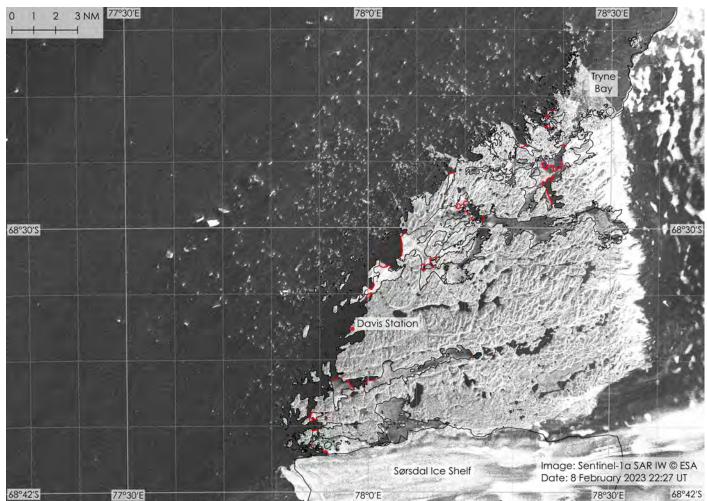
Figure 1: Sentinel-1a SAR IW data acquired 8 February 2023 at 22:27 UT and provided by PolarView.

Figure 1 shows high-resolution (15 m horizontal) SAR data off Davis Station. The fast-ice edge is marked by a red line.

Only minimal fast ice remains in sheltered bay off the hills. Offshore, most of the icebergs are grounded but some are still drifting.

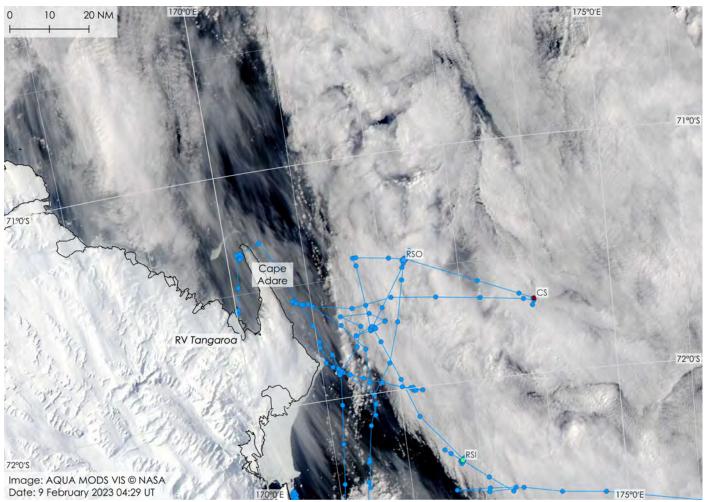
Figure 1: AQUA MODIS visible composite data acquired 9 February 2023 at 04:29 UT and provided by NASA.

Figure 1 shows visible data of the north-western Ross Sea. The cruise track of RV *Tangaroa* is included as a blue line (up until 9 February 2023 22:00 UT).

Nearshore around Cape Adare, sea ice continues decaying and has been recently pushed back against the shore. A spit-like feature of sea ice can be seen around the northern tip of Cape Adare

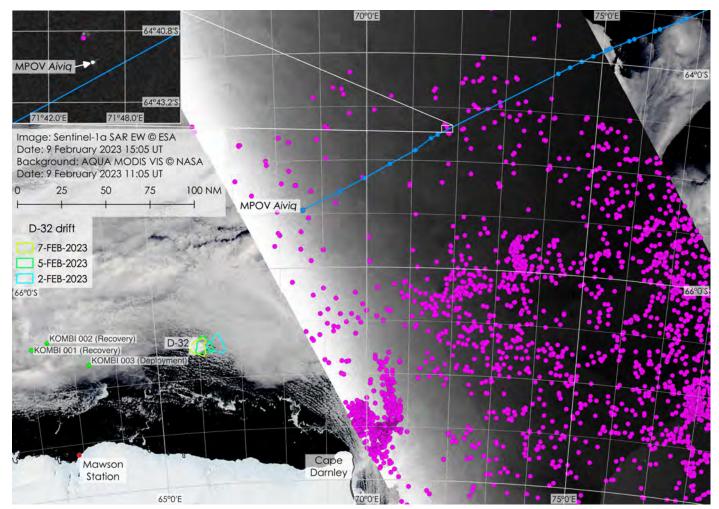
Figure 1: Sentinel-1a SAR data acquired 9 February 2023 at 15:05 UT and provided by PolarView; background: AQUA MODIS VIS composite data acquired 9 February 2023 at 11:05 UT and provided by NASA.

Figure 1 shows a composite of SAR visible data off Mawson Coast. A white diagonal hairline is a stitching artefact where two consecutive scenes join. The cruise track of MPOV *Aiviq* is indicated by the blue line (up until 10 February 2023 00:20 UT).

The inset in the figure shows MPOV Aiviq at the time of data acquisition as a bright reflection.

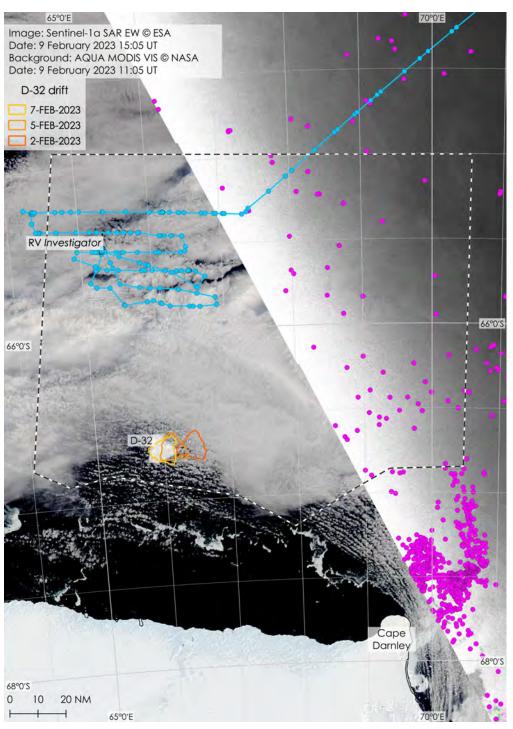
Figure 1 shows a composite of visible and SAR data north of Mawson Coast. The black/white outline marks the proposed survey area of RV *Investigator* voyage IN2023-V01. The cruise track of the vessel is given by the blue line (up until 10 February 2023 02:00 UT).

The SAR data have been analysed for iceberg presence and features have been marked by pink dots.

Iceberg D-32 continues its drift westward roughly along the continental shelf break.

The entire proposed survey area is largely free of drifting pack ice, but icebergs are present throughout the region. Only the southern part of the survey area may be affected by occasional decaying ex-fast ice floes originating from Cape Darnley.

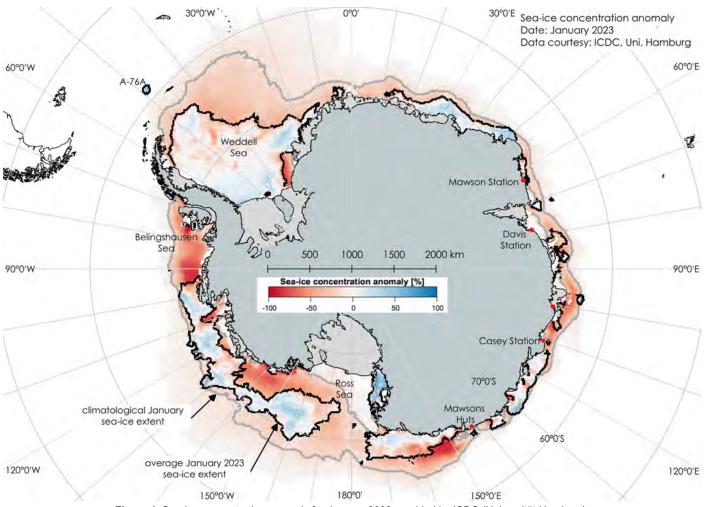
Figure 1: Sea-ice concentration anomaly for January 2023 provided by ICDC (Universität Hamburg).

Figure 1 shows the pan-Antarctic sea-ice concentration anomaly based on passive microwave remote sensing data.

Pan-Antarctic sea-ice conditions continue to be overall low with trends from December 2022 accelerated.

Northeast of the northern tip of the Antarctic Peninsula, an isolated apparent positive anomaly is caused by the drift of large iceberg A-76A, which is north (outside) of the sea-ice zone and drifting further northward into the southern South Atlantic.

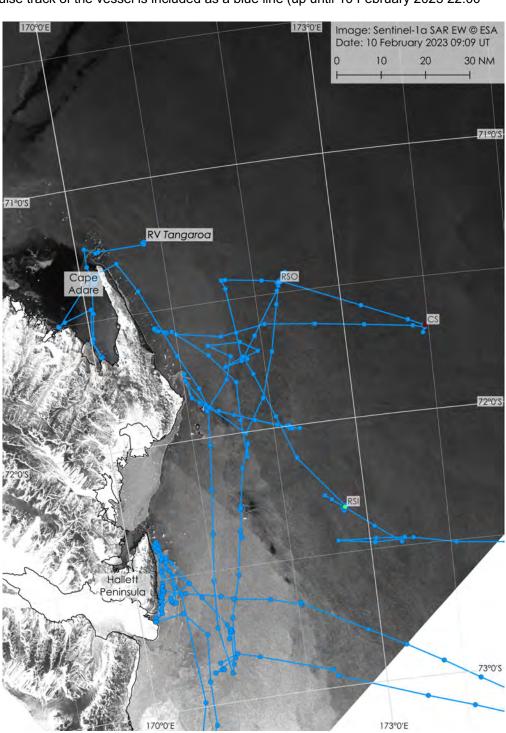
Figure 1: Sentinel-1a SAR EW data acquired 10 February 2023 at 09:09 UT and provided by PolarView.

Nearshore between Cape Adare and Hallett Peninsula, sea ice continues decaying and has been pushed back against the shore.

North and west of Cape Adare, no sea ice is present in the north-eastern Ross Sea however, icebergs are drifting freely in the region.

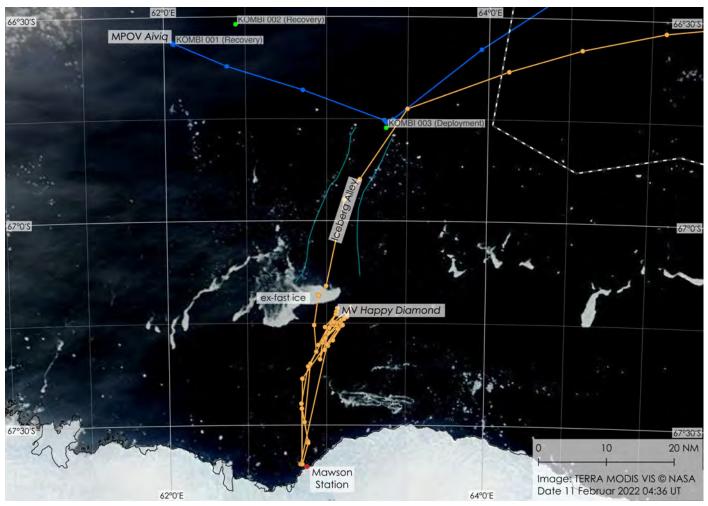
Figure 1: TERRA MODIS VIS composite data acquired 11 February 2023 at 04:36 UT and provided by NASA.

Figure 1 shows visible data north of Mawson Station. The cruise tracks of the MPOV *Aiviq* and MV *Happy Diamond* are given by the blue and orange lines, respectively (up until 11 February 2023 06:15 UT).

The southern end of Iceberg Alley (marked by blue outlines) is partly covered by drifting ex-fast ice, which originated from the eastern side of Cape Darnley (not shown in the figure).

The entire proposed survey area is largely free of drifting pack ice, but icebergs are present throughout the region. Iceberg D-32 continues its drift westward roughly along the continental shelf break.

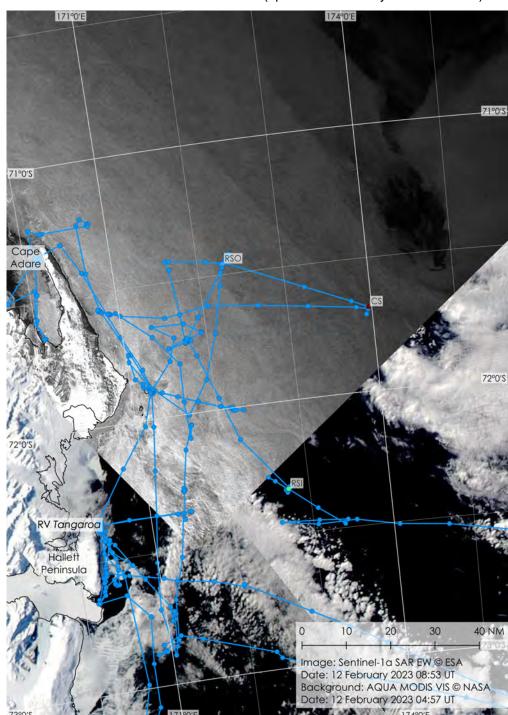
Northeast of Cape Adare, minimal sea ice is present in the north-western Ross Sea however, north of 70°0'S and west of 170°0'E, decaying sea ice and icebergs are drifting freely in the region.

Figure 1: Sentinel-1a SAR EW data acquired 12 February 2023 at 08:53 UT and provided by PolarView; background of AQUA MODIS VIS data acquired 12 February 2023 at 04:57 UT and provided by NASA.

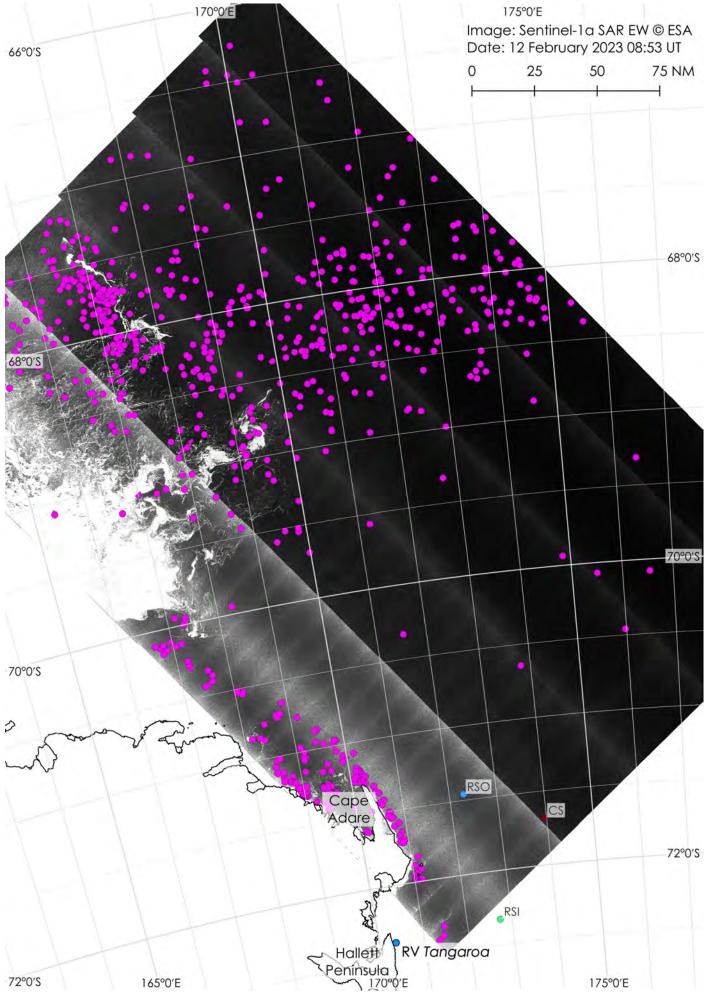
Figure 2 shows a larger scale overview north of Cape Adare. The data has been analysed for iceberg presence and more than 700 features have been marked by pink dots.

Figure 2: Sentinel-1a SAR EW (cross-polarised intensity) data acquired 12 February 2023 at 08:53 UT and provided by ESA.

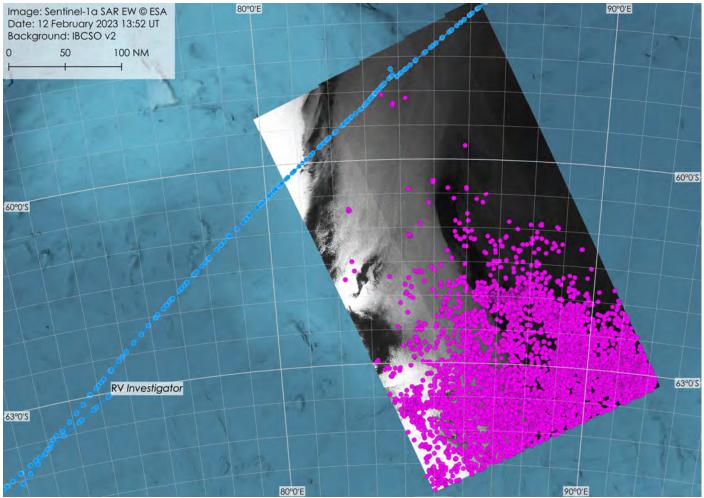
Figure 1 shows SAR data north of West Ice Shelf. The cruise track of RV *Investigator* voyage IN2023-V01 is given by the blue line (up until 13 February 2023 04:00 UT).

Figure 1: Sentinel-1a SAR data acquired 12 February 2023 at 13:52 UT and provided by PolarView.

The SAR data have been analysed for iceberg presence and more than 6600 features have been marked by pink dots. Isolated icebergs are as far north as 59°0'S.

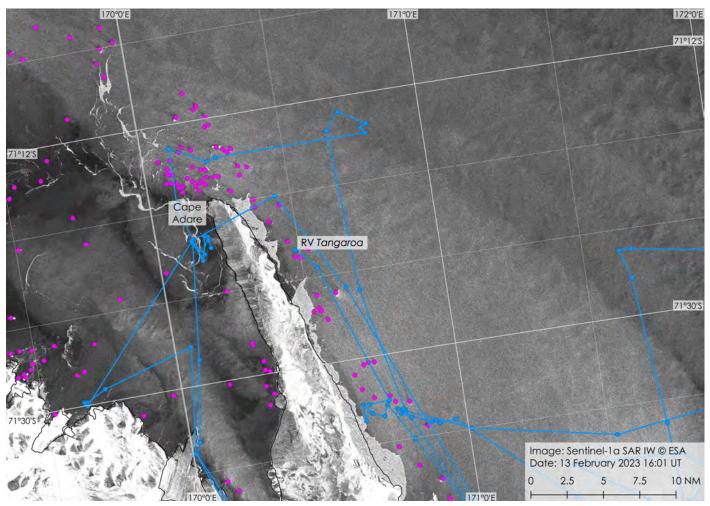
Figure 1 shows high-resolution SAR data of the north-western Ross Sea. The voyage track of RV *Tangaroa* TAN2302 cruise is included as a blue line (up until 13 February 2023 22:00 UT).

Figure 1: Sentinel-1a SAR IW data acquired 13 February 2023 at 16:01 UT and provided by PolarView.

Nearshore around Cape Adare, sea ice has been pushed northward and against the shore.

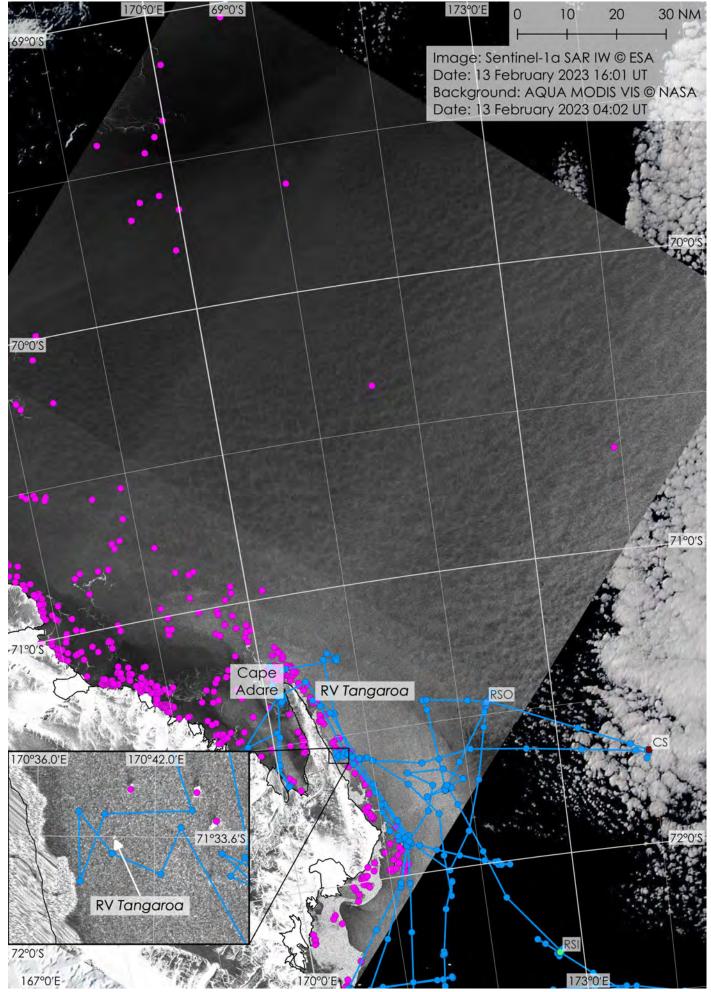
North of Cape Adare, minimal sea ice is present in the north-western Ross Sea however, strips and patches of decaying sea ice are present of south of 69°0'S and west of 170°0'E and icebergs are drifting freely in the region.

Figure 2: Sentinel-1a SAR IW data acquired 13 February 2023 at 16:01 UT and provided by PolarView; background of AQUA MODIS VIS data acquired 13 February 2023 at 04:02 UT and provided by NASA.

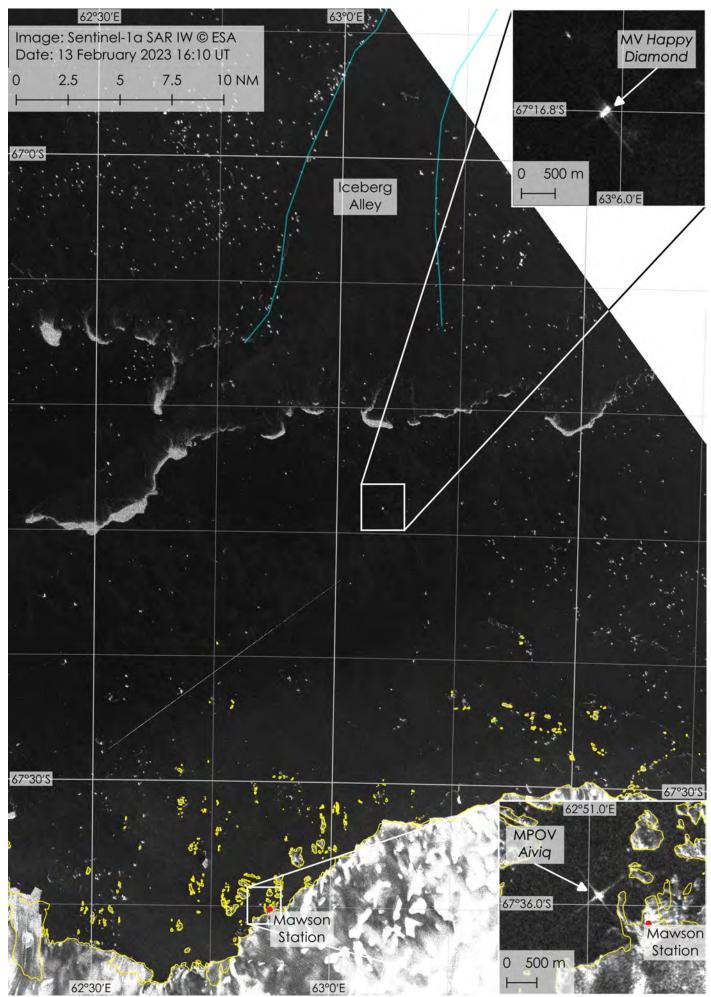
Figure 3 shows high-resolution (15 m horizontal) SAR data north of Mawson Station. A diagonal hairline is a stitching artefact where two consecutive scenes join. The insets show MV *Happy Diamond* offshore and MPOV *Aiviq* off station as bright starshaped reflections.

Figure 3: Sentinel-1a SAR IW data acquired 13 February 2023 at 16:10 UT and provided by PolarView.

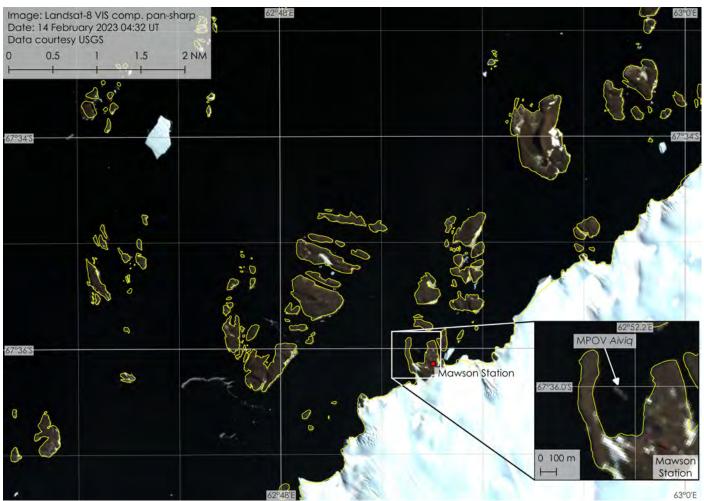
Figure 1 shows high-resolution (15 m horizontal) visible data off Mawson Station. The inset shows the position of MPOV *Aivig* at the time of data acquisition.

Figure 1: Landsat-8 visible composite pan-sharpened data acquired 14 February 2023 at 04:32 UT and provided by USGS.

Minimal sea ice remains in the vicinity of the station and the islands offshore. Some icebergs are in between the islands as well.

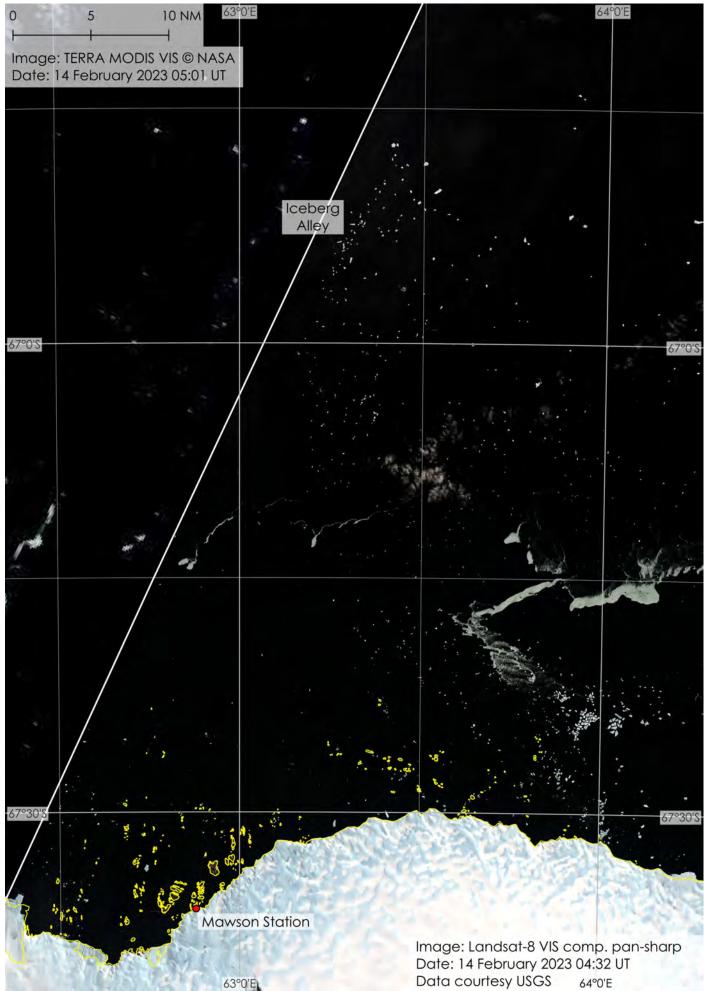
Further north, decaying ex-fast ice keeps drifting westward south of Iceberg Alley (see Figure 2).

Figure 2: Landsat-8 visible composite pan-sharpened data acquired 14 February 2023 at 04:32 UT and provided by USGS; complemented by TERRA MODIS VIS data acquired 14 February 2023 at 05:01 UT and provided by NASA.

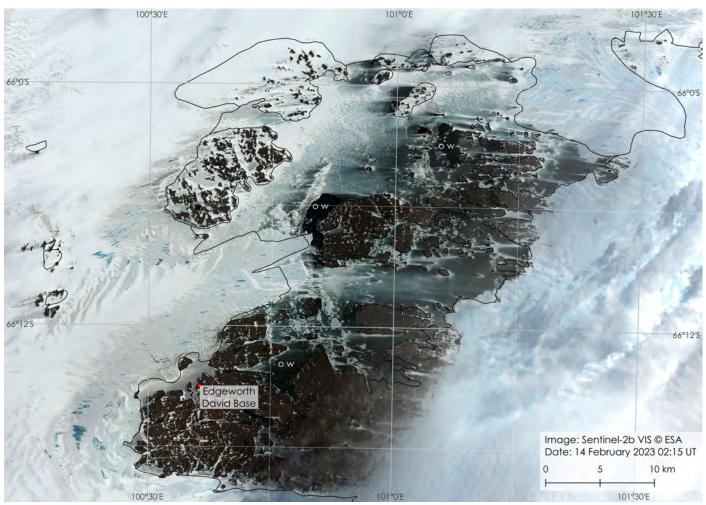
Figure 1 shows high-resolution (10 m horizontal) visible data of the Bunger Hills.

Figure 1: Sentinel-2b visible composite data acquired 14 February 2023 at 02:15 UT and provided by ESA.

The eastern part of the Bunger Hills is slightly obscured by clouds.

Some of the smaller fjords are marked as open water and some of the lakes are ice free as well.

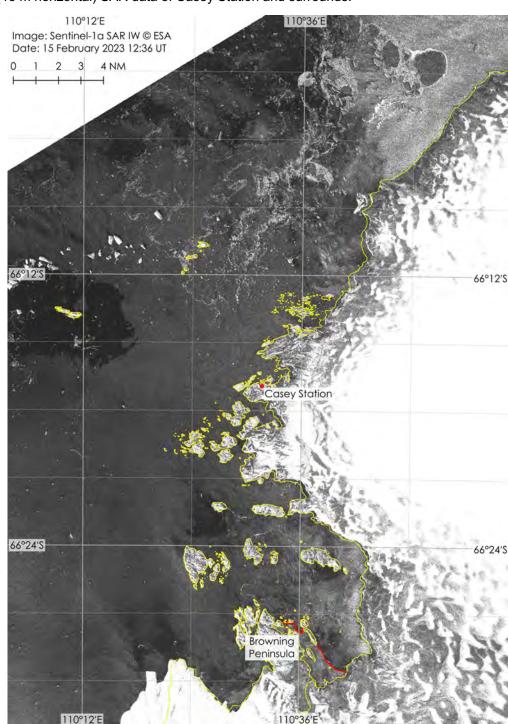
After the final collapse of any fast ice northwest of Law Dome on 3 February 2023, a melange of ex-fast ice and newly forming sea ice is now drifting north of Casey Station.

Only in the sheltered bay east of Browning Peninsula, some fast ice appears to have survived the summer.

Figure 1: Sentinel-1a SAR IW data acquired 15 February 2023 at 12:36 UT and provided by PolarView.

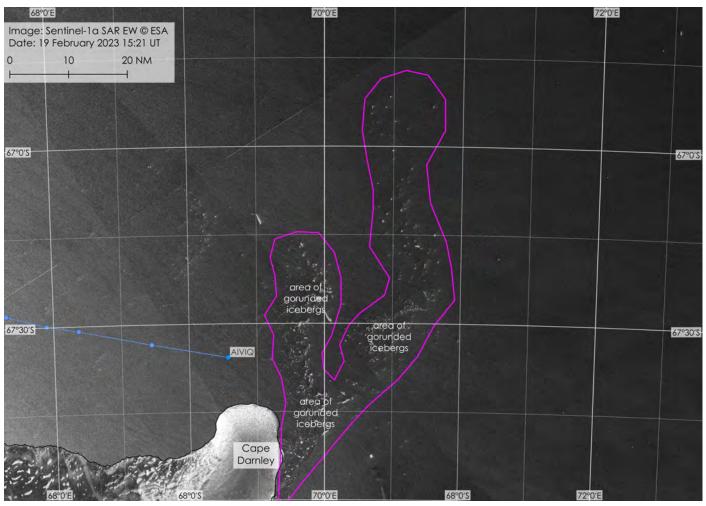
Figure 1 shows SAR data north of Cape Darnley. The cruise track of MPOV *Aiviq is* given by the blue line (up until 19 February 2023 21:00 UT). A white, diagonal hairline is a stitching artefact where two consecutive scenes join.

Figure 1: Sentinel-1a SAR data acquired 19 February 2023 at 15:21 UT and provided by PolarView.

The pink outline marks an area of mostly grounded icebergs northeast of Cape Darnley. Further afield, freely drifting icebergs are present throughout the region, but minimal sea ice remains.

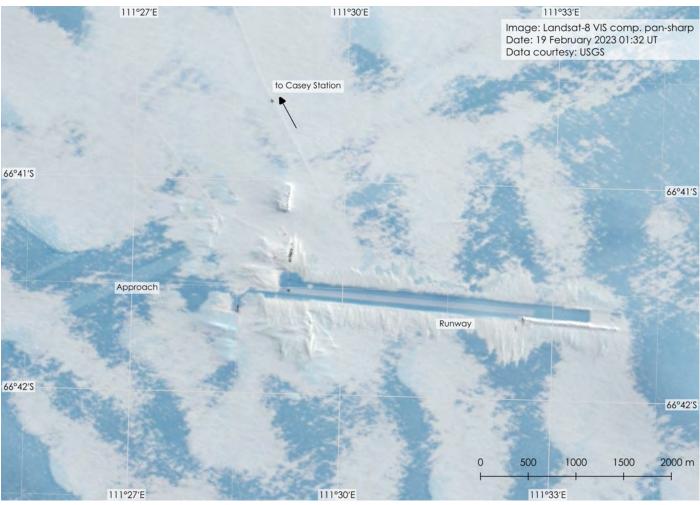
Figure 1 shows high-resolution (15 m horizontal) visible data of Wilkins Aerodrome.

Figure 1: Landsat-8 visible composite pan-sharpened data acquired 19 February 2023 at 01:32 UT and provided by USGS.

North and south of the runway, snow dunes are left from previous clearing the runway. At the time of data acquisition, the Australian A-319 aircraft was on the ground.

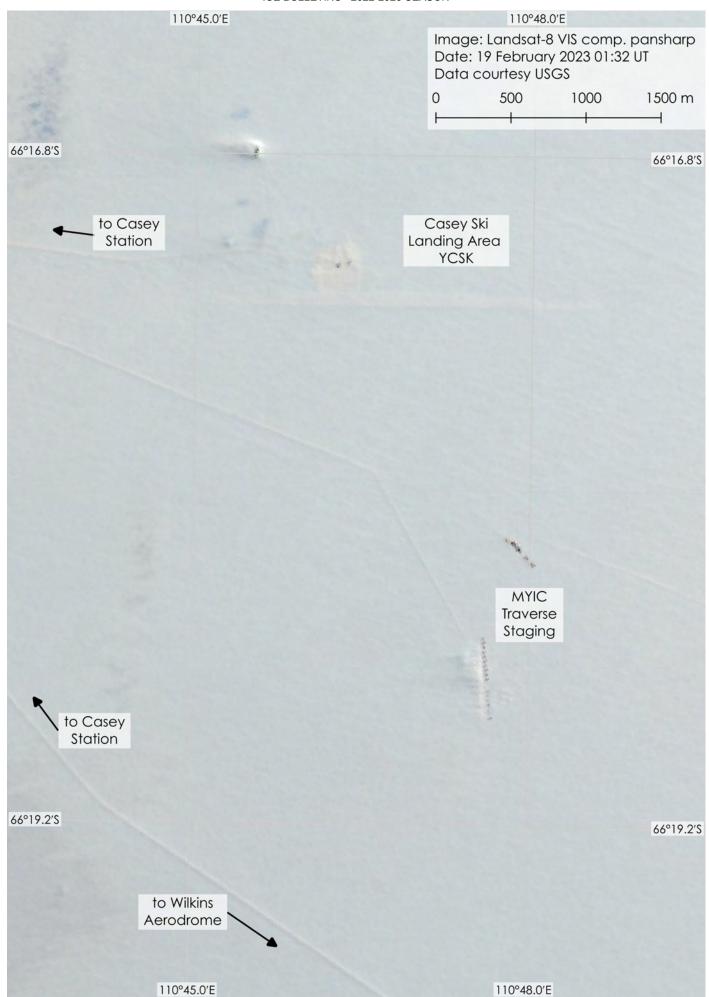
Figure 2 shows a close-up of the region around the Casey Ski Landing Area (YCSK).

Figure 2: Landsat-8 VIS composite pan-sharpened data acquired 19 February 2023 at 01:32 UT and provided by USGS.

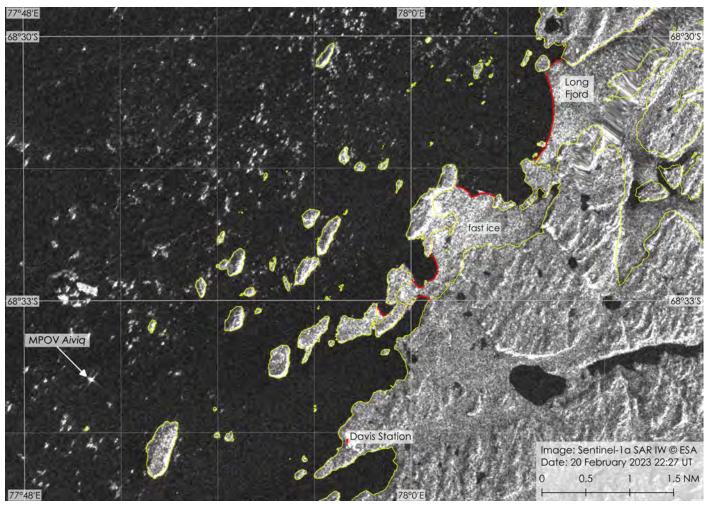
Figure 1 shows high-resolution (15 m horizontal) SAR data off Davis Station. The fast-ice edge is marked by a red line.

Figure 1: Sentinel-1a SAR IW data acquired 20 February 2023 at 22:27 UT and provided by PolarView.

Only minimal fast ice remains in sheltered bays off the hills. Offshore, most of the icebergs are grounded but some are still drifting. The location of MPOV *Aiviq* at the time of data acquisition is shown as a bright star.

Some of the inshore fjords and channels remain partially frozen over.

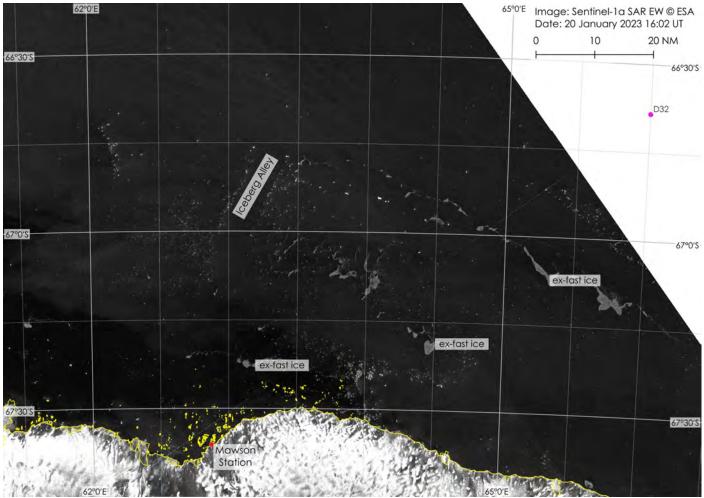
Figure 1 shows SAR data off Mawson Station. A diagonal white hairline is a stitching artefact where two consecutive scenes join.

Figure 1: Sentinel-1a SAR EW data acquired 20 February 2023 at 16:02 UT and provided by PolarView.

There is no more fast ice nearshore. Some patches of decaying ex-fast ice are drifting westward offshore.

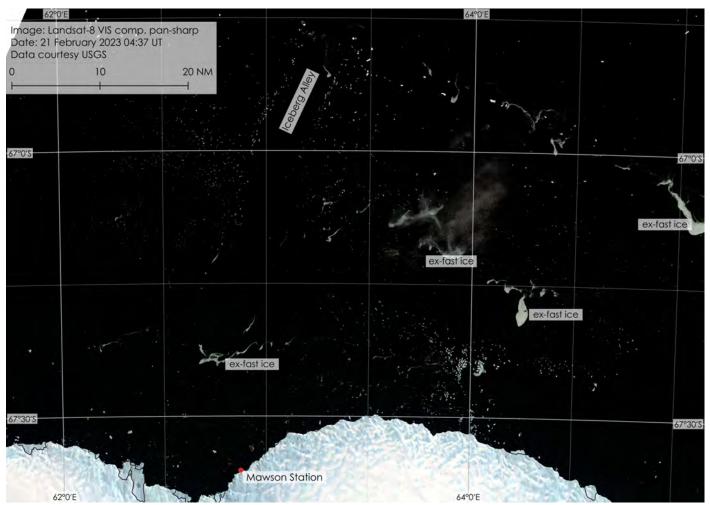
Figure 1 shows high-resolution (15 m horizontal) visible data off Mawson Station.

Figure 1: Landsat-8 visible composite pan-sharpened data acquired 21 February 2023 at 04:37 UT and provided by USGS.

There is no more fast ice nearshore. Some patches of decaying ex-fast ice are drifting westward offshore. Figure 2 shows a close-up around the station. Between the northern offshore islands, some icebergs are present.

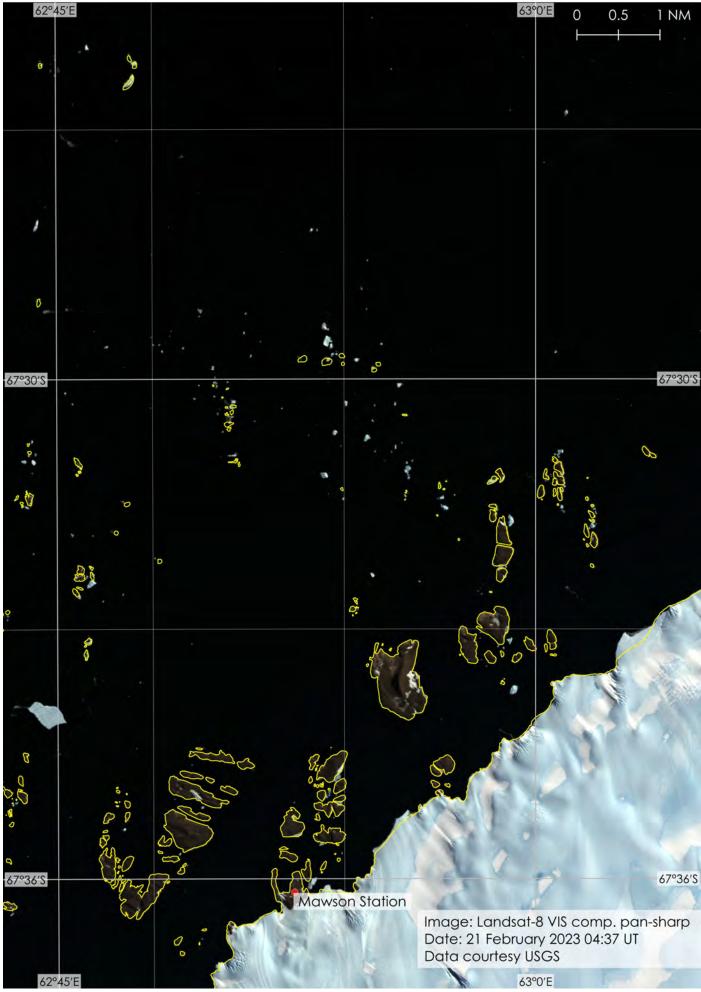
Figure 2: Landsat-8 visible composite pan-sharpened data acquired 21 February 2023 at 04:37 UT and provided by USGS.

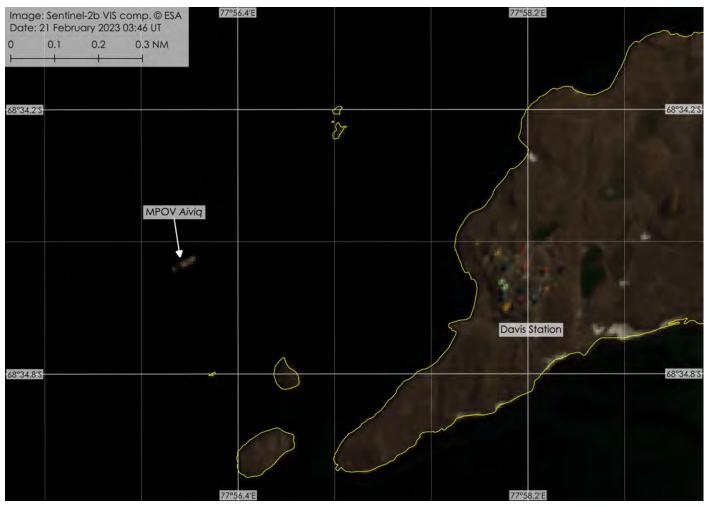
Figure 1 shows high-resolution (10 m horizontal) visible data of Davis Station. The location of MPOV *Aiviq* at the time of data acquisition is marked by a white arrow.

Figure 1: Sentinel-2b VIS composite data acquired 21 February 2023 at 03:46 UT and provided by ESA.

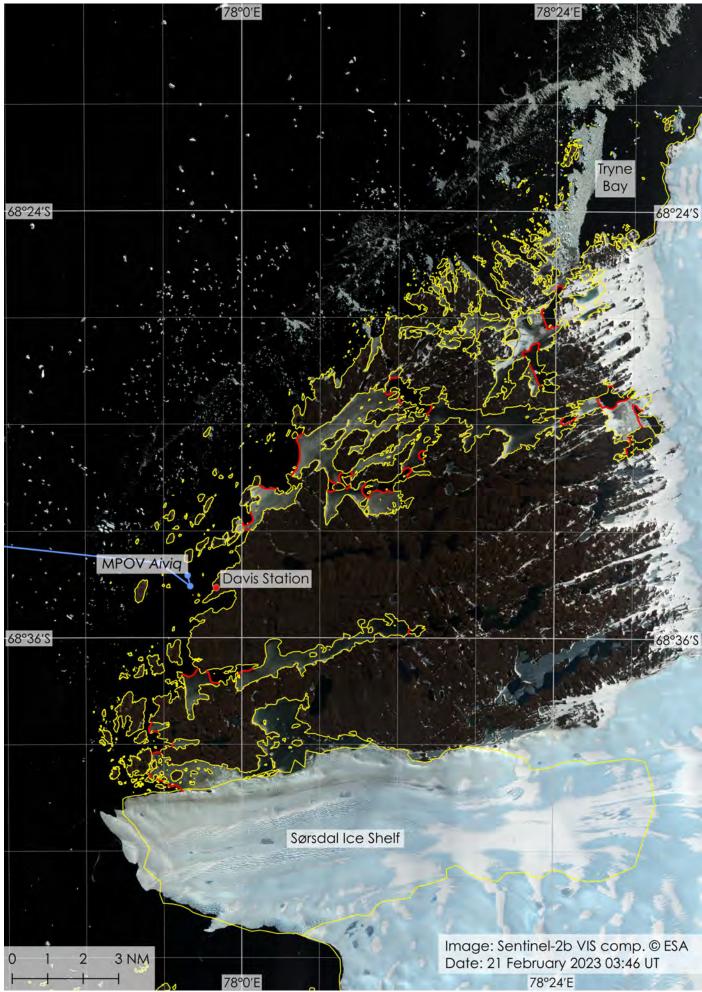
Figure 2 shows a larger-scale overview of the entire Vestfold Hills. The recent track of MPOV *Aiviq* is given by the blue line. The fast-ice edge is marked by a red line.

Only minimal fast ice remains in sheltered bays off the hills. Offshore, most of the icebergs are grounded but some are still drifting. Some of the inshore fjords and channels remain partially frozen over.

Figure 2: Sentinel-2b VIS composite data acquired 21 February 2023 at 03:46 UT and provided by ESA.

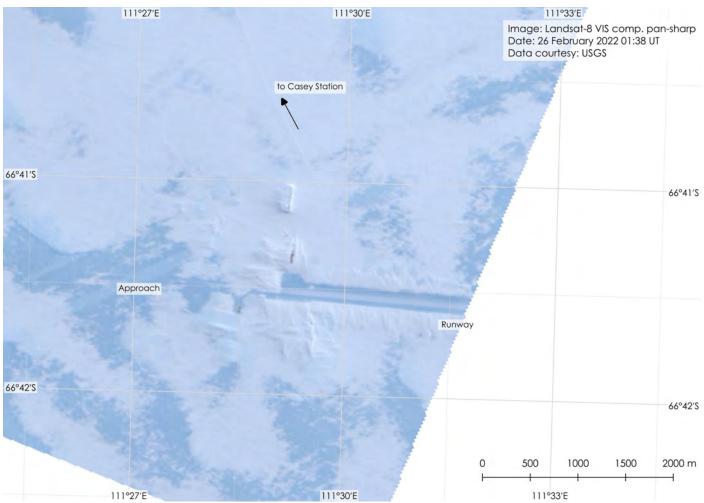
Figure 1 shows high-resolution (15 m horizontal) visible data of Wilkins Aerodrome.

Figure 1: Landsat-8 visible composite pan-sharpened data acquired 26 February 2023 at 01:38 UT and provided by USGS.

North and south of the runway, snow dunes are left from previous clearing the runway. Snow dunes have also accumulated around the camp and other structures.

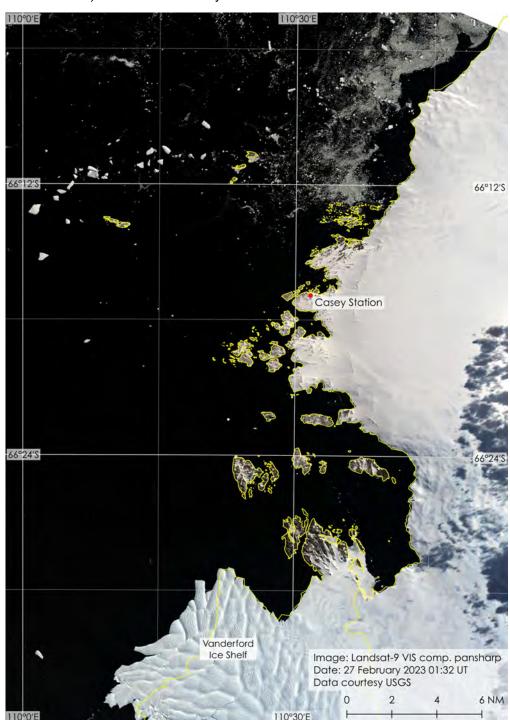
Ex-fast ice is drifting southward along the northwestern flank of Law Dome and is mixing with newly forming sea ice.

Only minimal fast ice remains in sheltered bays northeast of Browning Peninsula northeast of the Vanderford Ice Shelf.

Figure 1: Landsat-9 visible composite pan-sharpened data acquired 27 February 2023 at 01:32 UT and provided by USGS.

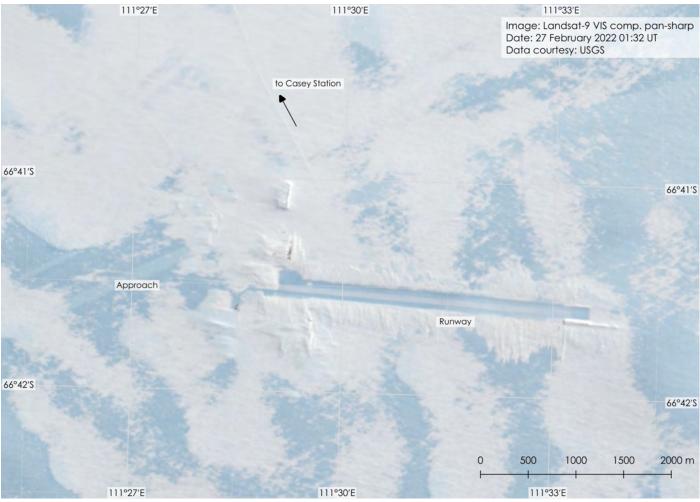
Figure 1 shows high-resolution (15 m horizontal) visible data of Wilkins Aerodrome.

Figure 1: Landsat-9 visible composite pan-sharpened data acquired 27 February 2023 at 01:32 UT and provided by USGS.

North and south of the runway, snow dunes are left from previous clearing the runway. Snow dunes have also accumulated around the camp and other structures.

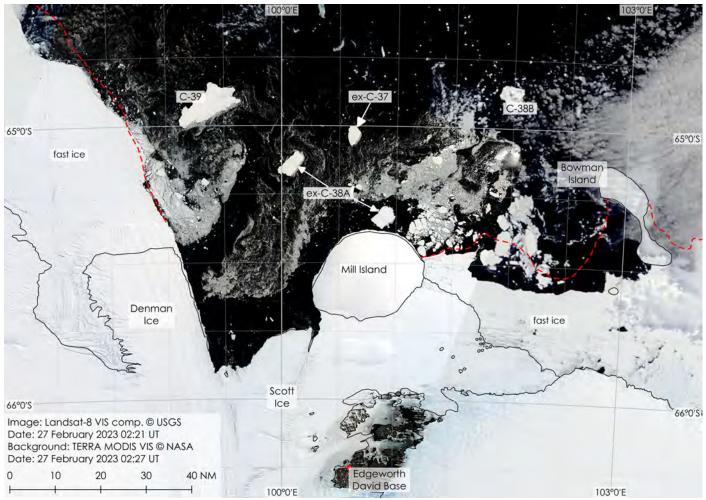
Figure 1 shows high-resolution (15 m horizontal) visible data around Mill Island. The fast-ice edge on 9 February 2023 is indicated by a dashed red line.

Figure 1: Landsat-8 visible composite pan-sharpened data acquired 27 February 2023 at 02:21 and provided by USGS; background of TERRA MODIS VIS data acquired 27 February 2023 at 02:27 UT and provided by NASA.

Icebergs C-37 and C-38A are not satisfying the criteria for large icebergs that are tracked specifically anymore however, they are still clearly discernible.

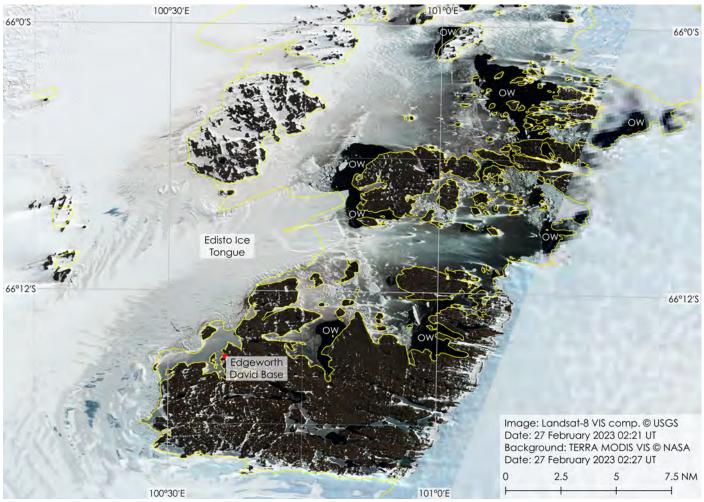
Figure 2: Landsat-8 visible composite pan-sharpened data acquired 27 February 2023 at 02:21 and provided by USGS; background of TERRA MODIS VIS data acquired 27 February 2023 at 02:27 UT and provided by NASA.

Figure 2 shows a close-up view of the Bunger Hills. Areas of open water in between the hills are marked with 'OW'.
