Ice Bulletins for the Antarctic Shipping Season 2022 – 2023

Prepared by Dr Jan L Lieser

Antarctic Meteorology Section — Bureau of Meteorology

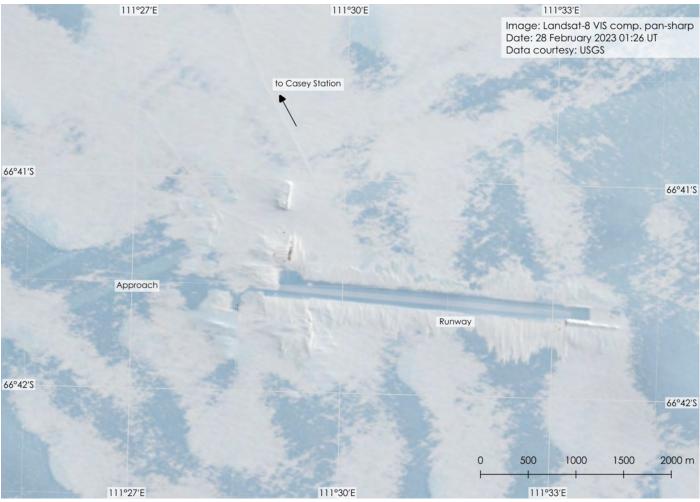
Figure 1: Landsat-8 visible composite pan-sharpened data acquired 28 February 2023 at 01:26 UT and provided by USGS.

Figure 1 shows high-resolution (15 m horizontal) visible data of Wilkins Aerodrome.

North and south of the runway, snow dunes are left from previous clearing the runway. Snow dunes have also accumulated around the camp and other structures.

Figure 3 shows the Wilkins Aerodrome.

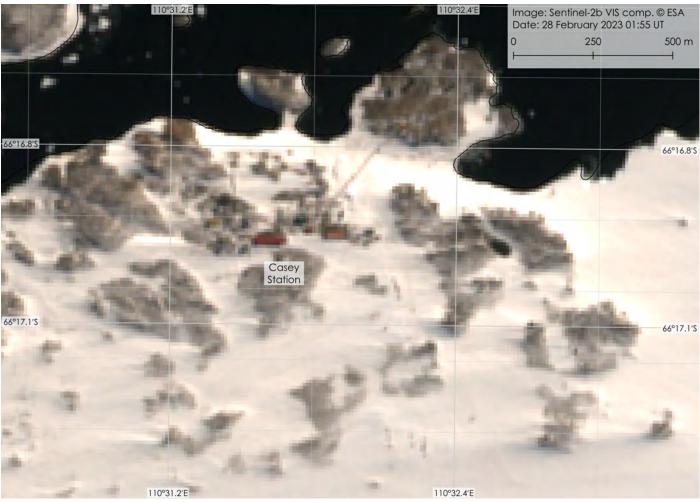
Figure 1: Sentinel-2b visible composite data acquired 28 February 2023 at 01:55 UT and provided by ESA.

Figure 1 shows high-resolution (10 m horizontal) visible data of Casey Station.

Individual buildings of the station can be seen clearly in the figure.

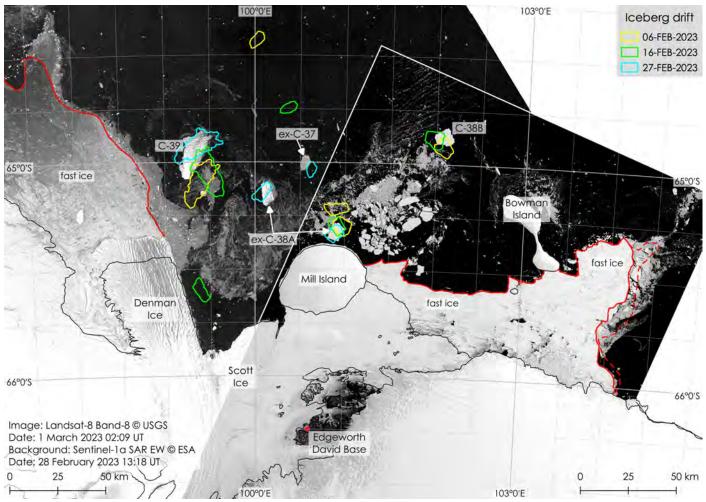
Figure 1: Landsat-8 Band-8 (panchromatic) data acquired 1 March 2023 at 02:09 and provided by USGS; background of Sentinel-1 SAR EW data acquired 28 February 2023 at 13:18 UT and provided by PolarView.

Figure 1 shows a composite of SAR and high-resolution (15 m horizontal) panchromatic data around Mill Island. The fast-ice edge is marked by a red line (a dashed red line for 27 February 2023).

West of Mill Island, new sea ice is forming and circulating in the bay. East of Bowman Island, fast ice continues breaking up. A melange of pack ice and ex-fast ice is present north of the fast-ice edge where also new sea ice is forming.

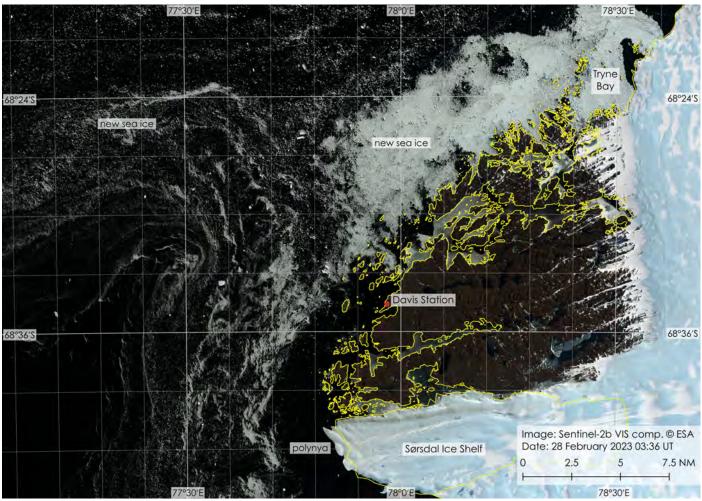
Figure 1: Sentinel-2b visible composite data acquired 28 February 2023 at 03:36 and provided by ESA.

Figure 1 shows high-resolution (10 m horizontal) visible data of Davis Station and the Vestfold Hills.

New sea-ice formation has started off the Vestfold Hills. Minimal fast ice has survived in the fjords of the hills.

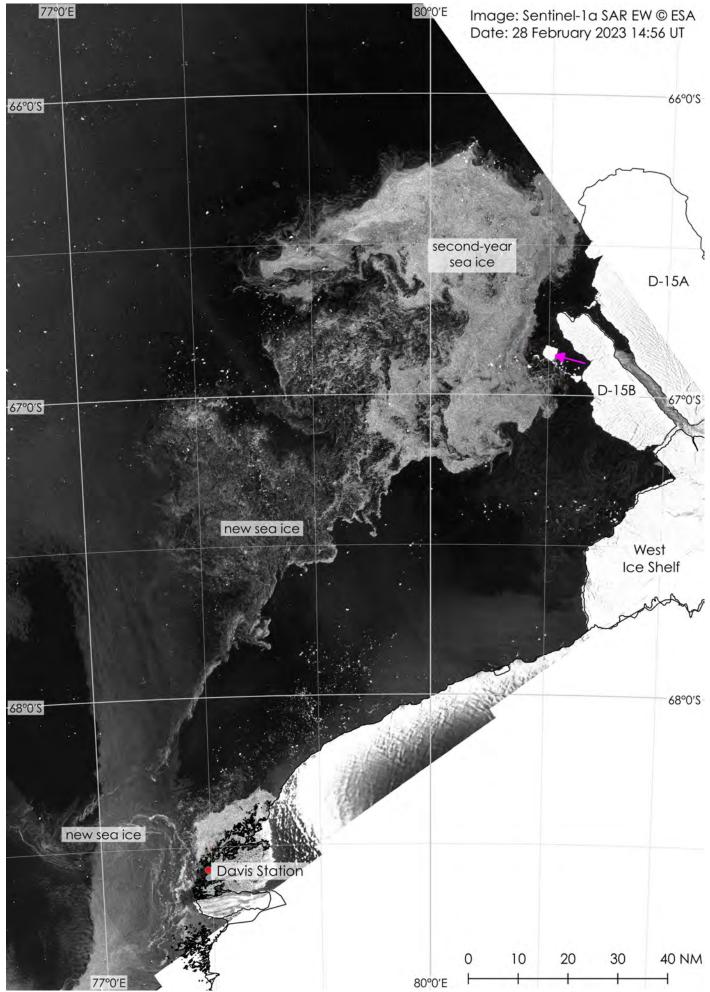
Figure 2: Sentinel-1 SAR EW data acquired 28 February 2023 at 14:56 UT and provided by PolarView.

During late-February, one large fragment of iceberg D-15B, which separated from the iceberg earlier, has now drifted westward away from its initial calving location (as indicated by the pink arrow). It remains currently north of a string of smaller icebergs that have also formed previously but will eventually enter a south-westward drift stream together with the second-year sea ice and newly forming sea ice.

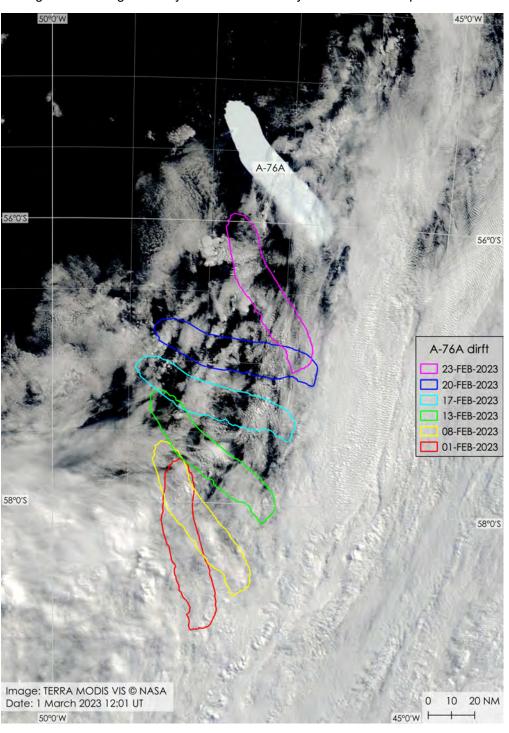
Figure 1 shows visible data northeast of the Antarctic Peninsula and northwest of the Weddell Sea. The drift of iceberg A-76A during February 2023 is indicated by colour-coded shapes.

During February, the iceberg drifted 160 nautical miles northward and is currently roughly 500 nautical miles north of the sea-ice edge based on passive microwave data (not shown in the figure). Due to the shape of the sea-ice edge, the iceberg is in fact more than 700 nautical miles north of the sea-ice edge when the longitude coordinate of the iceberg's centre is considered.

The iceberg is currently crossing the latitude of South Georgia Island in the Scotia Sea in the southern South Atlantic Ocean and therefore the latitude of the southern edge of South America. It has entered shipping routes that run across the southern South Atlantic.

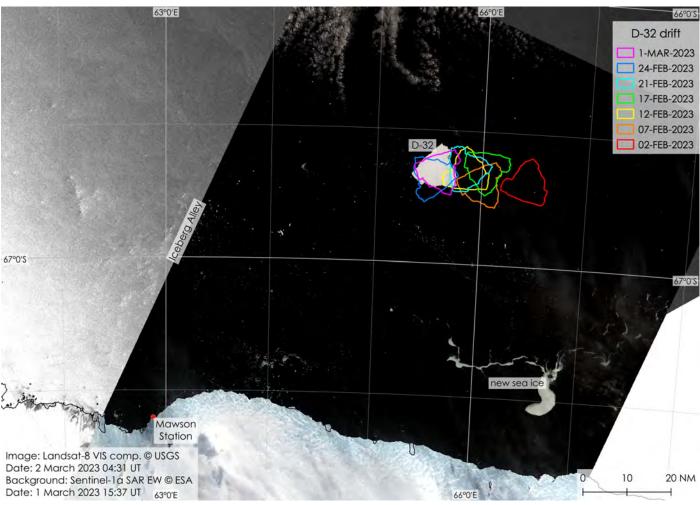
Figure 1: Landsat-8 visible composite data acquired 2 March 2023 at 04:31 UT and provided by USGS; Background: Sentinel-1a SAR EW data acquired 1 March 2023 at 15:37 UT and provided by PolarView.

Figure 1 shows composite data off Mawson Station. The drift of iceberg D-32 is indicated by colour-coded shapes.

There is no more fast ice nearshore. Some patches of new sea ice with incorporated ex-fast ice are drifting westward offshore. During February, iceberg D-32 rotated clockwise more than two complete rotations while drifting more than 22 nautical miles westward north of the continental shelf break.

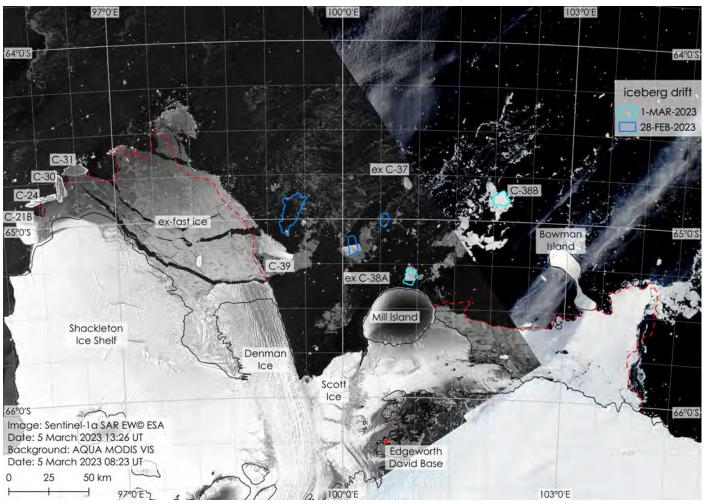
Figure 1: Sentinel-1 SAR EW data acquired 5 March 2023 at 13:26 UT and provided by PolarView; Background: AQUA MODIS VIS data acquired 5 March 2023 at 08:23 UT and provided by NASA.

Figure 1 shows a composite of SAR and visible data around Mill Island. The fast-ice edge is marked by a dashed red line for 1 March 2023.

Northeast of the Shackleton Ice Shelf, roughly 5400 km² (approximately 4 times the size of Flinders Island, Tasmania) of multi-year fast ice has broken off on 4 March 2023. This happened at a time when new sea ice is already forming west and north of Mill Island. East of Bowman Island, fast ice continues breaking up and a melange of pack ice and ex-fast ice is present off the fast-ice edge where also new sea ice is forming.

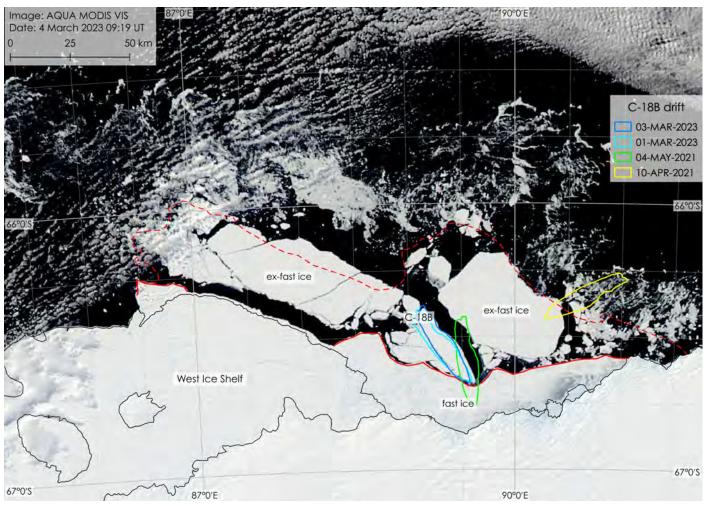
Figure 1: AQUA MODIS VIS data acquired 4 March 2023 at 09:19 UT and provided by NASA.

Figure 1 shows visible data of the eastern West Ice Shelf. The fast-ice edge is marked by a red line (dashed red line for 21 February 2023).

In early-March 2023, roughly 7200 km² (more than 5 times the size of Flinders Island, Tasmania) of second-year fast ice has broken off northeast of the West Ice Shelf. This happened at a time when new sea ice started forming.

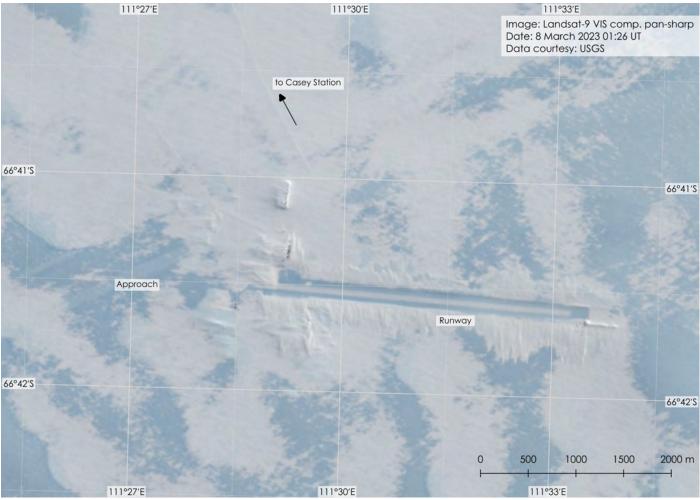
Figure 1: Landsat-9 visible composite pan-sharpened data acquired 8 March 2023 at 01:26 UT and provided by USGS.

Figure 1 shows high-resolution (15 m horizontal) visible data of Wilkins Aerodrome.

North and south of the runway, snow dunes are left from previous clearing the runway. Snow dunes have also accumulated around the camp and other structures.

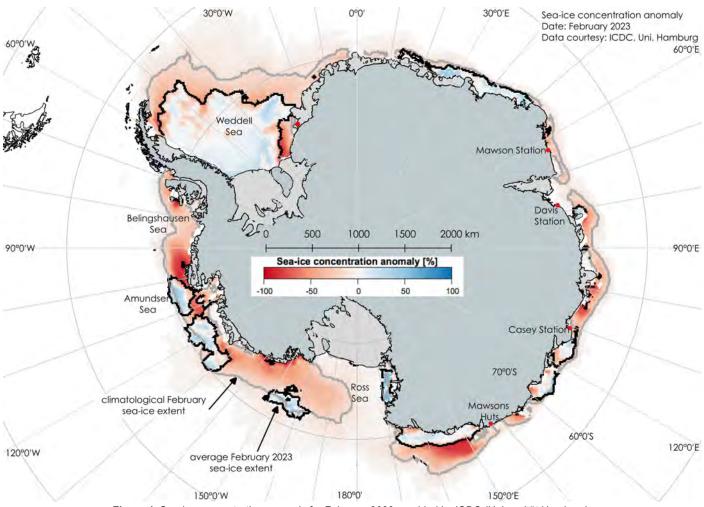
Figure 1: Sea-ice concentration anomaly for February 2023 provided by ICDC (Universität Hamburg).

Figure 1 shows the pan-Antarctic sea-ice concentration anomaly based on passive microwave remote sensing data.

Pan-Antarctic sea-ice conditions reached a record minimal low and trends from December 2022 accelerated.

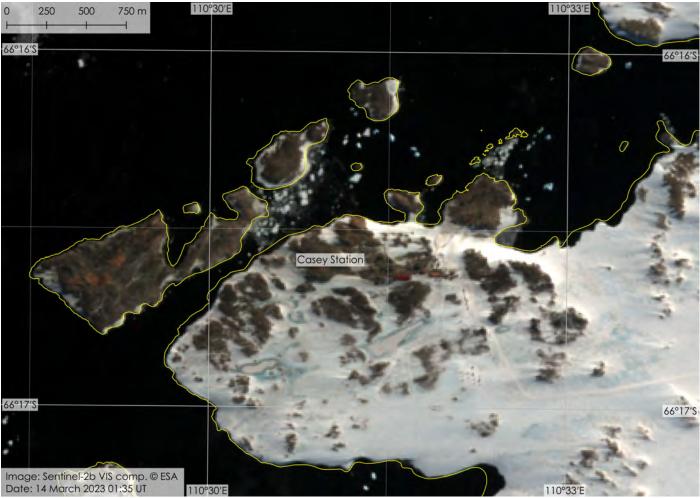
Figure 1: Sentinel-2b visible composite data acquired 14 March 2023 at 01:35 UT and provided by ESA.

The figures of this Ice Bulletin show high-resolution (10 m horizontal) visible data of Casey Station and surrounds.

Individual buildings of the station can be seen clearly in Figure 1.

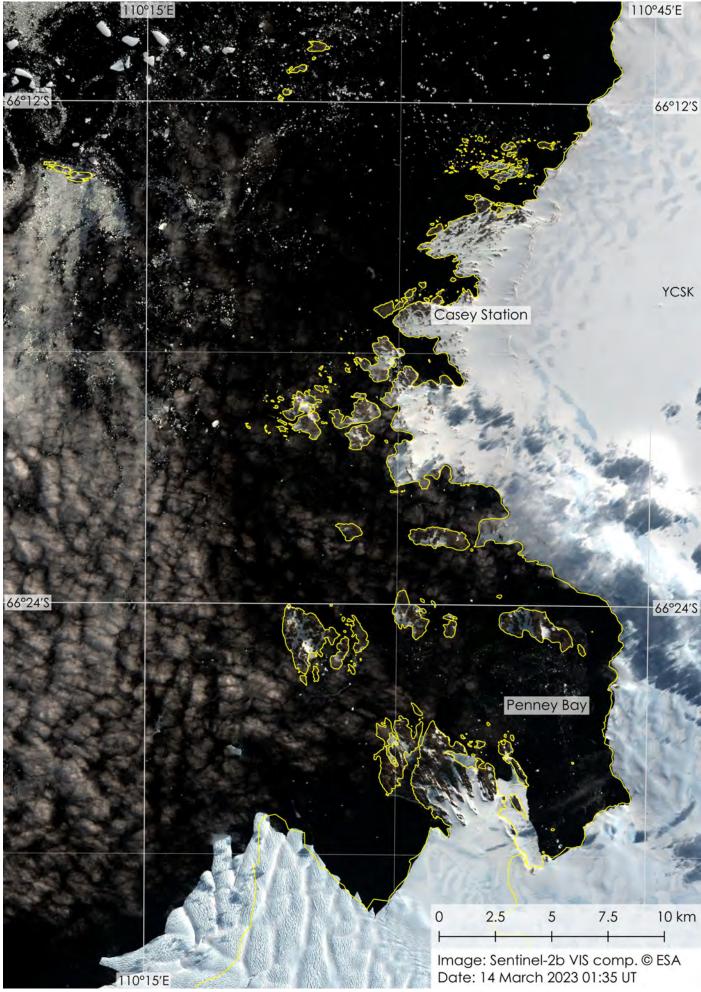
Figure 4: Sentinel-2b visible composite data acquired 14 February 2023 at 01:35 UT and provided by ESA.

Figure 4 shows a larger-scale overview of the entire region. Minimal fast ice has survived the summer sheltered in the south-western Penney Bay.

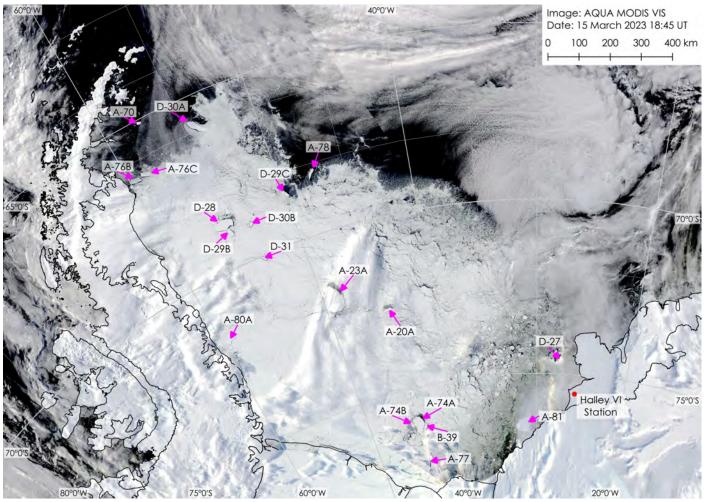
Figure 1: AQUA MODIS visible composite data acquired 15 March 2023 at 18:45 and provided by NASA.

Figure 1 shows visible data of the Weddell Sea.

Currently, 19 large (named) tabular icebergs are drifting in the southern and western Weddell Sea. Icebergs A-70 and A-78 are north of the sea-ice zone and additionally two more icebergs, namely D-29A and A-76A, are 630 km and 1350 km, respectively, north of the sea-ice edge and not shown in the figure. Furthermore, four icebergs are currently at the sea-ice edge.

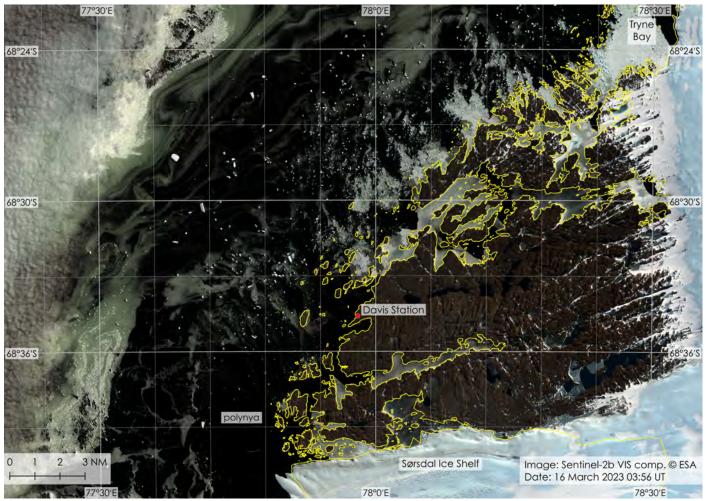
Figure 1: Sentinel-2b visible composite data acquired 16 March 2023 at 03:56 and provided by ESA.

Figure 1 shows high-resolution (10 m horizontal) visible data of Davis Station and the Vestfold Hills.

New sea-ice formation has started off the Vestfold Hills. Minimal fast ice has survived in the fjords of the hills.

Some of the new ice appears discoloured due to late-blooming algae, which are using the new brash ice as vessels protecting from predation and a convenient lift to sunlight as the new ice floats on the ocean surface. This kind of discoloured sea ice is found in multiple places around the Antarctic this season, including off Cape Darnley, around the Commonwealth Bay region, in Terra Nova Bay and McMurdo Sound as well as the coastal Amundsen Sea.

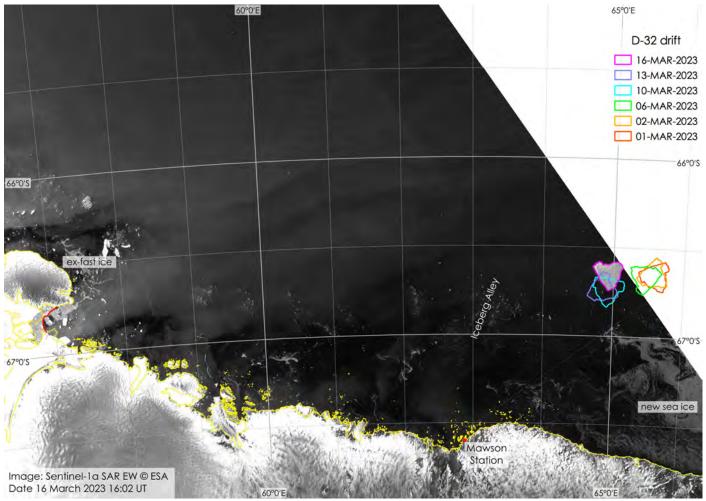
Figure 1: Sentinel-1a SAR data acquired 16 March 2023 at 16:02 and provided by PolarView.

Figure 1 shows SAR data of Mawson Coast and off Mawson Station.

Along Mawson Coast, only very minimal fast ice has survived the summer melt season in the far west (marked by a red line).

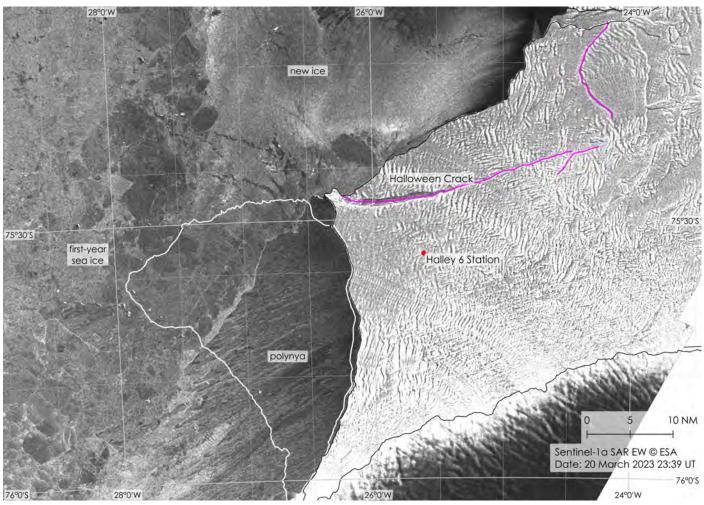
Figure 1: Sentinel-1a SAR data acquired 20 March 2023 at 23:39 and provided by PolarView.

Figure 1 shows SAR data of the Brunt Ice Shelf in the eastern Weddell Sea.

West of Halley 6 Station, the white outline marks the extent of what is now iceberg B-81 and drifting southwest of the ice shelf (not shown in the figure). The area is currently largely occupied by a polynya (open ocean).

North of the station, the Halloween Crack was first spotted on 31 October 2016 and has since progressed eastward. Since the calving of iceberg A-81 in late-January 2023, the western part of the crack has significantly widened by an additional roughly 50 m in two months. Pre-calving, the Halloween Crack had widened to roughly 1300 m since 2016 (on average 17 m per month).

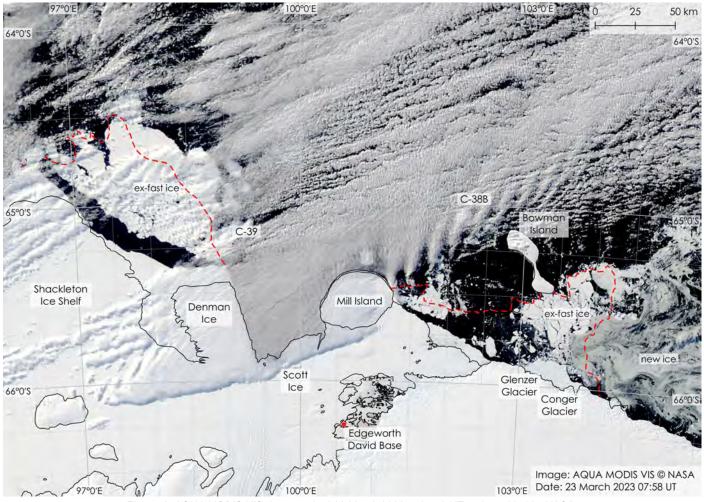
Figure 1: AQUA MODIS VIS data acquired 23 March 2023 at 07:58 UT and provided by NASA.

Figure 1 shows visible data around Mill Island. The fast-ice edge on 1 March 2023 is marked by a dashed red line.

Late-season fast-ice break up continues in the region. Earlier this month, roughly 5400 km² (approximately 4 times the size of Flinders Island, Tasmania) of multi-year fast ice broke away from northeast of the Shackleton Ice Shelf. Also south of Bowman Island, fast ice has now completely disintegrated, and a melange of pack ice and ex-fast ice is present while additionally new sea ice is advected into the region from the east.

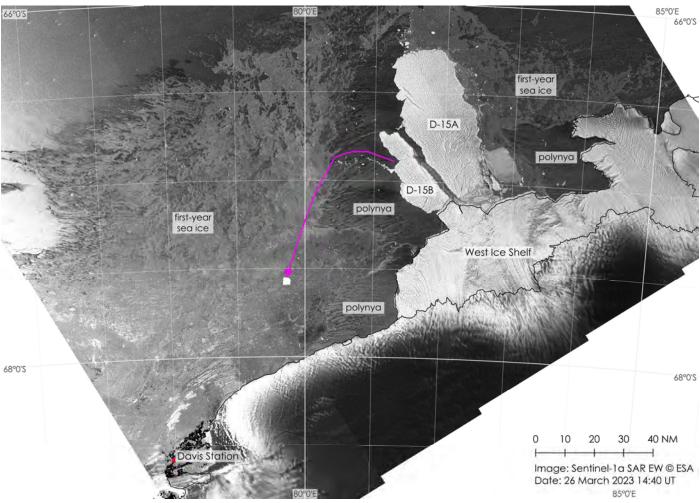
Figure 1: Sentinel-1a SAR EW data acquired 26 March 2023 at 14:40 UT and provided by PolarView.

Figure 1 shows SAR data off Ingrid-Christensen Coast and Davis Station.

Off Davis Station and further north towards the West Ice Shelf, fast ice is starting to consolidate but is yet to form an outer edge. Further offshore, new ice and first-year sea ice is forming and generally drifting westward.

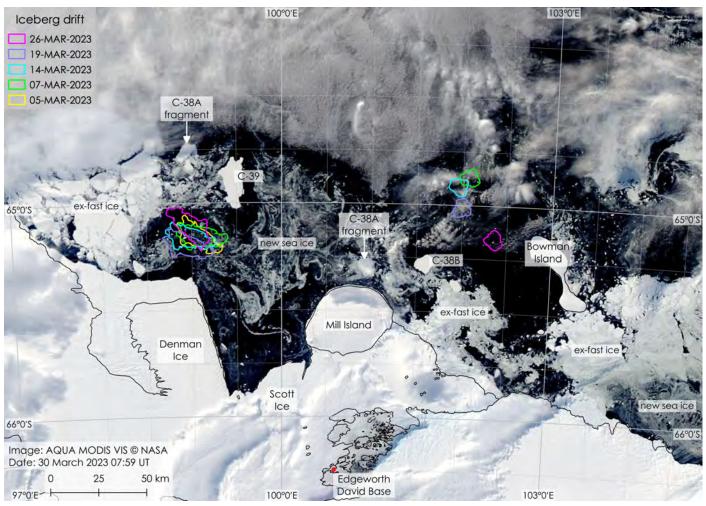
Figure 1: AQUA MODIS VIS data acquired 30 March 2023 at 07:59 UT and provided by NASA.

Figure 1 shows visible data around Mill Island. The drift of large icebergs during March is indicated by colour-coded shapes.

North of the Denman Glacier ice shelf (Denman Ice), the multi-year fast ice that broke away earlier this month continues to break up into smaller floes. Also south of Bowman Island, fast ice completely disintegrated, and a melange of pack ice and ex-fast ice is present while additionally new sea ice is advected into the region from the east.
